**FINAL REPORT**

**AIC 18-1004**

**AIR NIUGINI LIMITED**

**Boeing 737-8BK**

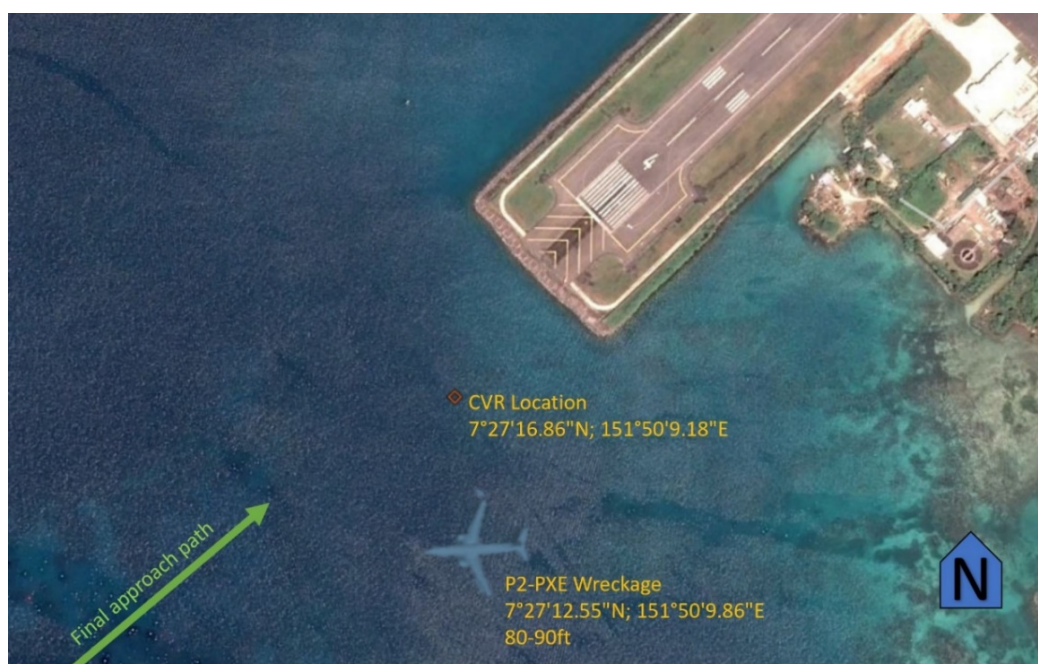
The aircraft deflected across the water several times before it settled in the water and turned clockwise through 210 deg and drifted 460 ft (140 m) south east of the runway 04 extended centreline, with the nose of the aircraft pointing about 265 deg.

**Figure 1: Depiction of aircraft in relation to Chuuk International Airport runway 04 threshold.**

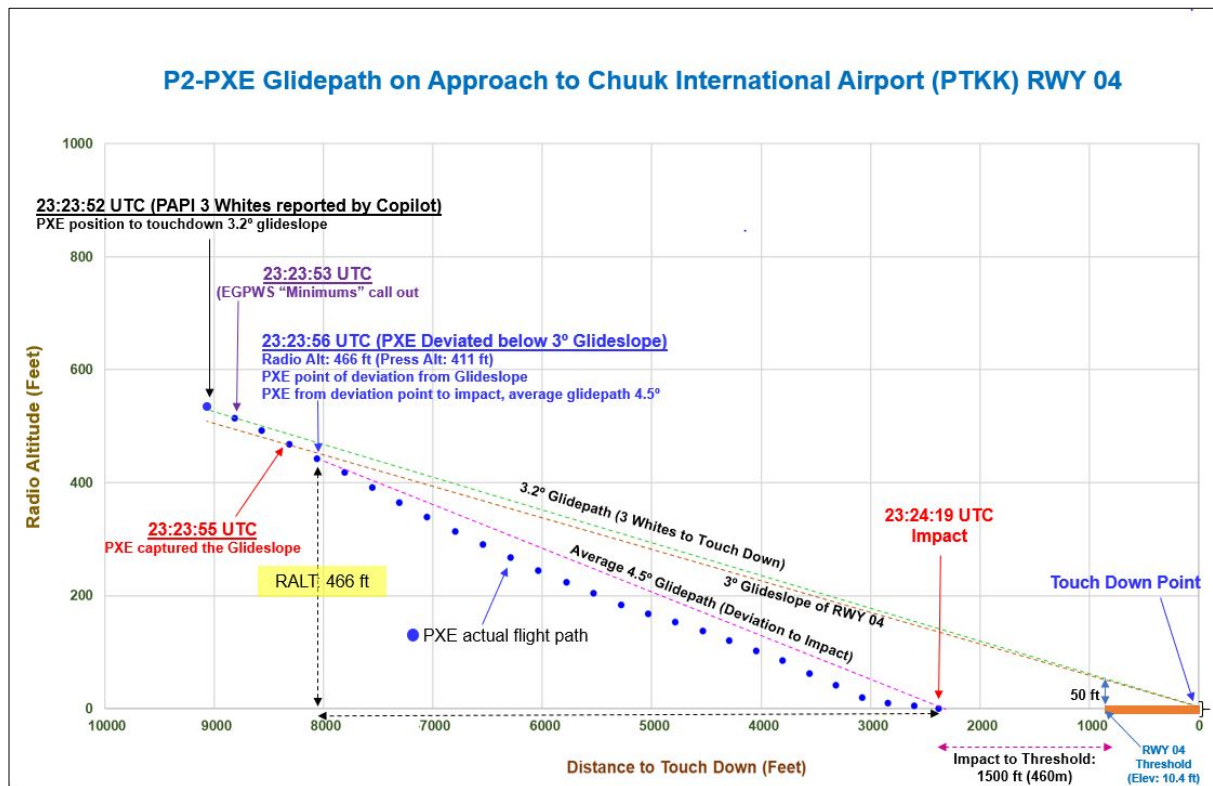
The FDR data showed an unstable approach from 625 ft (**677 ft**) and a flight path deviation from the 3° glideslope to an approach path profile averaging 4.5°.

**Figure 7: Diagram showing glidepath deviation**

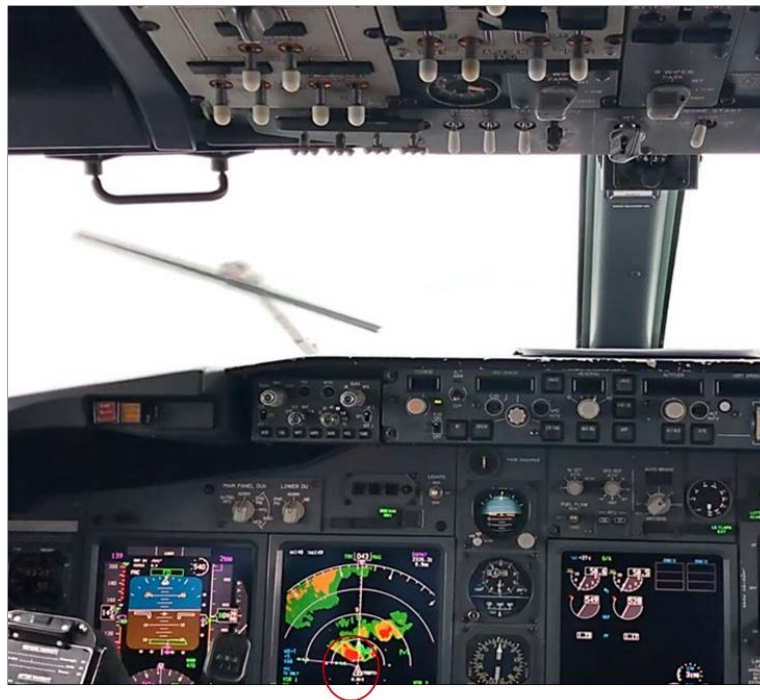
A storm cell situated immediately after the missed approach point was *painted*<sup>45</sup> on the weather radar on the PIC's Navigation Display.

The crew continued past the missed approach point and entered into IMC and subsequently into heavy rain.

**Figure 9: PFD and NAV display<sup>46</sup> showing weather and missed approach track.**

**NOTE:** In Figure 9, the windscreen wipers are ON (activated). The Triangle circled on the NAV display represents the aircraft.

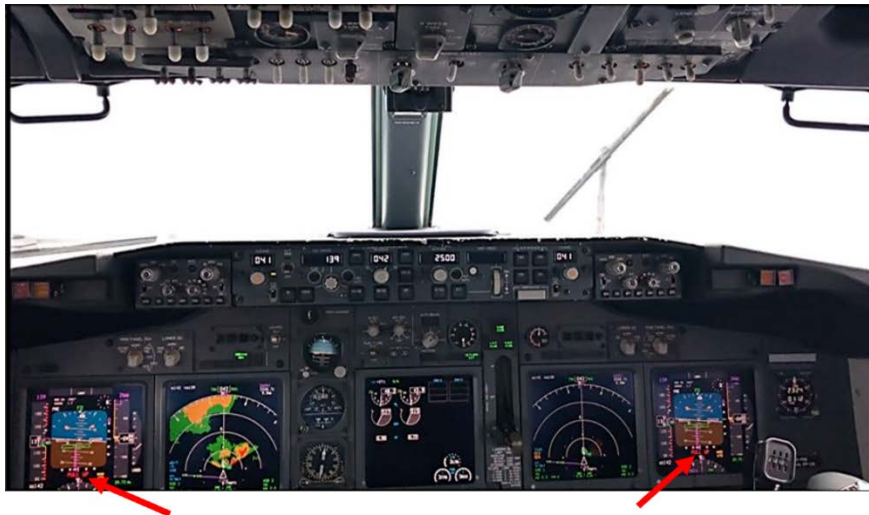
Figure 12: One second before impact. Showing **PULL UP** on PFD display<sup>50</sup>

There was no evidence that the high rate of descent (ROD) was caused by environmental forces. The CVR data and video synchronizations do not show any sign of the crew noticing any unusual aircraft displacements against control inputs, nor a notion of a subtle recovery. There was evidence, though, that aircraft movements during the approach were in response to positive control inputs by the PIC.

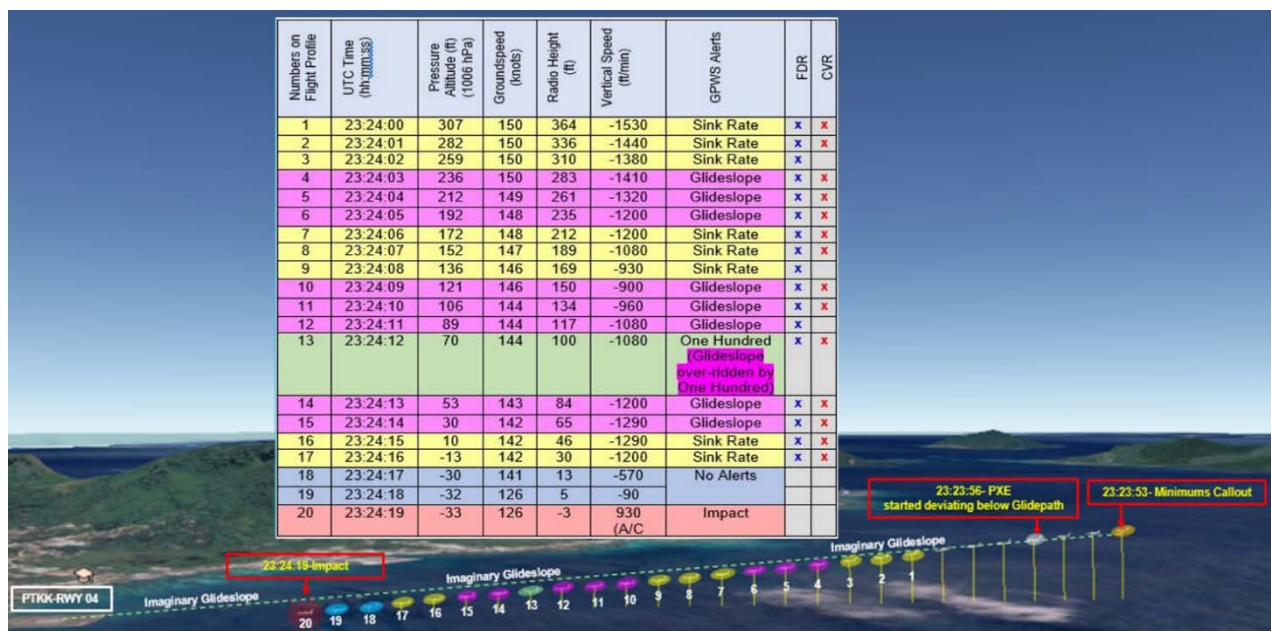
Figure 13: Glideslope and Sink Rate aural alerts graphic plotted using Derived Data

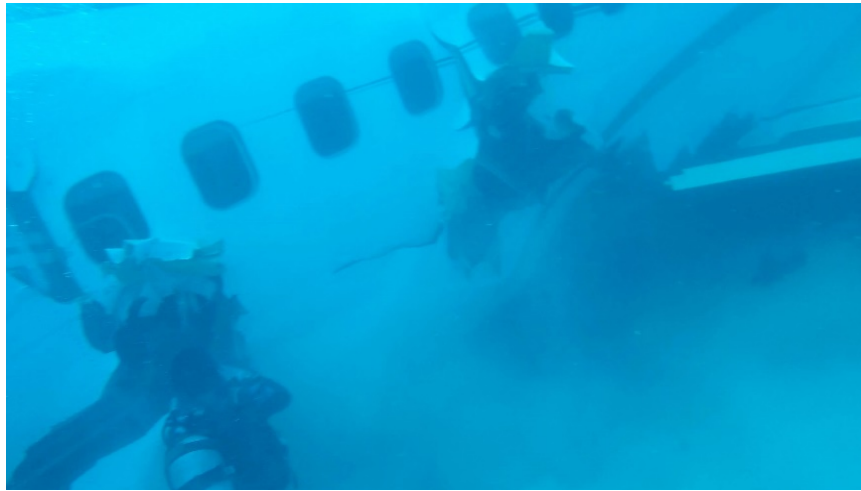
**Figure 15: Fuselage fracture right side behind the wing at wing root, in the area of seat row 22**

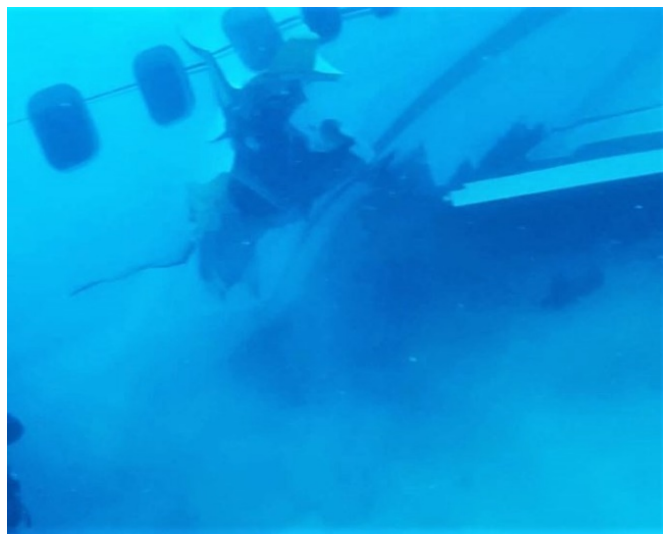
**Figure 16: Fuselage fracture right side behind the wing showing wing flap separation**

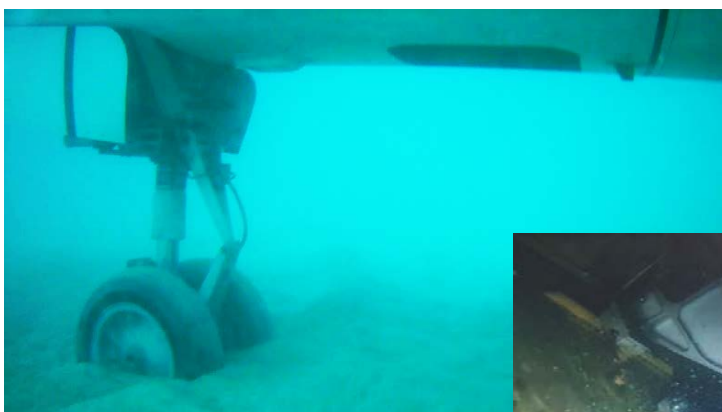
The main landing gear separated from the aircraft during the water impact, but the nose landing did not appear to have sustained impact damage.

**Figure 17: Nose landing gear assembly**  
(Avionics bay in belly behind landing gear)

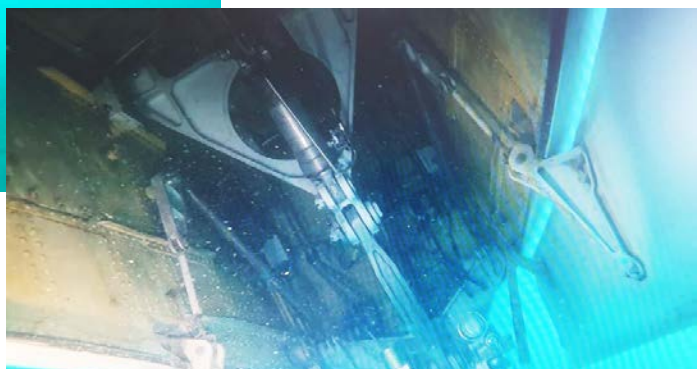
**Figure 18: Nose landing gear assembly looking into the landing gear bay**

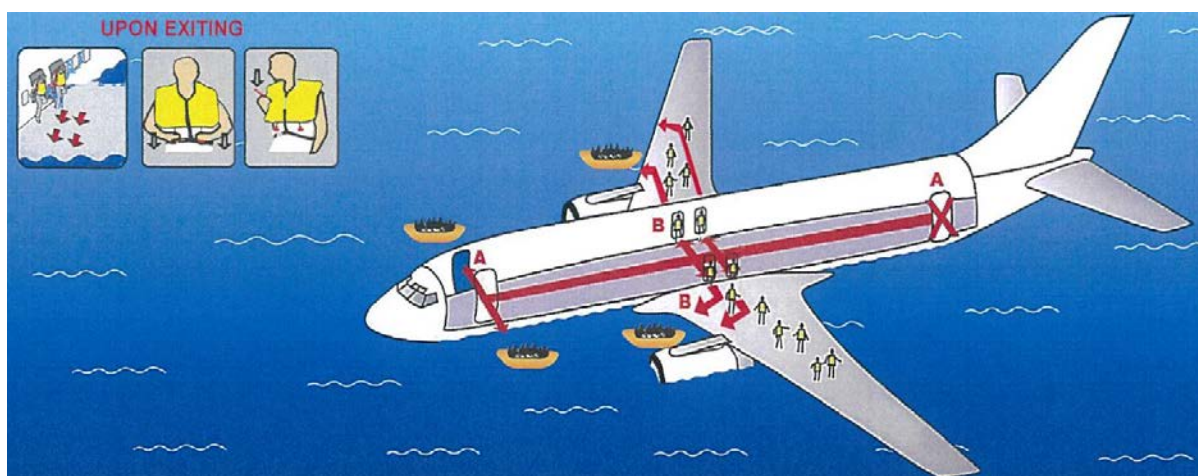
The investigation determined that the *Safety on Board Card* (passenger briefing card) for P2-PXC and P2-PXE incorrectly showed a path to the doors 1L and 1R with a life raft deployed from each door.

**Figure 23: Safety on Board Card (Version PX3-11009 Rev.A) Incorrect depiction.**

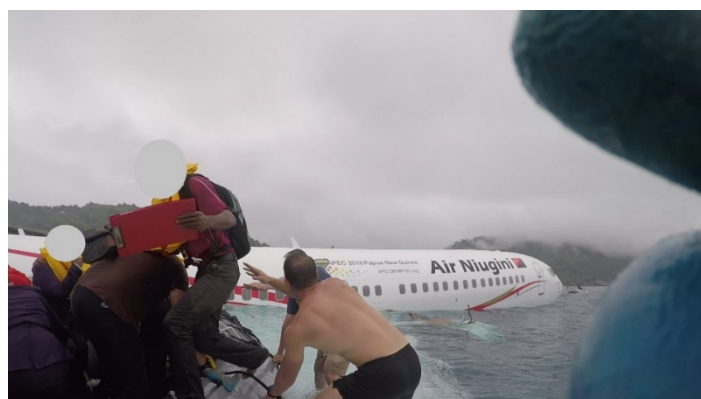
One of the cabin crew members took a uniform issued hand-bag from the front of the aircraft, through the cabin to the right over wing exit. Likewise, the load master carried a backpack, a clipboard and shoes off the aircraft. Both of his hands were full.

**Figure 25: Load master getting into a rescue boat with baggage taken from the aircraft, both hands full.**

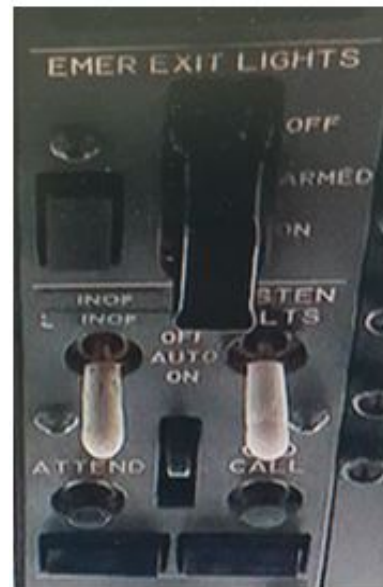
**Figure 29: P2-PXE Cockpit Overhead Panel Emergency Light switch during the approach**  
(Source: Snapshot taken from video taken by jump seat occupant from top of descent to impact.)

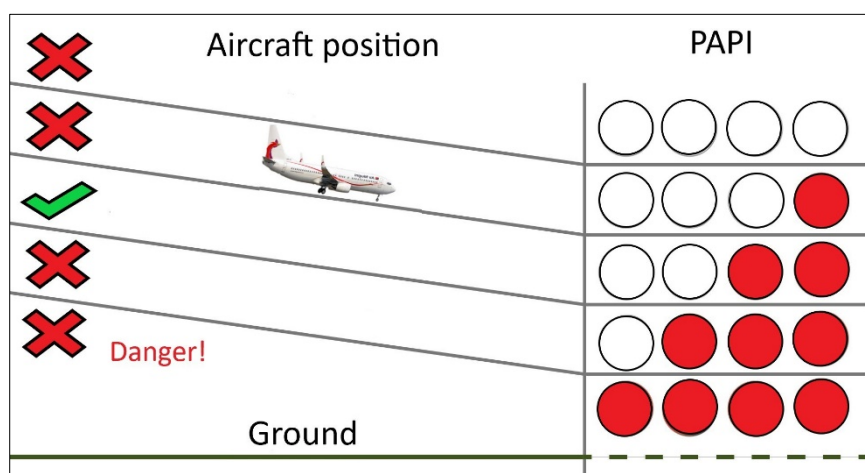
PXE actual glidepath at the MDA is depicted in the figure 44 below.

Figure 44: PXE flight profile at the MDA on approach to land
