**KOMITE NASIONAL KESELAMATAN TRANSPORTASI
REPUBLIC OF INDONESIA**

KNKT.18.10.35.04

Aircraft Accident Investigation Report

**PT. Lion Mentari Airlines
Boeing 737-8 (MAX); PK-LQP
Tanjung Karawang, West Java
Republic of Indonesia
29 October 2018**

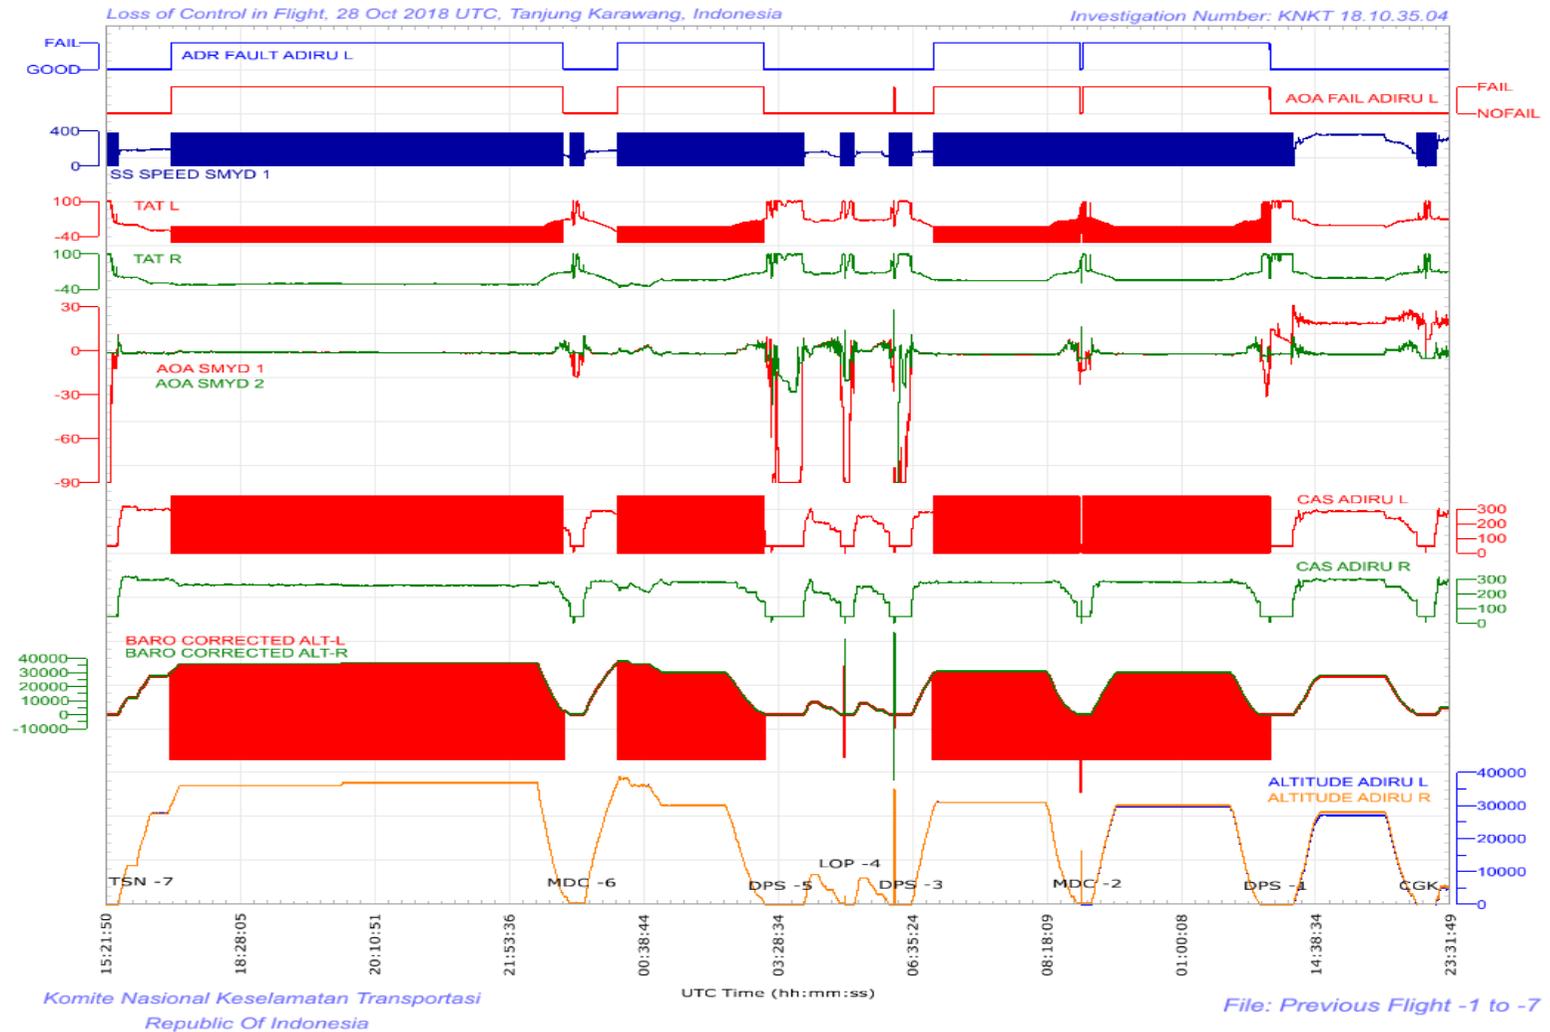
Figure 24: The FDR recorded IAS and ALT FLAG appeared since the flight from Tianjin

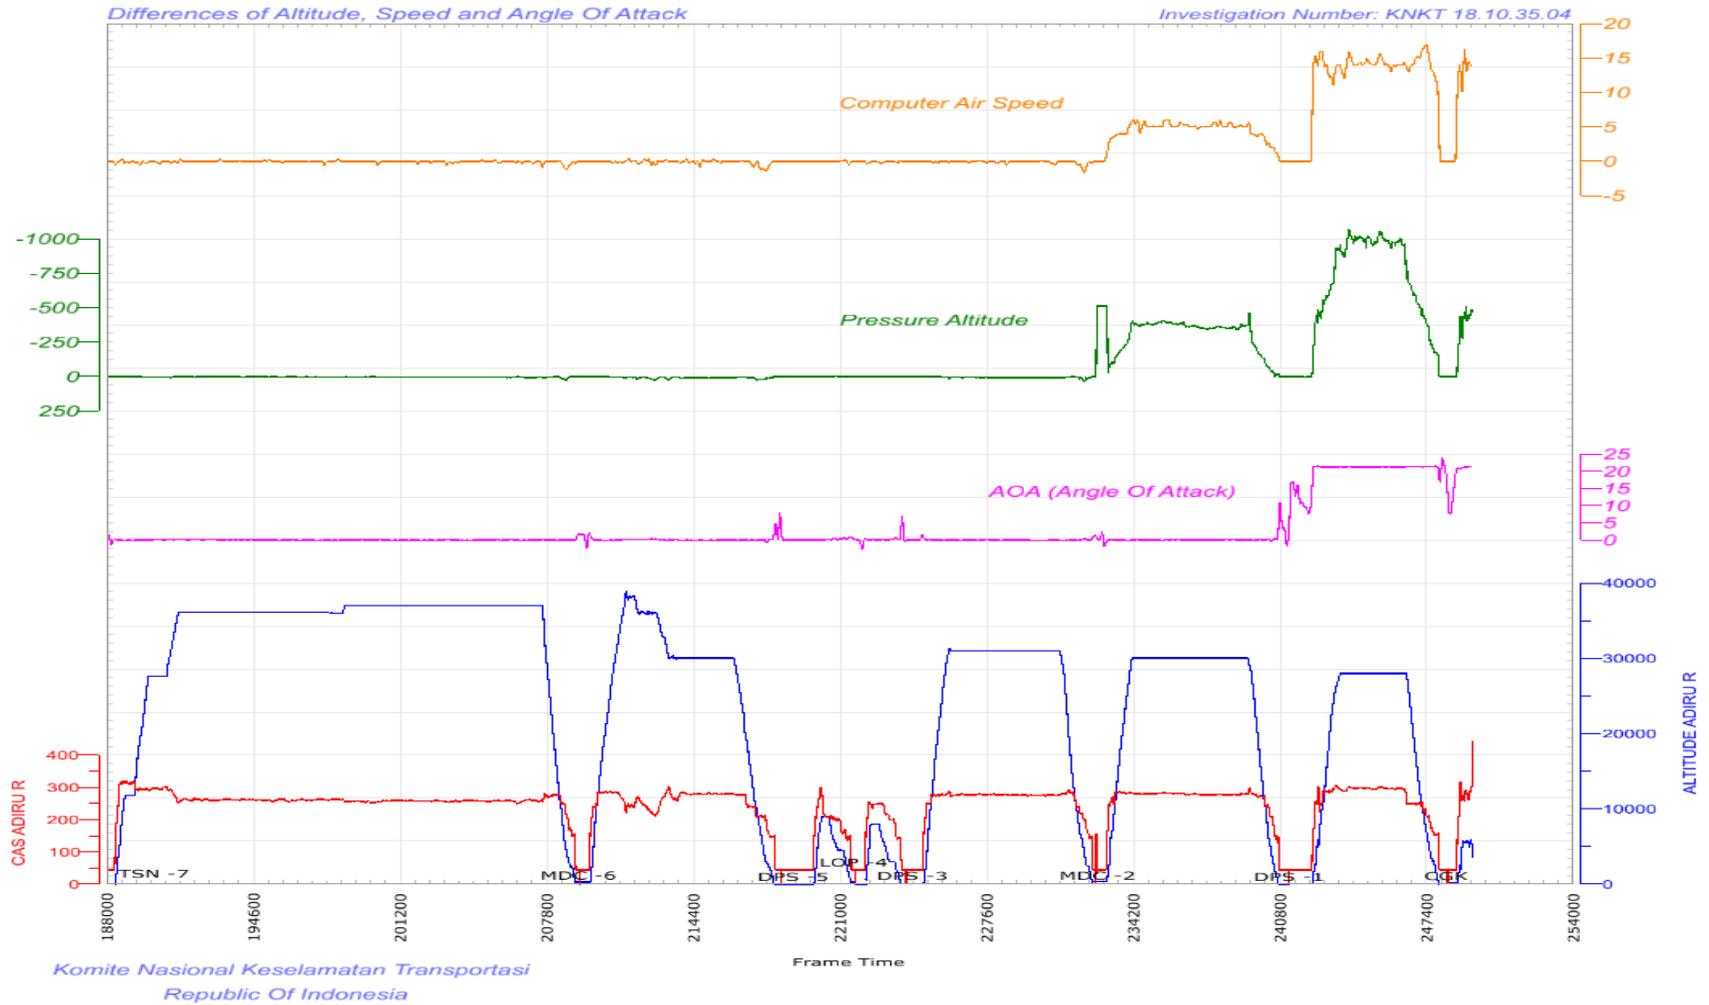
Figure 25: The differences in speed indicator and altitude between left and right instruments recorded on the DFDR

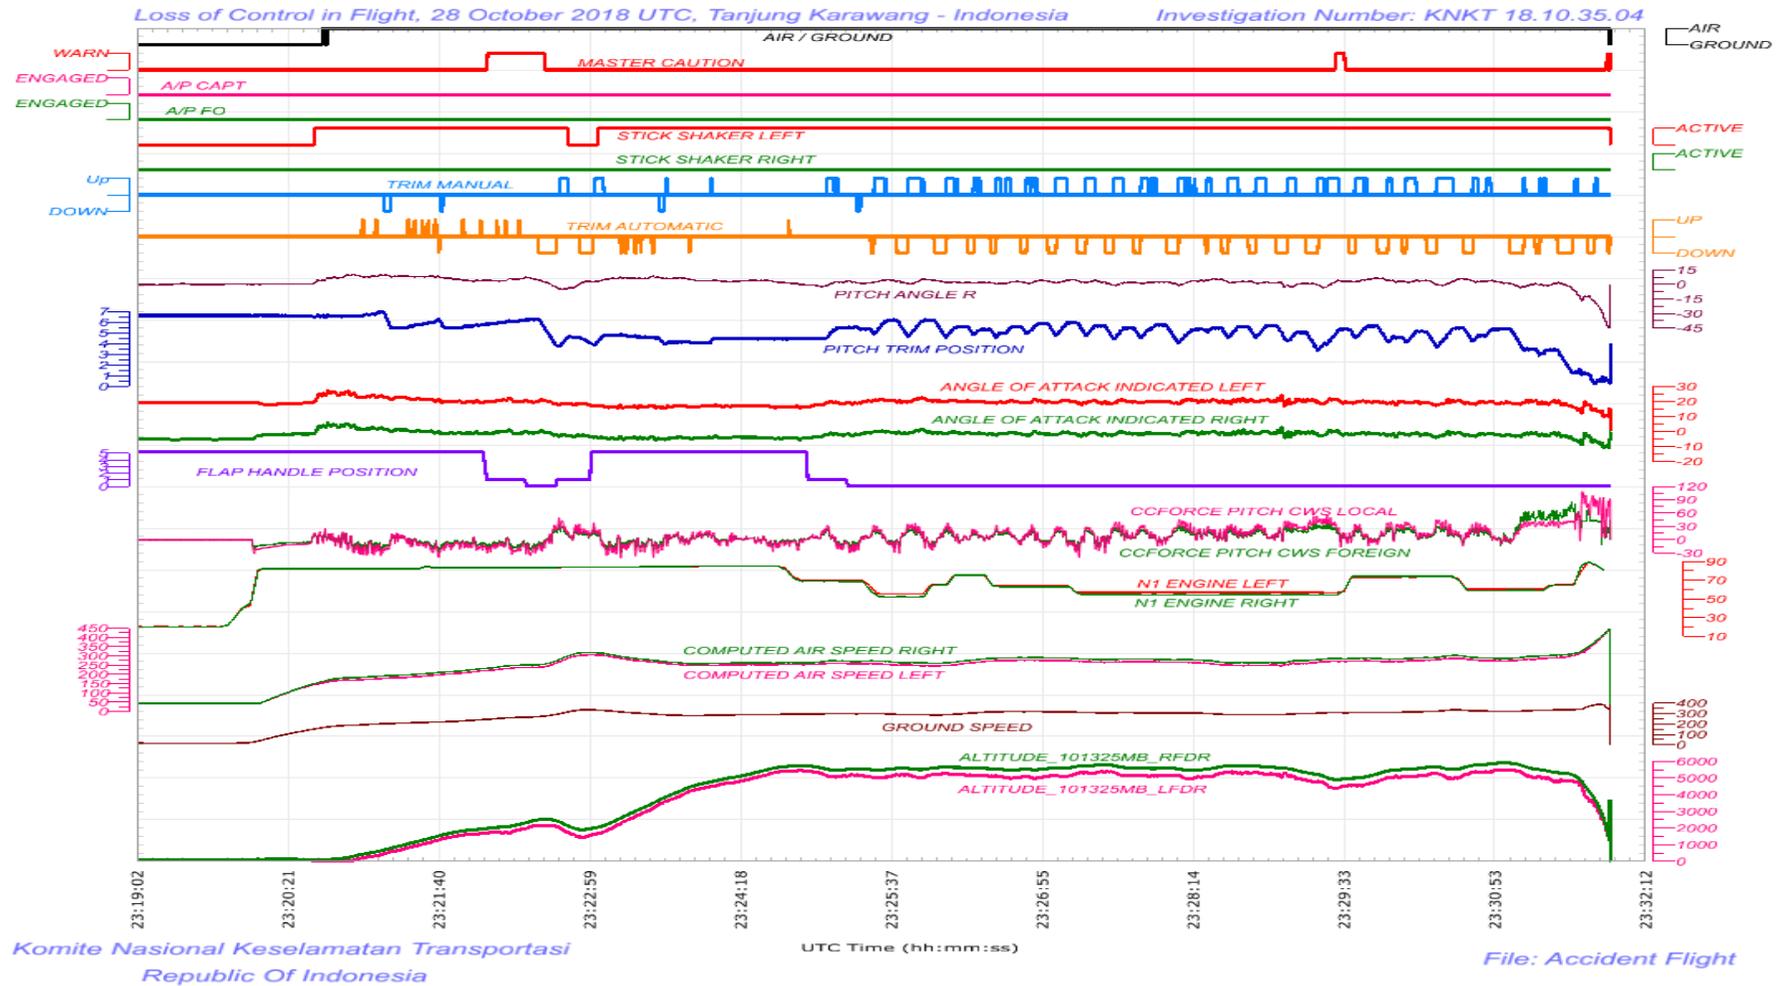
Figure 29: The significant parameters from the accident flight

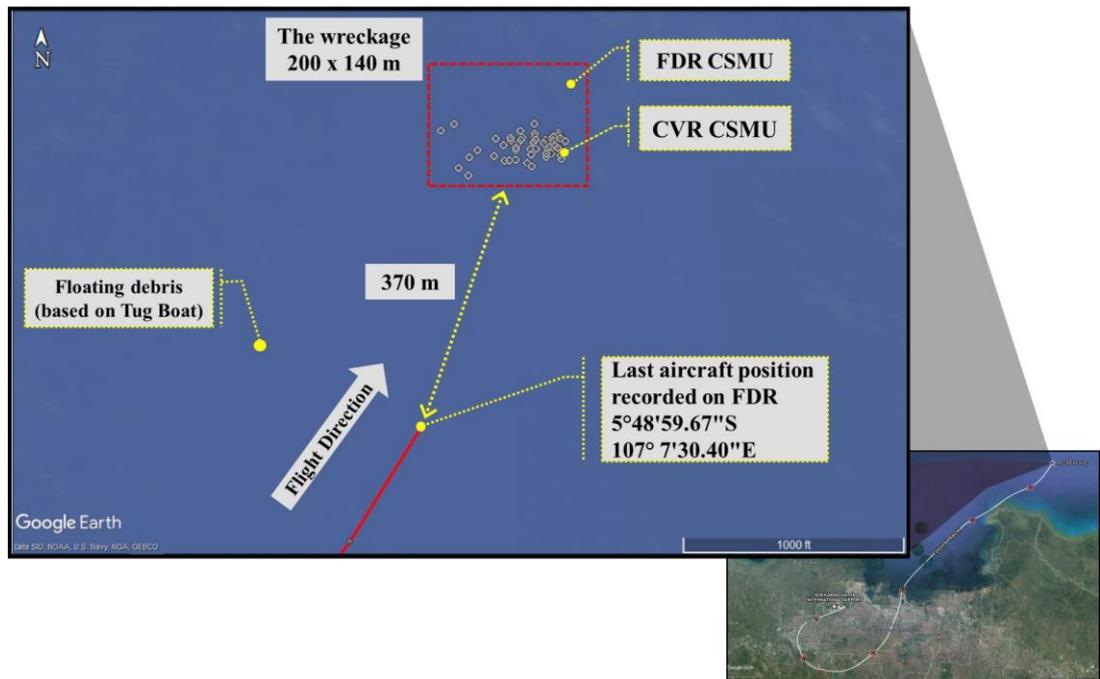
The recovered wreckage identified consisted of, but was not limited to, parts from the left and right engines, both main landing gears, parts of the empennage, parts of the forward and aft left passenger doors, parts of the wings, a flight crew oxygen bottle, and parts of a circuit breaker panel. The damage to the aircraft suggested a high energy impact.

Figure 30: The wreckage distribution

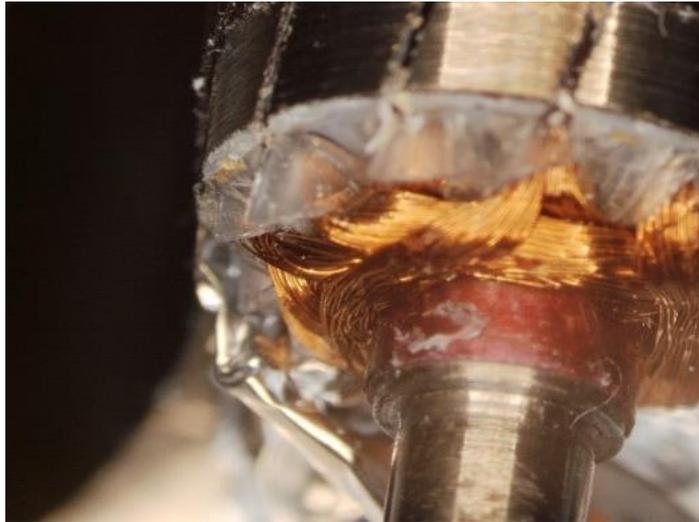
Using CT Scans, physical examinations, and Scanning Electron Microscope (SEM) imaging, the open circuit was found to be a broken magnet wire on the rotor coil. A loose loop in the coil of the magnet wire had been epoxied between two different insulators on the rotor with different coefficients of thermal expansion for each insulator. As the rotor was exposed to cyclic differences in operating temperature over time, it is likely that the difference in the expansion rates of the two insulators induced a localized stress in the coil wire that led to a fatigue break in the wire that was open or closed dependent on temperature.

Figure 46: Coil exposed after End Cap removal

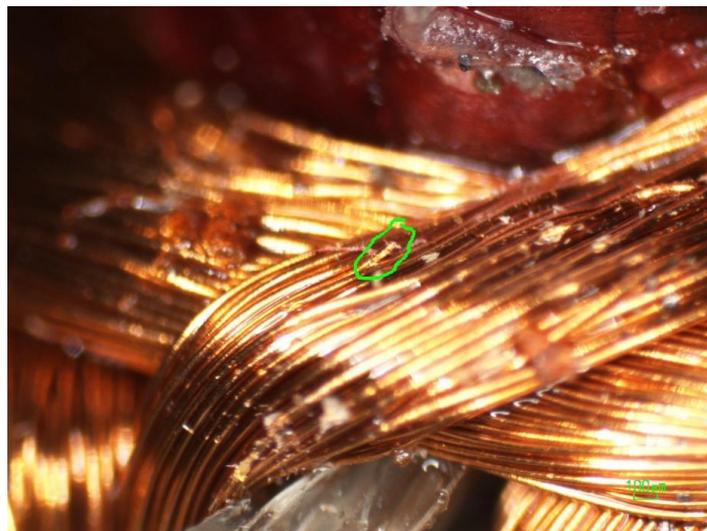
Figure 47: View of broken wire tensile failure on coil end
