Estonian
Safety
Investigation
Bureau

INVESTIGATION REPORT

ACCIDENT, LOSS OF CONTROL WITH AIRBUS A320-214
NEAR TALLINN AIRPORT ON 28.02.2018

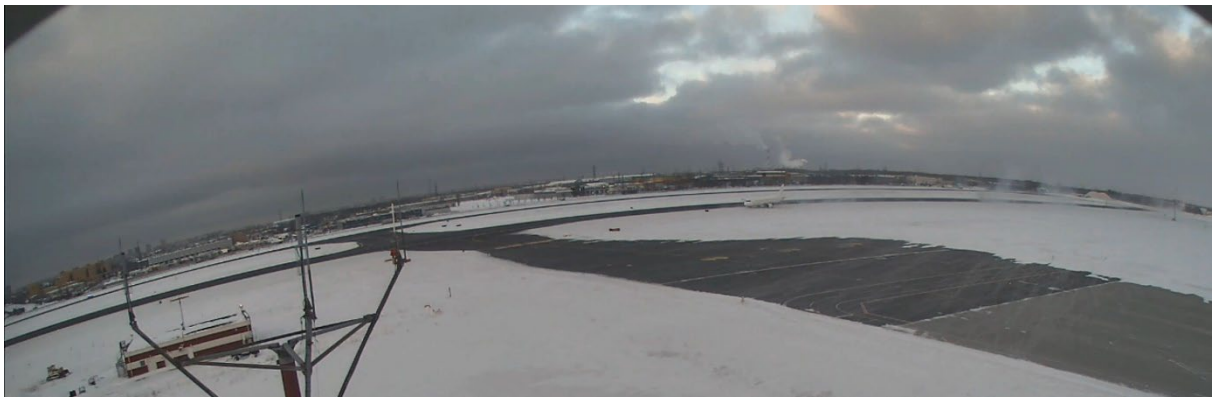
Figure 11. Aircraft position after coming to a full stop (a screenshot from the recordings of Tallinn Airport surveillance cameras)

The aircraft landing gear doors, landing gears, both engine nacelles, engines and aircraft fuselage suffered severe damage in this accident resulting in aircraft hull loss.

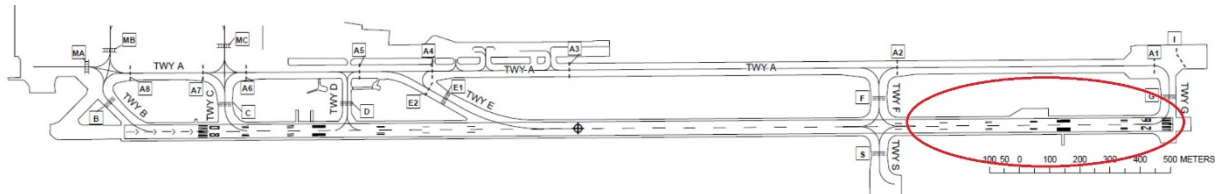
The accident occurred at the end of Tallinn airport runway 08. During the take-off phase, the aircraft hit the ground with the engines and L/G doors 200m before the end of the runway, flew for 2 minutes, then turned around and landed 150m before the threshold of runway 26 and came into stop 600m from the runway threshold (Figure 30).

Figure 30 Runway of Tallinn Airport, debris area

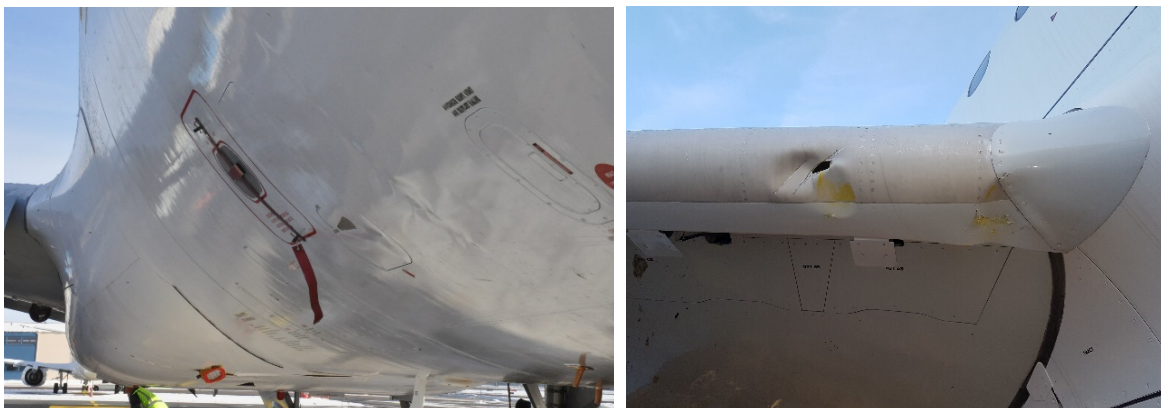
All observed damages were consistent with post-impact damages.

Figure 31 A/C skin wrinkled, fairings damaged by landing lights; slat punctured

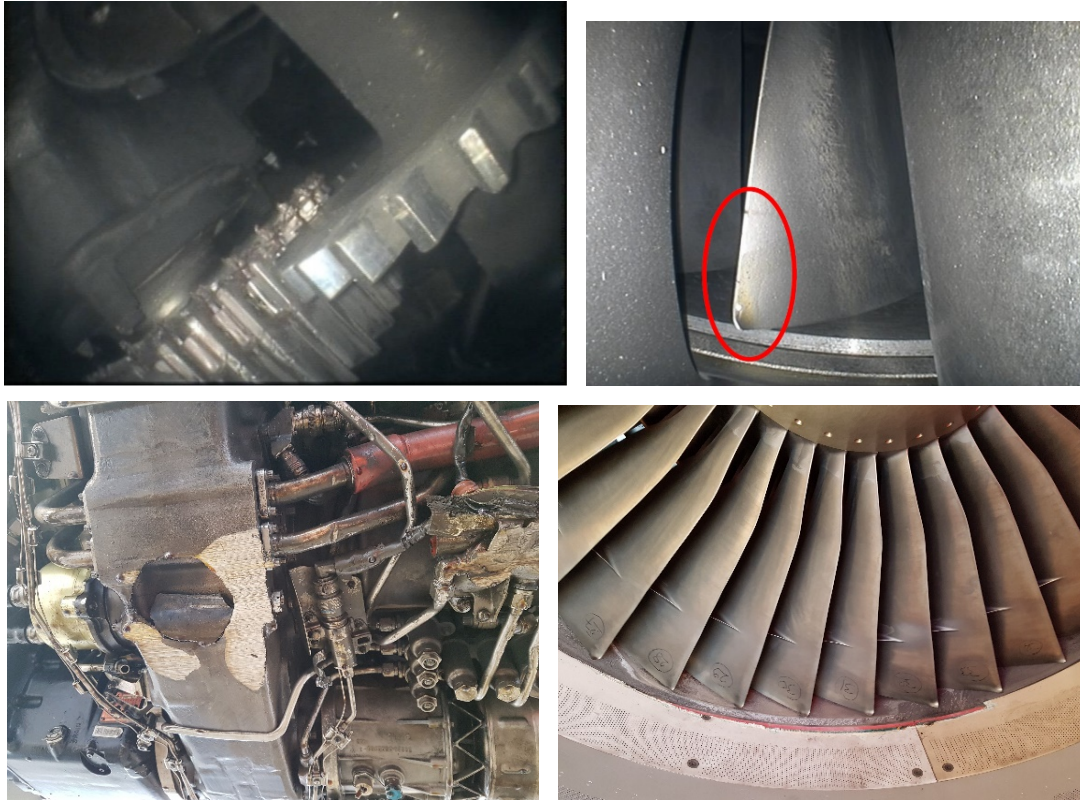
All damage was consistent with an impact with the ground.

Figure 32 Bound gears in AGB; minor tip curl at compressor stage 4; Perforated AGB case; Fan blade tip curl and scraped lining.

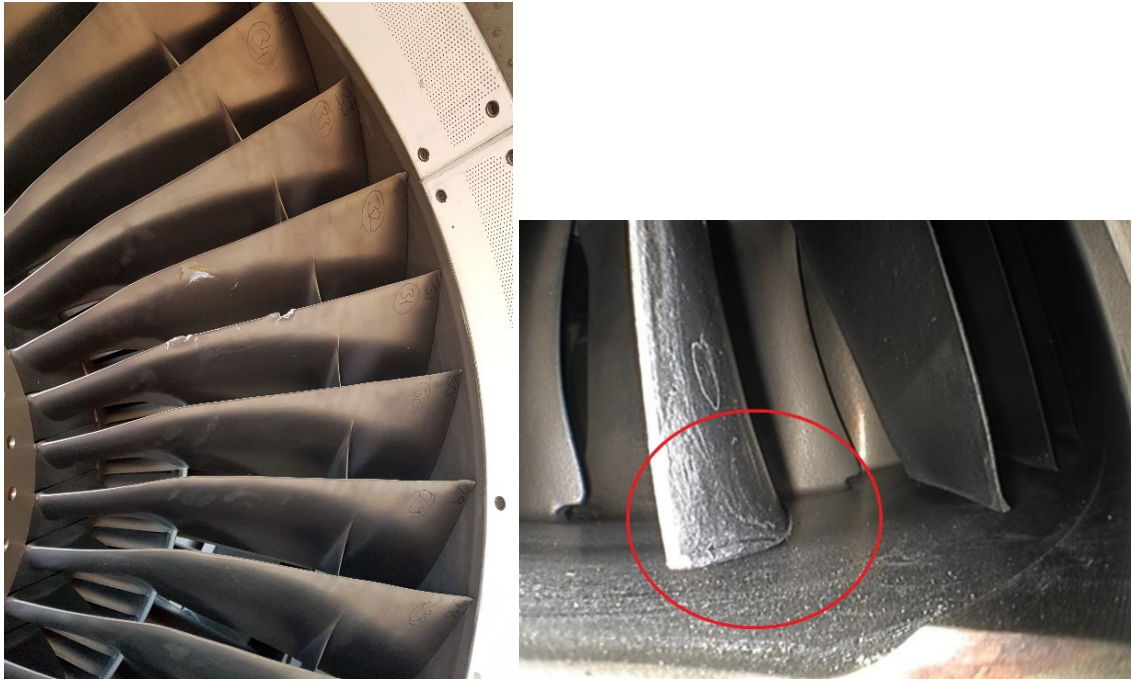
All damage was consistent with an impact with the ground.

Figure 33 FOD on fan blades; tip rub at compressor stage 3

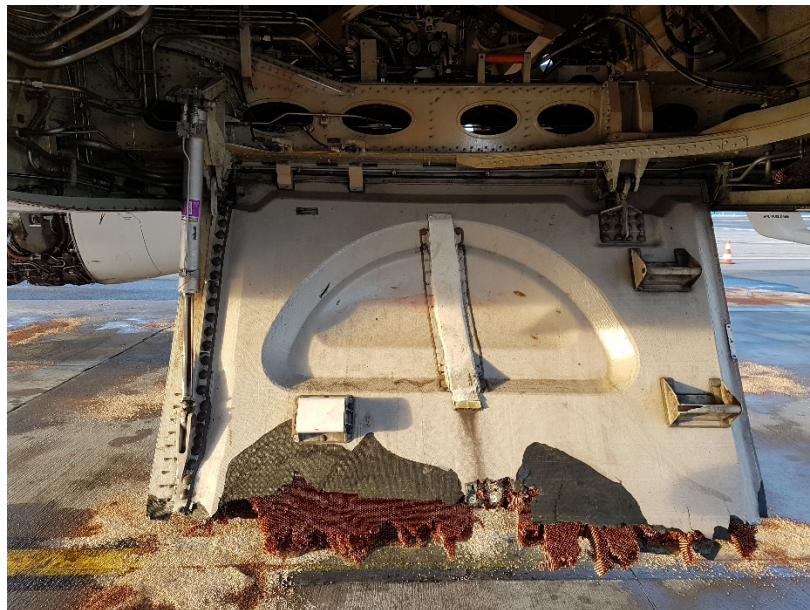
Main door, lower lip was completely missing, strut door attach rods sheared and door actuator piston rod bent (Figure 34). Both tires were burst with a flat spot. Hydraulic fluid leakage from O/B of the Rib 5 area.

Figure 34 Bent LH landing gear actuator and damaged door

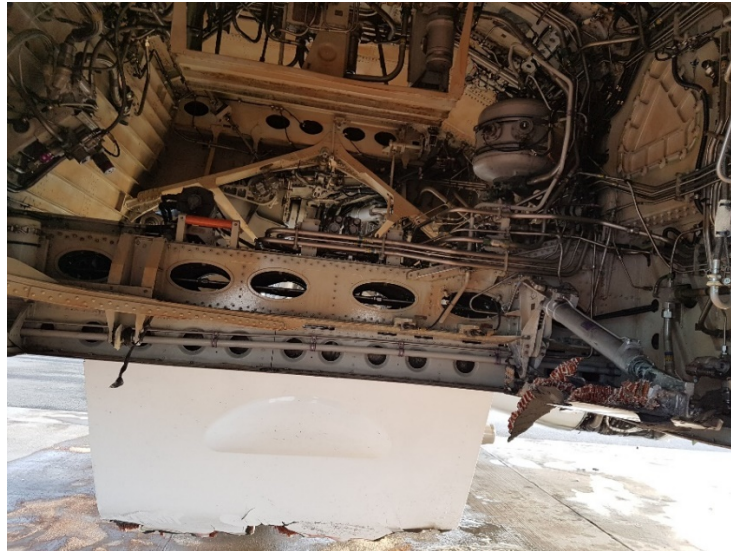
Main door was completely missing (Figure 35), hinge points remained intact, door actuator was in retracted position. Strut door actuator piston rod was bent. Both tires were burst with a flat spot. Evidence of significant Hydraulic fluid leakage, Rib 5 area.

Figure 35 RH landing gear actuator and missing door

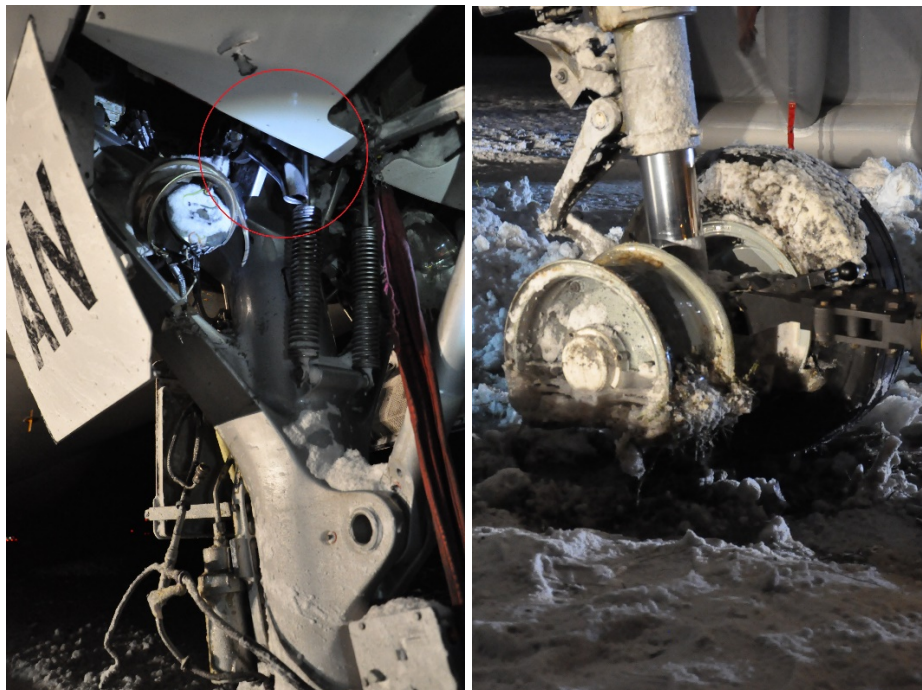
Actuator rod was sheared at the actuator body end (Figure 36). Strut was fully compressed. Turn off lights and taxi lights assemblies were broken and some of them missing. Both tires were burst, and RH tire ripped off from the wheel. RH wheel suffered major abrasion damage.

Figure 36 Sheared front landing gear actuator; abraded front wheel

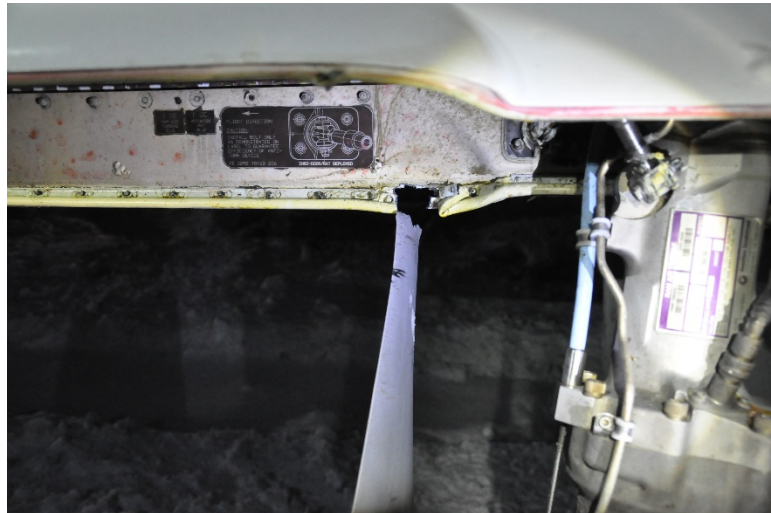
RAT was deployed, blade tips were damaged from the contact with the right RAT doors (Figure 37). RAT door link damper was broken and bent, one was missing.

Figure 37 Damaged RAT blade tips and rat doors

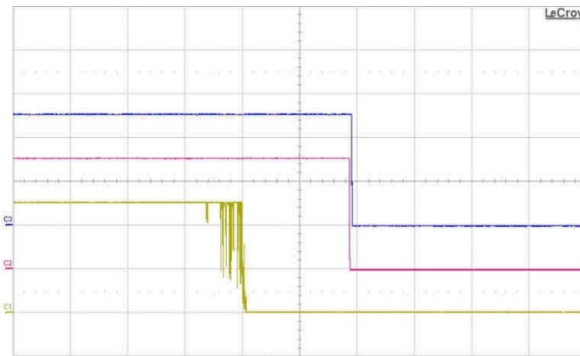
Figure 52 While ground setting is launched and manual input is held, switch 1 signal is activating with abnormal spikes. Switch 2 and 3 appears with delays after 2s.

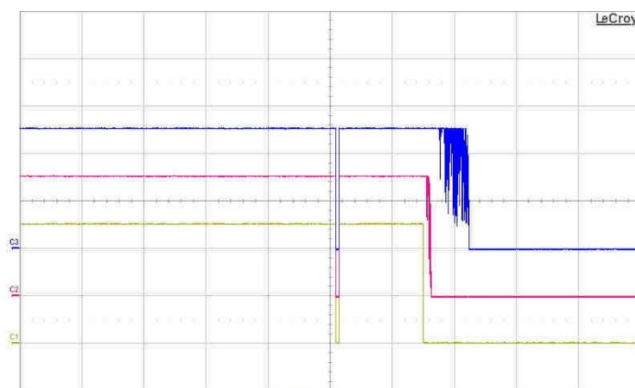
Figure 53 While ground setting is launched and manual input is held, switch 1, 2, 3 signal is transiently compliant for 100ms, disappears for 1,2s activating with abnormal spikes. Switch 2 and 3 appears with delays after 2s.

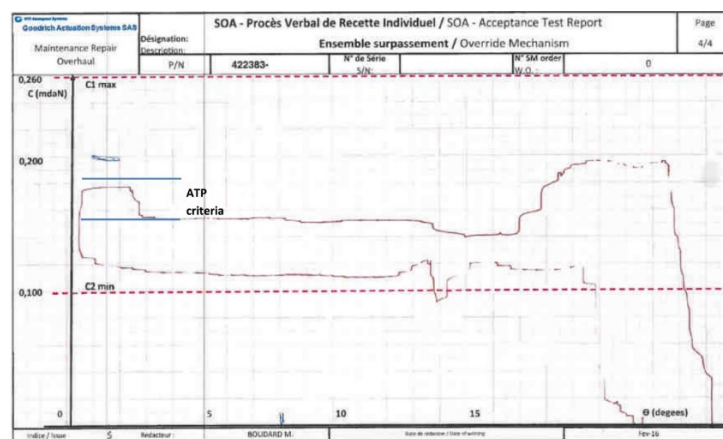
Figure 55 Override test results, the actual friction curve is slightly under the required criteria

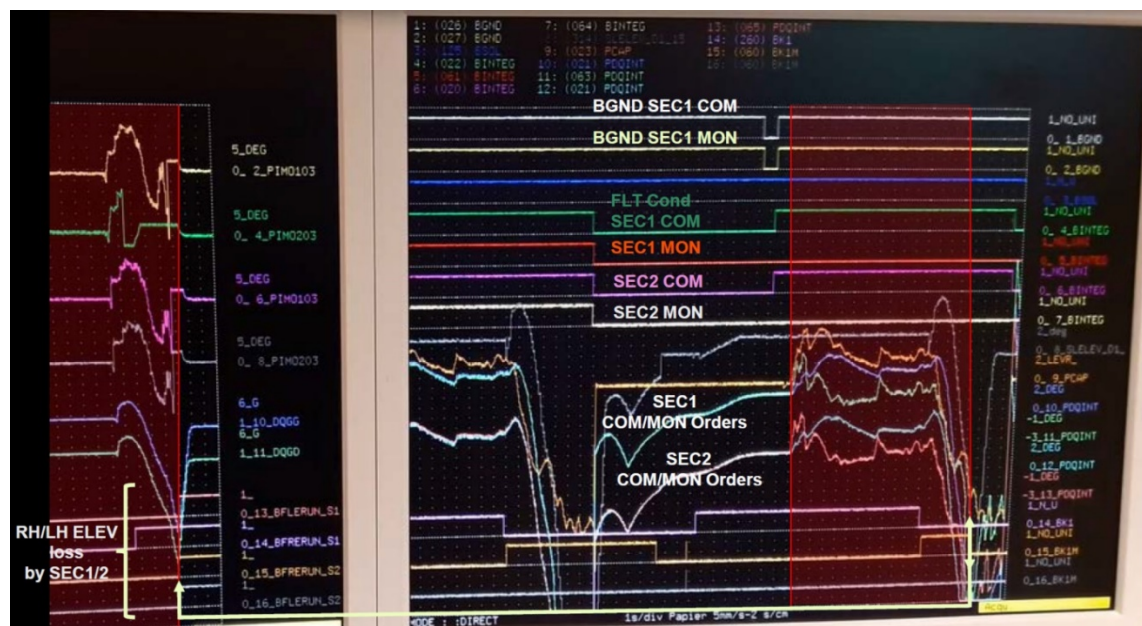
Figure 64 Loss of ELEV control by the two SECs by the discrepancy between SEC COM and MON Ground/Flight condition

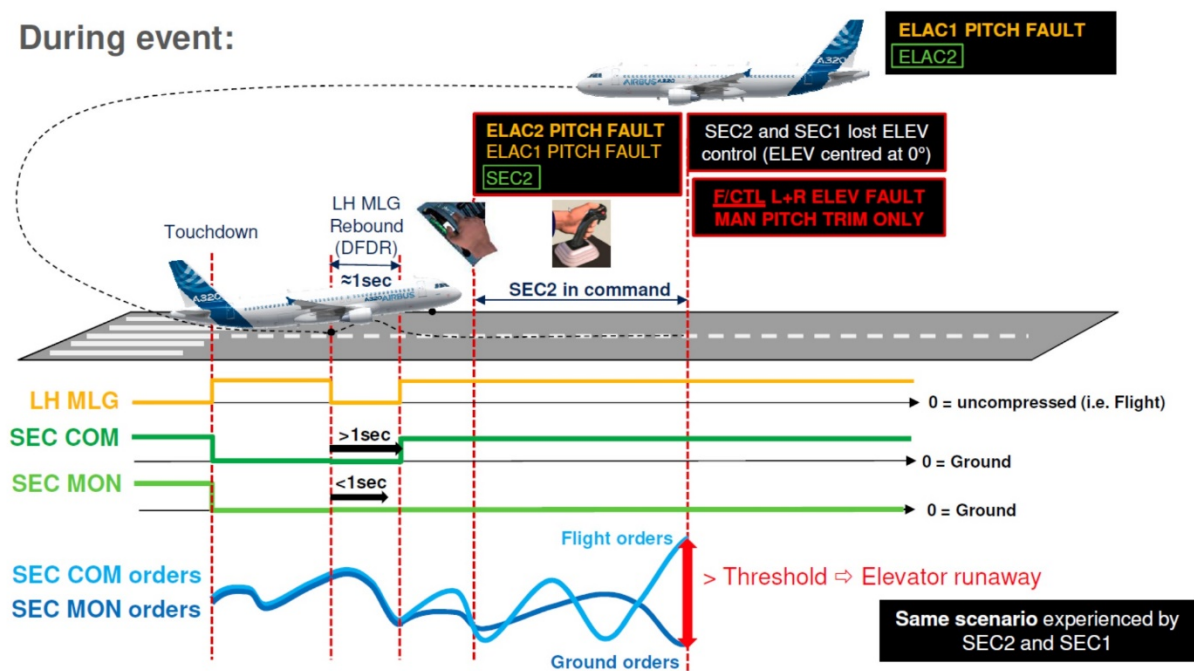
Figure 70 Sequence of events, discrepancy in SEC COM and MON orders
