Air Accident Investigation Sector

- Final Report -

AAIS Case N°: AIFN/0010/2017

Descent below Cleared Altitude during Approach and FMS not reconfigured following a reset during the Second Approach

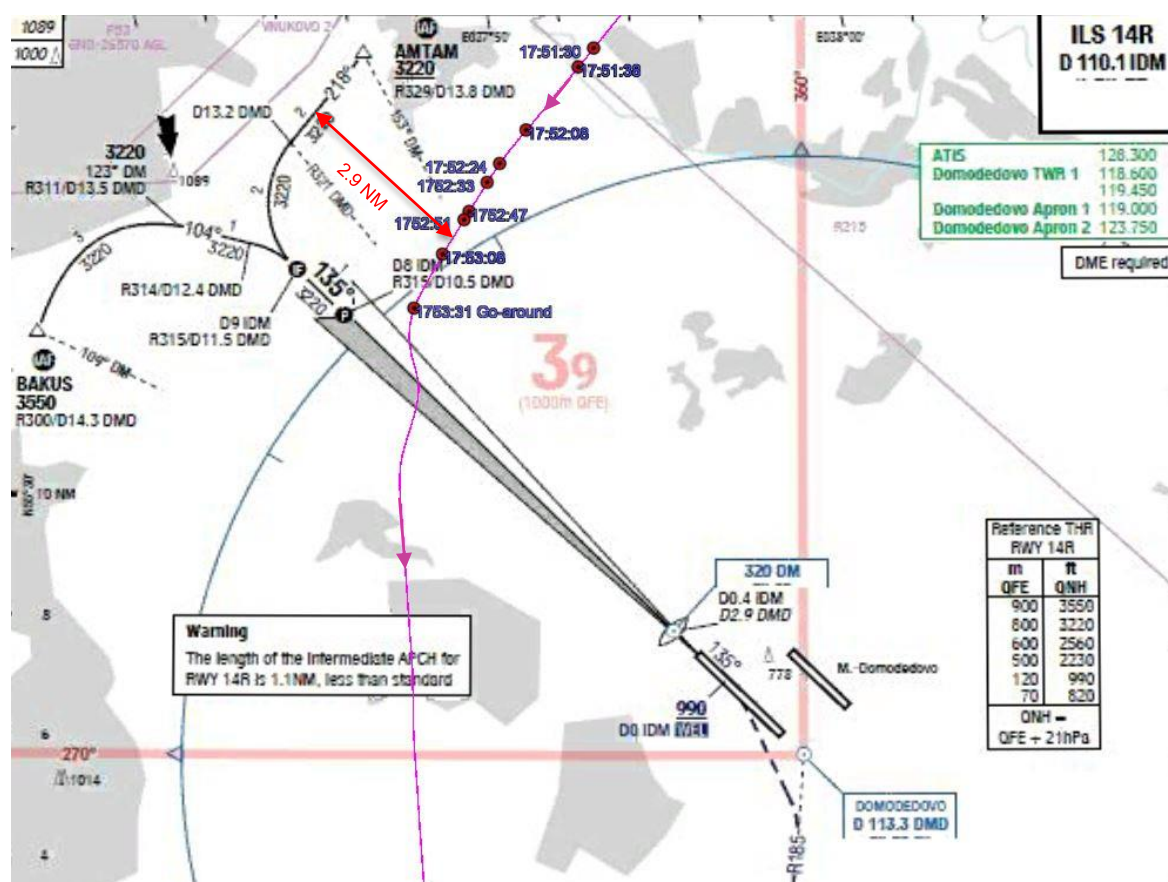
Figure 4 – First Approach and Go-around Flight Path on Instrument Approach Chart (IAC) for ILS 14R

The Radar Controller instructed EK131 to continue on its present 200-degree heading, and to climb to 900 meters QFE (3,550 feet QNH). While the Aircraft climbed through 2,128 feet pressure altitude, the controller instructed the flight crew to change heading to 180 degrees. The Radar Controller requested the reason for the go-around and the Commander replied that the approach had been unstable.

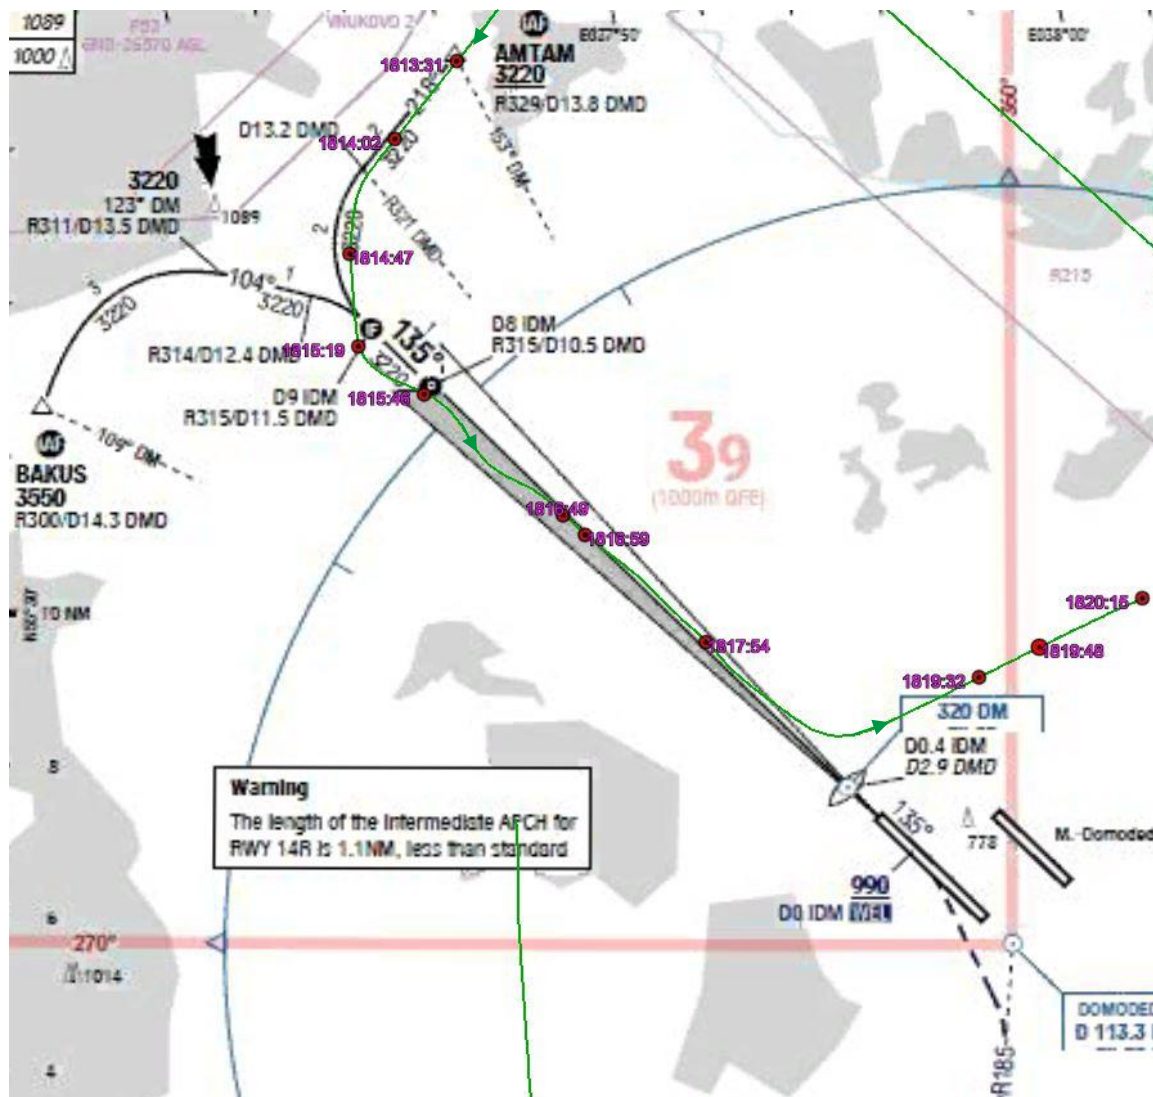
Figure 5 – Second Approach and Discontinued Approach Flight Path on the IAC Chart for ILS 14R

At 1813:31, the Radar Controller provided the clearance for ILS 14R and instructed the flight crew to maintain a 220 degree heading in order to establish on the localizer. No speed limit instruction was provided to EK131. The Radar Controller advised that there was one aircraft on final leg with a separation of approximately 10 kilometers from EK131, which was considered to be sufficient separation. EK131 was maintaining 3,280 feet pressure altitude.

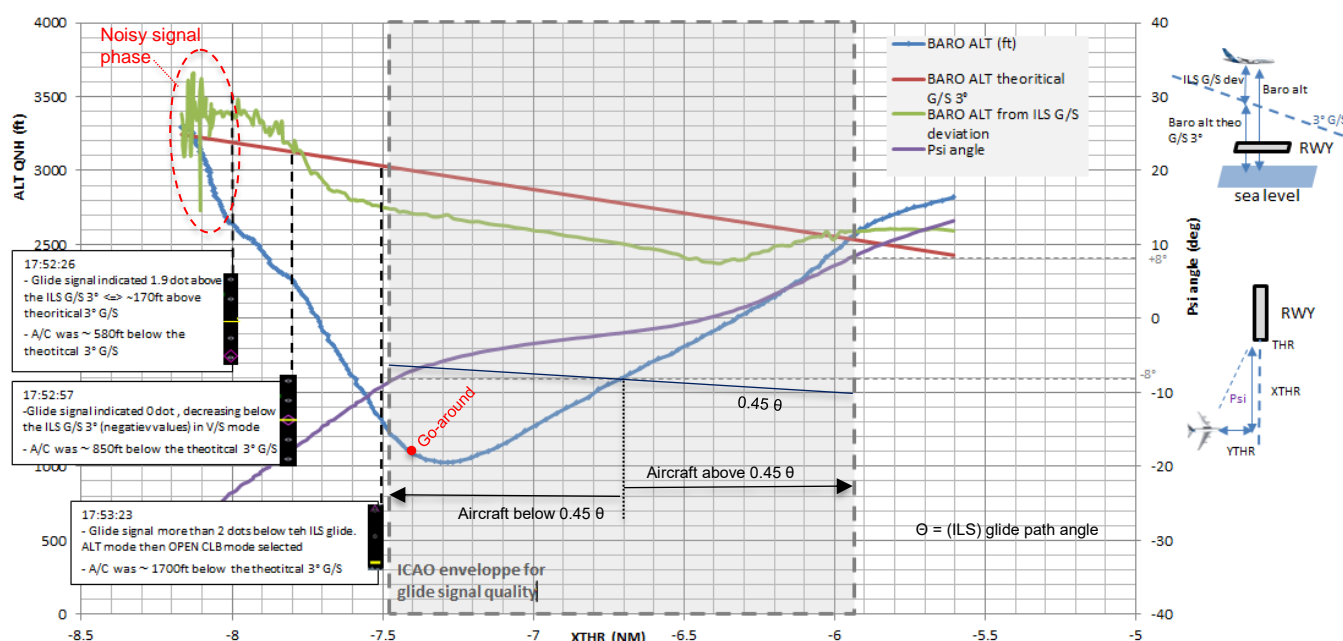
Figure 33. Selected Aircraft parameters as a function of the distance to the runway 14R threshold

deviation indication indicated that the Aircraft was on profile. Following this, the actual Aircraft height continued to decrease.

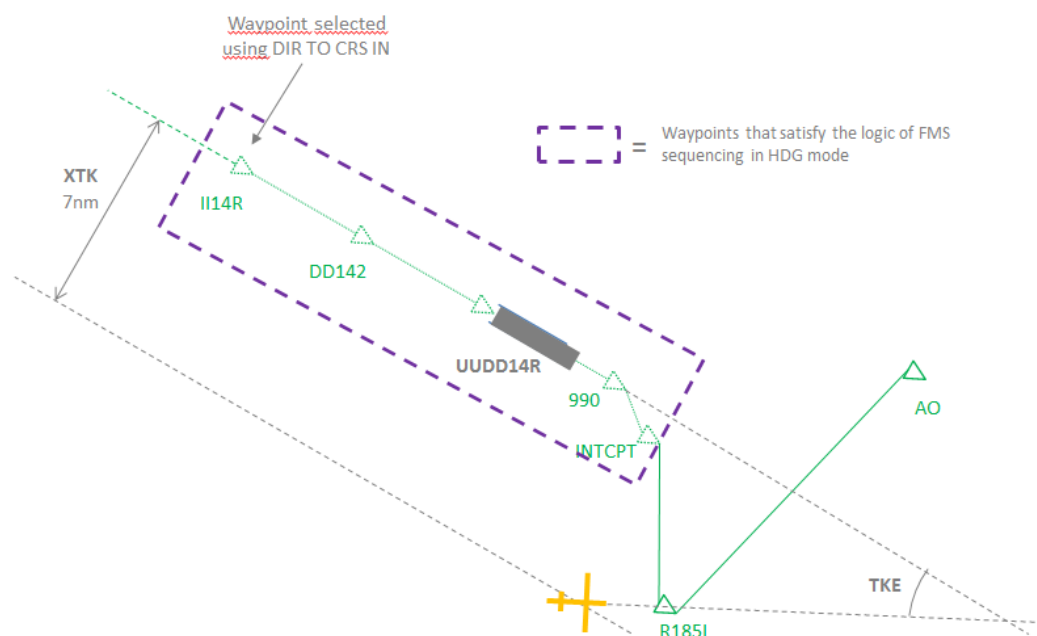
Figure 35. Illustration of the logic of waypoints sequencing

- (f) As the flight crew prepared for the second approach, a multi-waypoint sequencing in a row of the flight plan occurred when the crew performed a lateral revision of the flight plan using the DIR TO CRS IN pushbutton as per the SOP at a location where several waypoints satisfied the FMS geometrical waypoint sequencing rules. A real time computation issue caused an automatic reset of FMS1.

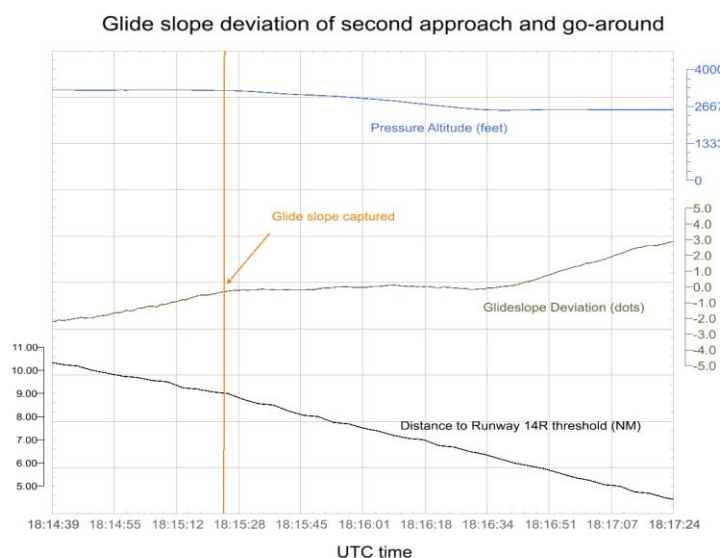
Figure 37. Glideslope deviation for the second approach and discontinued approach

Until the selection of the UDD14R waypoint using the DIR TO function, the Aircraft followed the glideslope, as shown in figure 37, the glideslope deviation indication showed approximately on the profile.

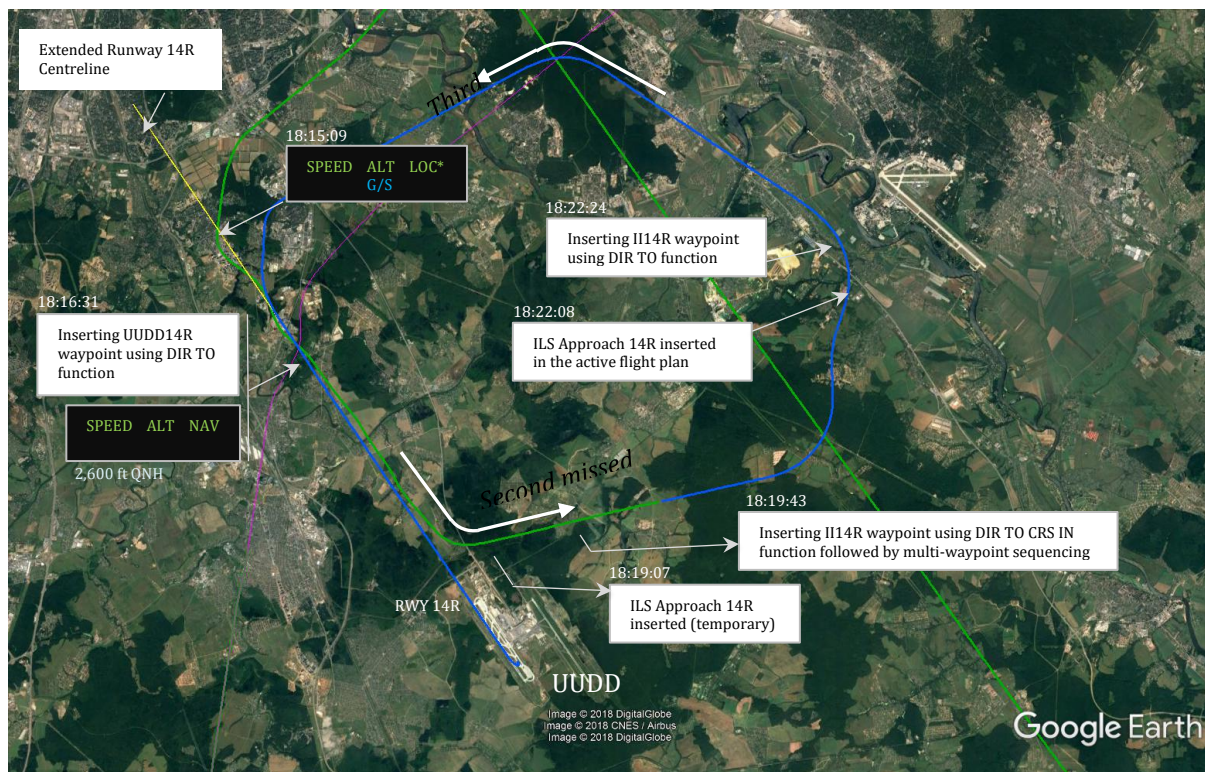
Figure 38. Aircraft trajectory of the discontinued approach, the third approach, and the landing

When the Aircraft was turning left onto the downwind leg at approximately 8.3 nautical miles from the extended runway centerline, the AO waypoint was inserted using the DIR TO function. Twenty four seconds later, a new destination from the AO waypoint was inserted into the temporary flight plan. The Investigation believes that the Commander performed both insertions. The Investigation believes that these insertions were made to anticipate and prevent a similar FMS auto-reset issue on the third approach attempt.
