## **Aircraft Accident Investigation Bureau of Myanmar**

**FINAL REPORT OF ACCIDENT OF A COLLISION WITH TERRAIN  
INVOLVING BIMAN BANGLADESH AIRLINES AIRCRAFT  
BOMBARDIER DHC-8-402, REGISTERED S2-AGQ AT YANGON  
INTERNATIONAL AIRPORT, MYANMAR ON 8 MAY, 2019**

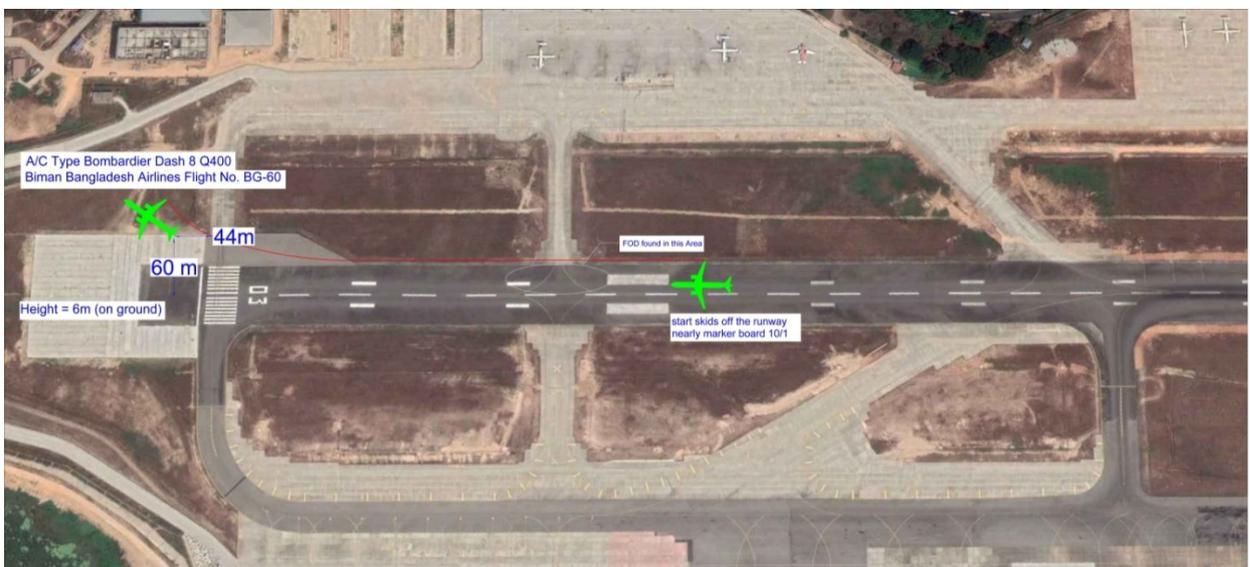
**Figure (1) Layout of Accident Site**

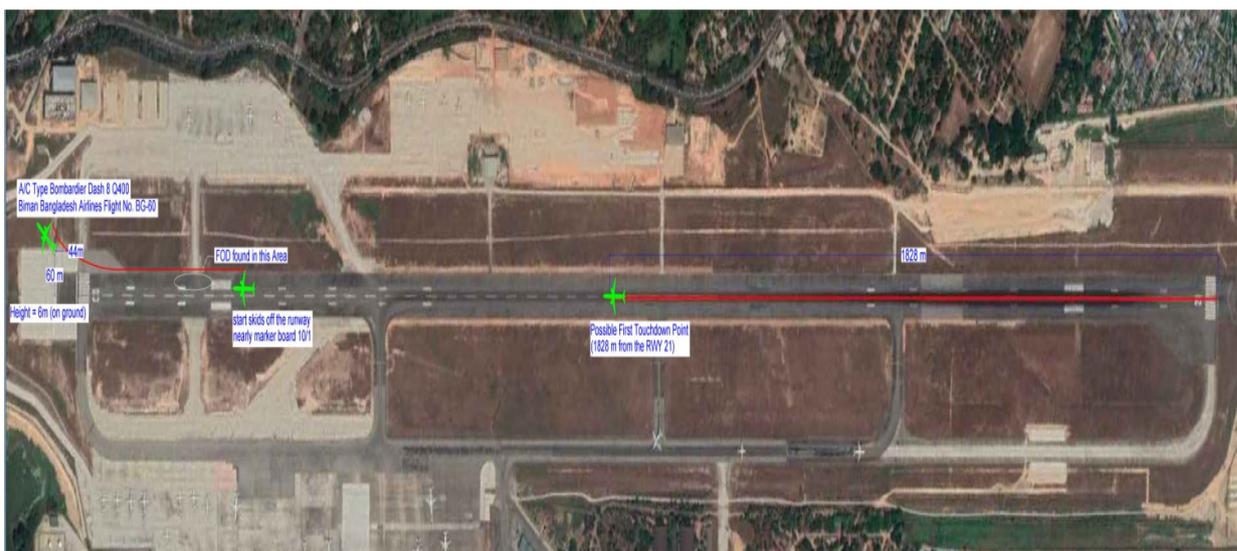
**Figure (2) Layout of Accident Site**

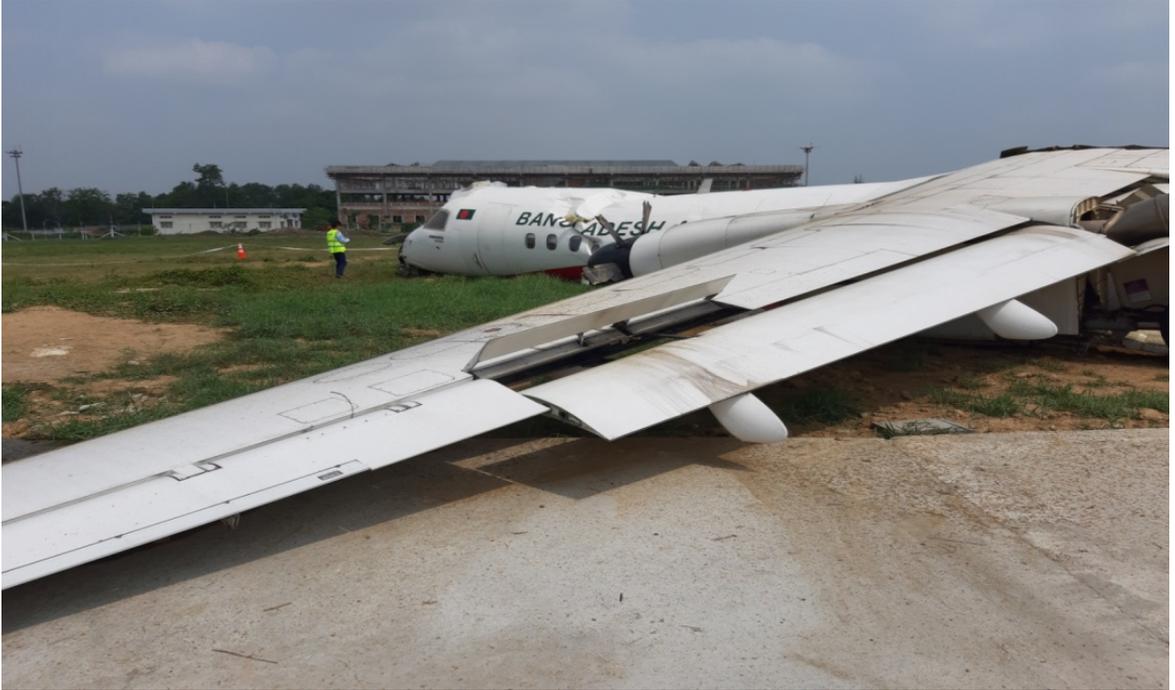
**Figure (3) Final position of the aircraft on the overrun of Runway 03**

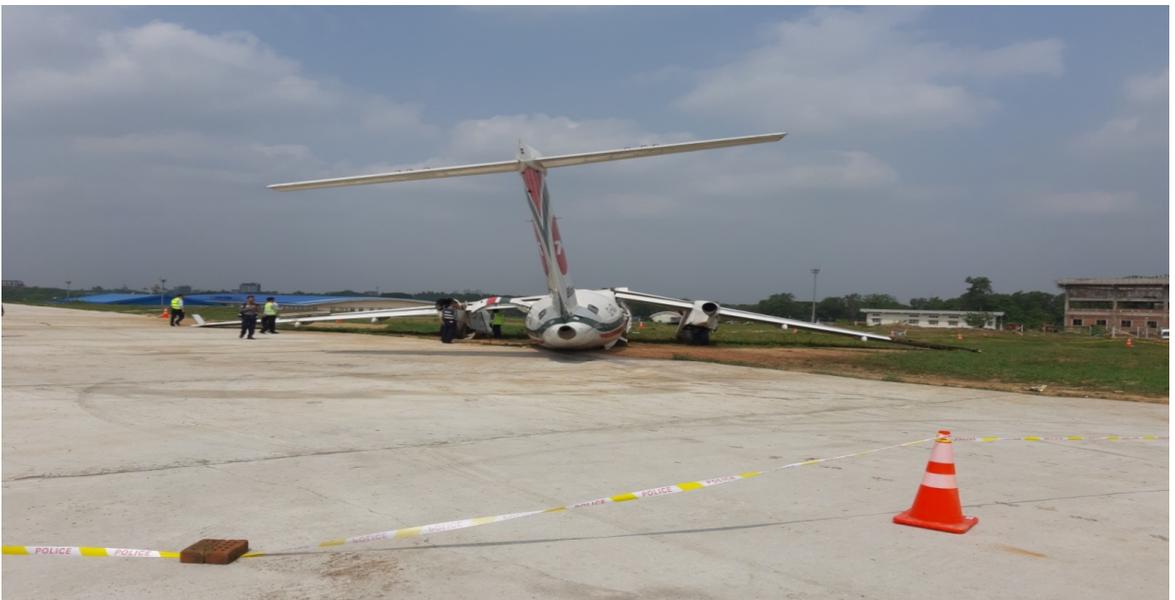
**Figure (4) Final position of the aircraft on the overrun of Runway 03**

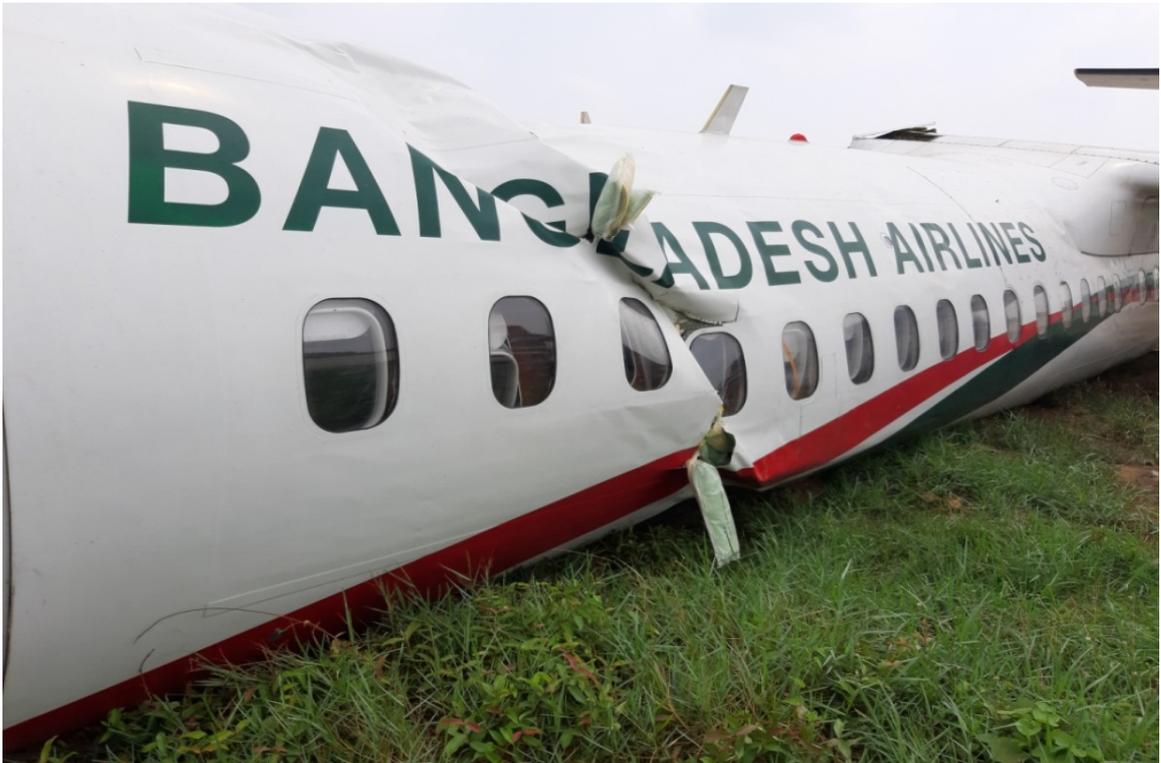
- (f) Aircraft Fuselage interior was broken and destroyed.
- (g) Aircraft Fuselage broke into three sections.
- (h) Cockpit door did not open due to fuselage damage.
- (i) Aircraft Emergency locator Transmitter (ELT) transmitted the distress signal.

**Figure (5) Damaged Fuselage of the Aircraft**

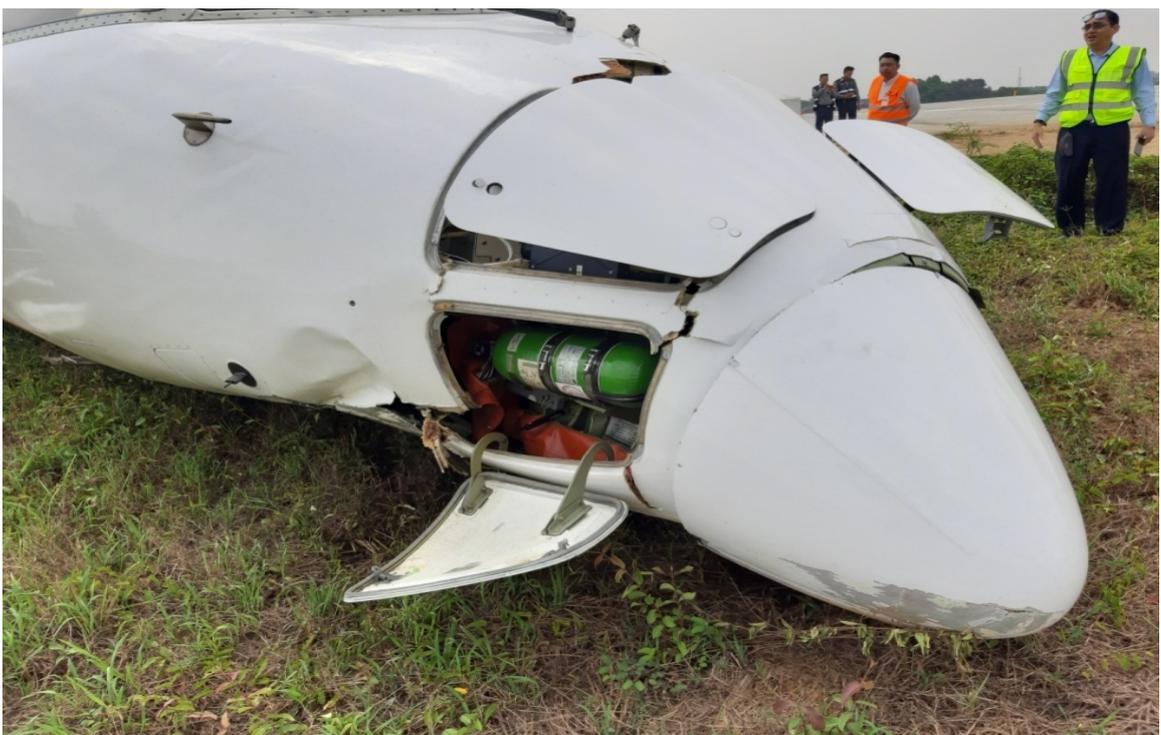
- (a) Aircraft Radome was cracked and damaged.
- (b) Aircraft Nose Landing Gear was collapsed and folded.
- (c) Aircraft Main Landing Gears' shock absorbers were broken and damaged.
- (d) Aircraft Right hand Wing was broken at the attachment point with the fuselage.
- (e) Left and Right Propeller Blades were broken into pieces.

**Figure (6) Damaged Radome of the Aircraft**

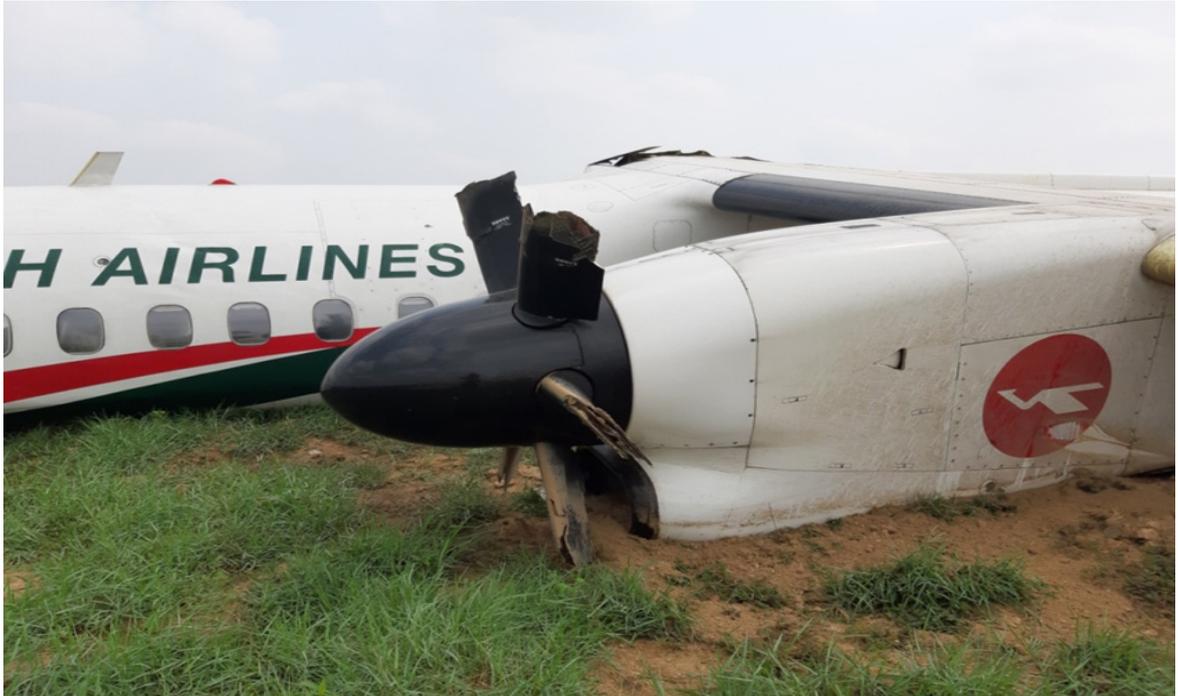
**Figure (7) Damaged Propellers of the Aircraft**

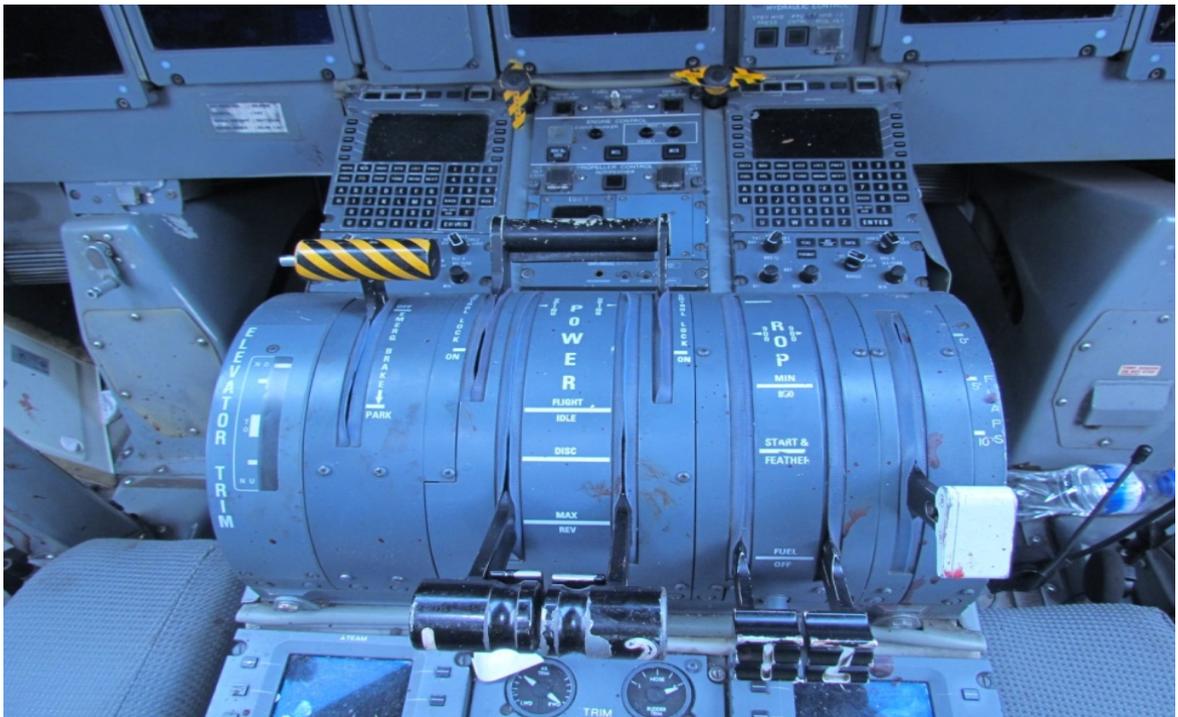
**Figure (8) The Cockpit view of the Aircraft**

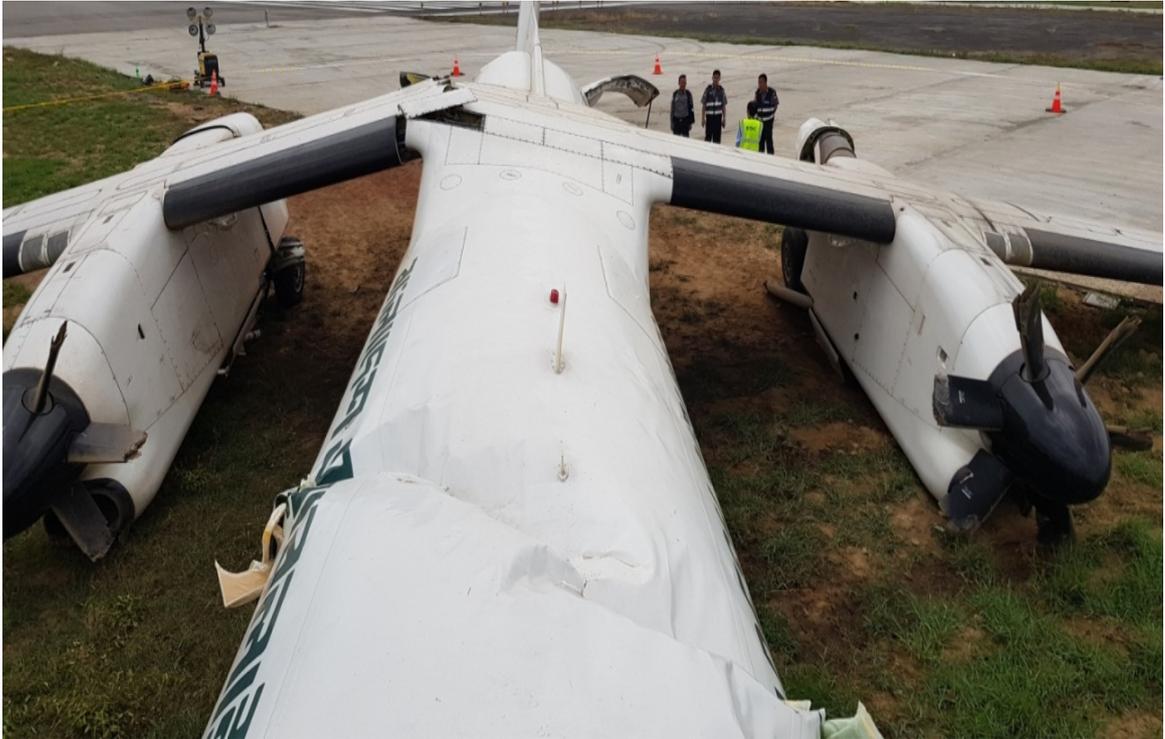
**Figure (9) Right hand wing of Aircraft broken at the attachment point with the fuselage**

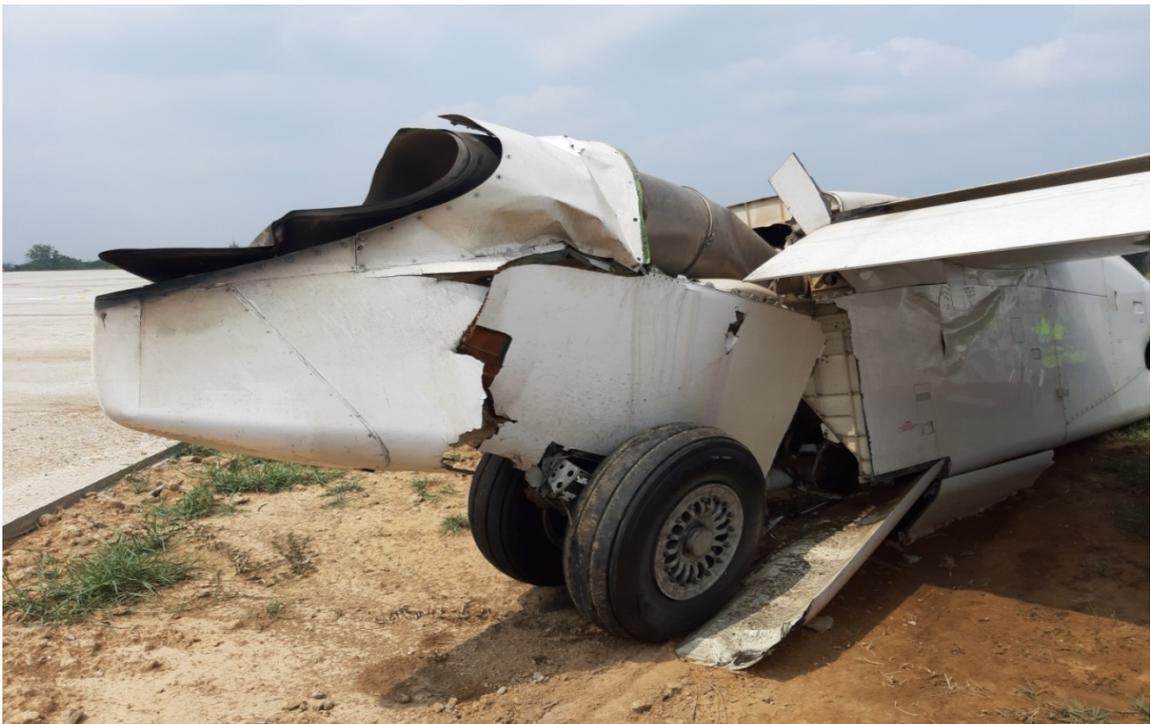
**Figure (10) Damaged main landing gears of the Aircraft**

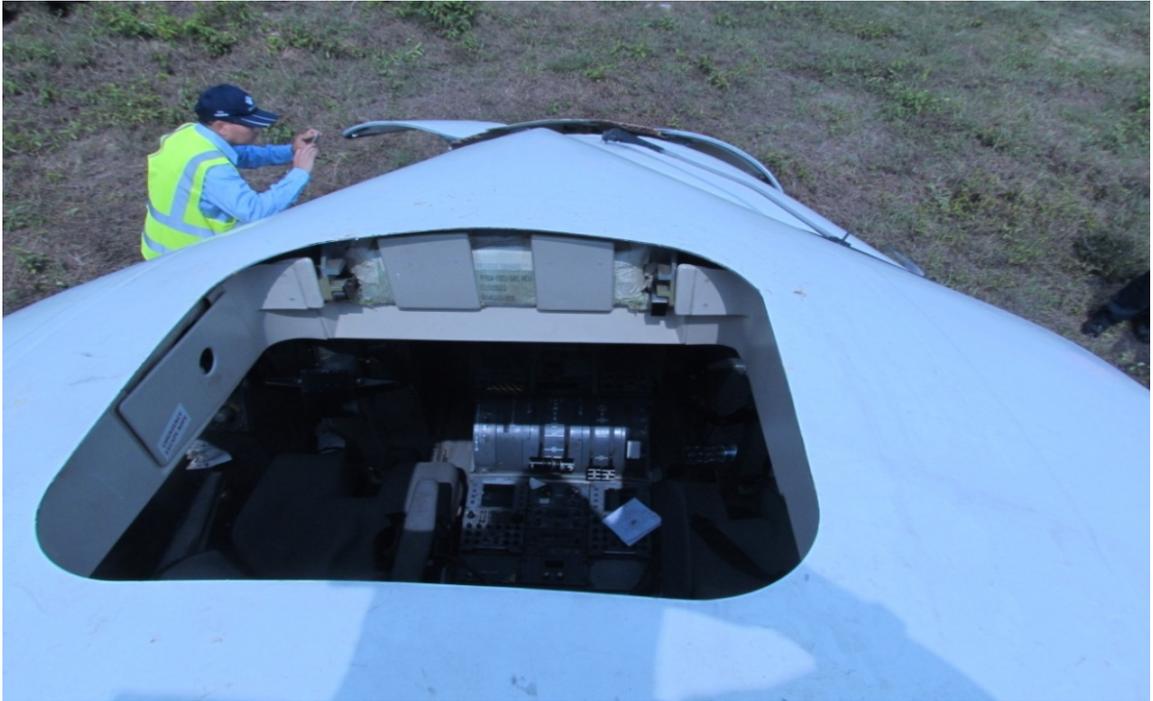
**Figure (11) Escape hatch was opened to rescue the flight crew**

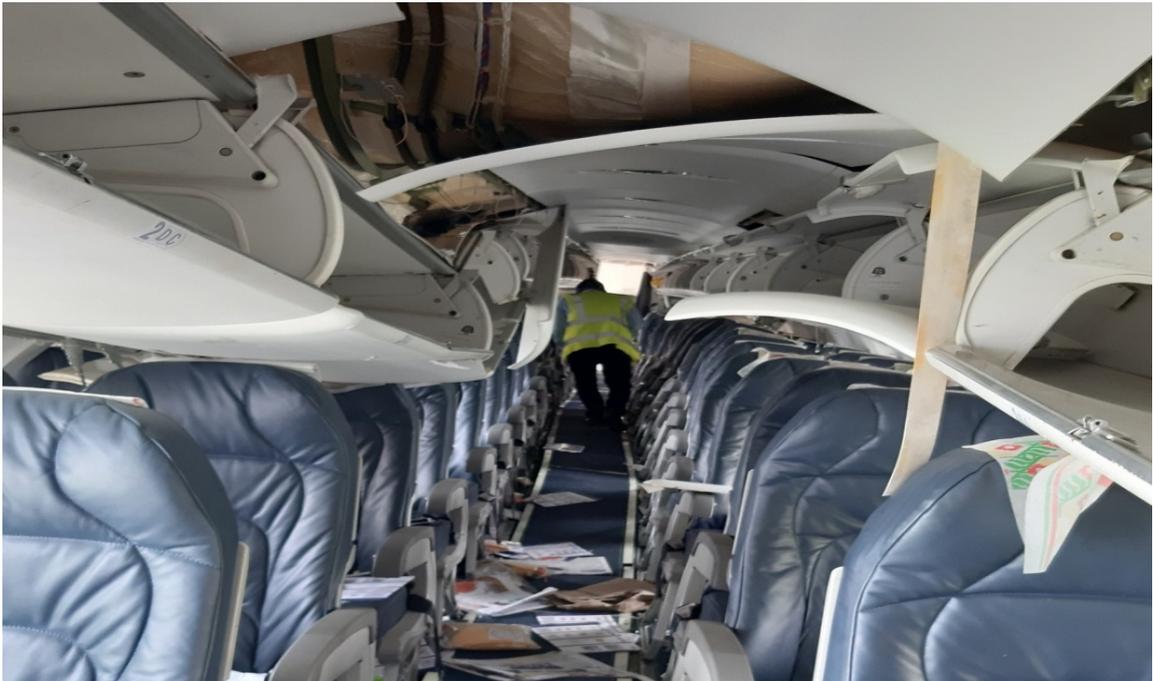
**Figure (12) Damaged Cabin Interiors of the Aircraft**

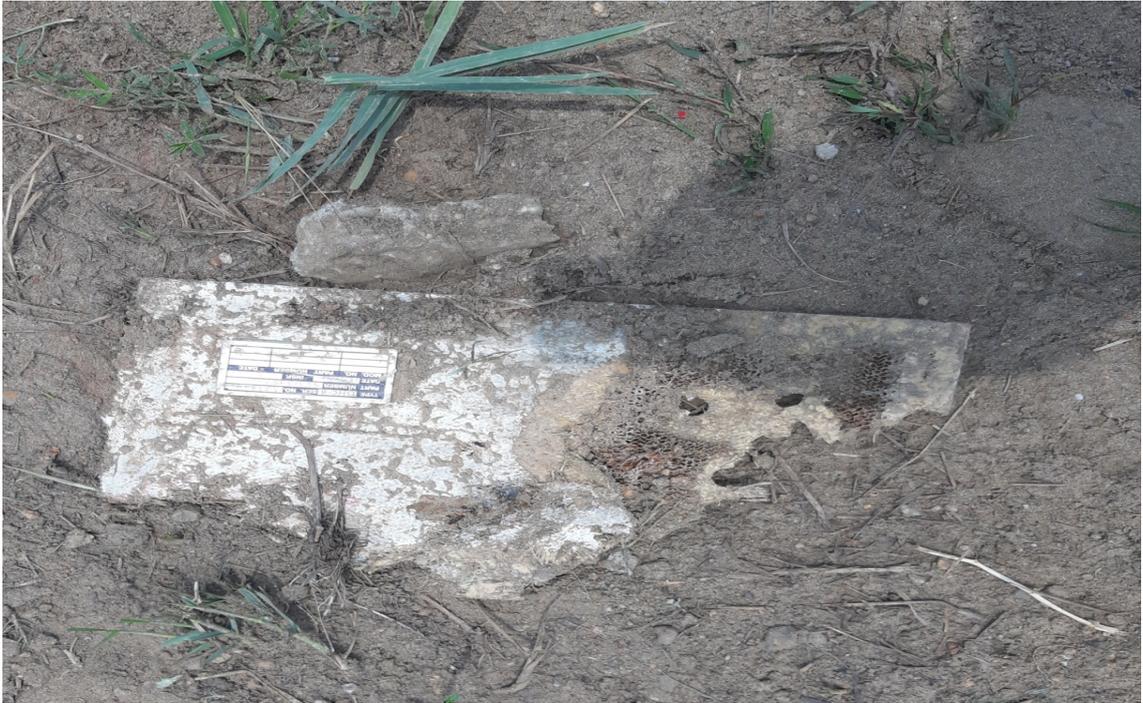
**Figure (13) The debris of the Aircraft scattered on the ground**

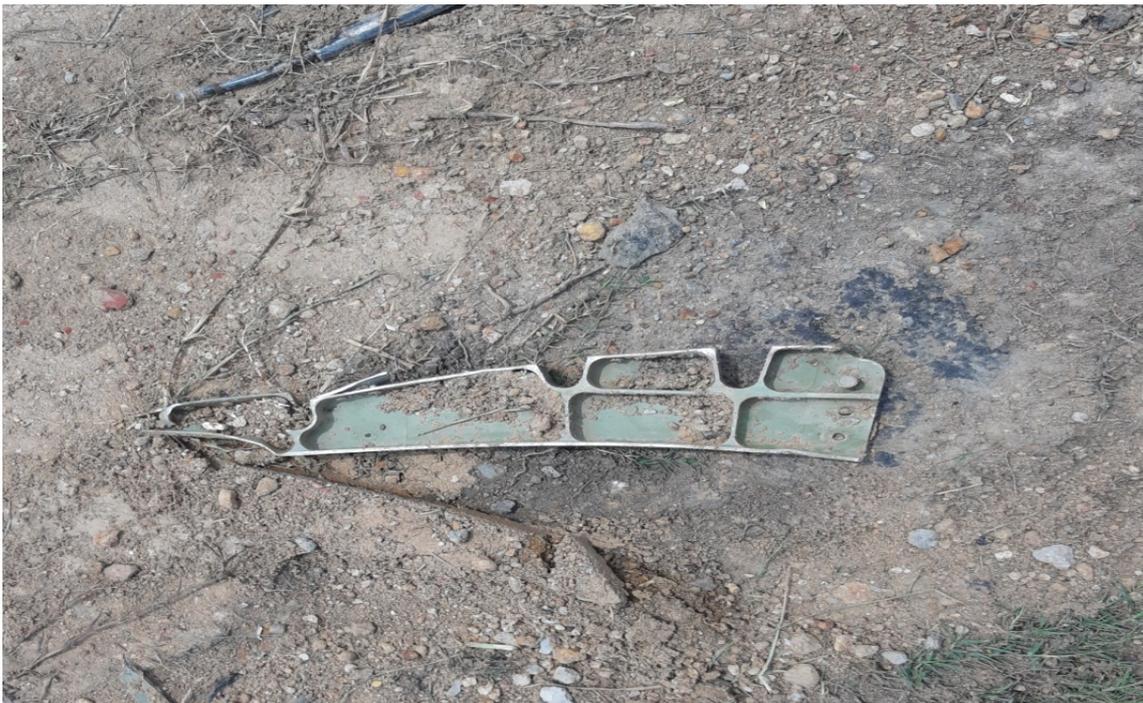
**Figure (14) The debris of the Aircraft scattered on the ground**

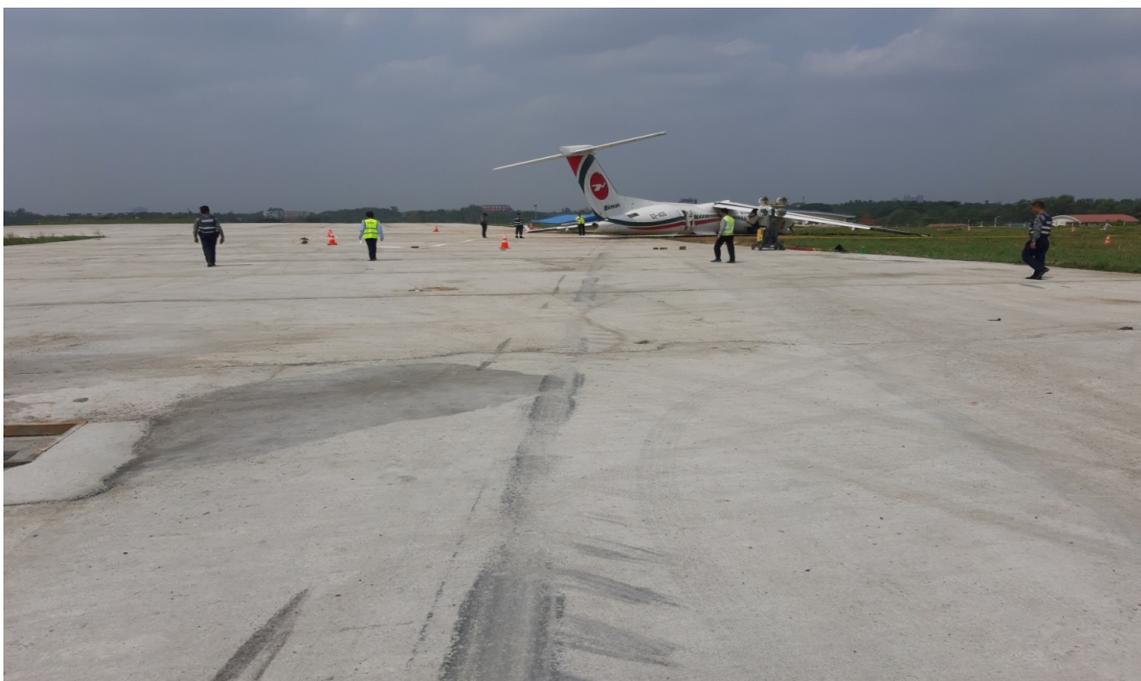
**Figure (15) Wheel tracks and propeller striking marks on the overrun**

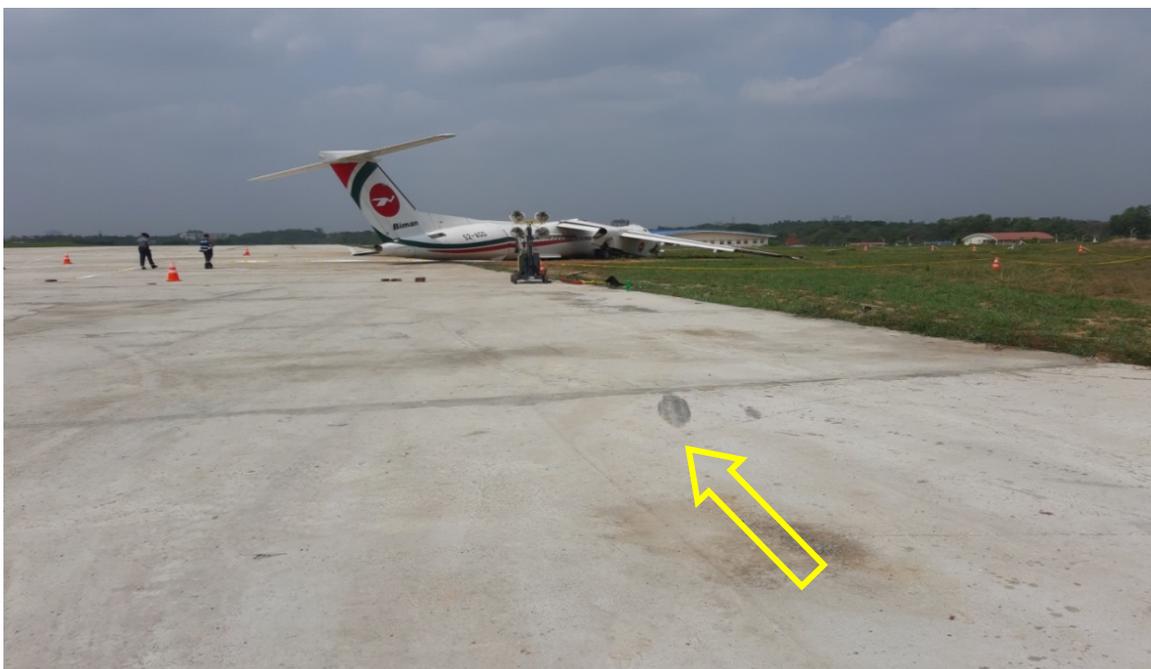
**Figure(16) Wheel marks of the Aircraft on the overrun**
