Report

Incident on **25 May 2001**
at **Cayenne-Rochambeau Airport (French Guyana)**
to the **Airbus A340-311**
registered **F-GLZC**
operated by **Air France**

BEA

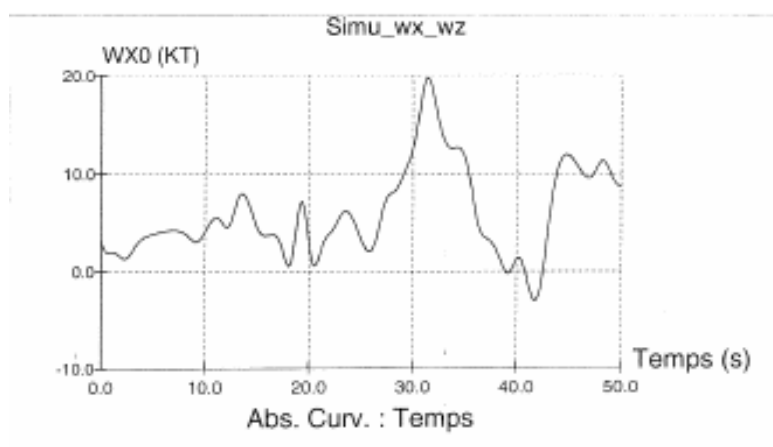
Horizontal wind component (add 3 kt)⁽⁵⁾

⁽⁵⁾The value on the graph being obtained by subtracting the speed ground from the CASE, 3 kt should be added, that's to say the difference between the CASE and the TAS, to obtain the effective wind.

The effect of the horizontal component was preponderant in the incident. Ten seconds before the first wheel touchdown (corresponding to time 32 on the abscissa), at about 120 ft radio height, the effective headwind was 23 kt then it dropped to practically nothing at touchdown.

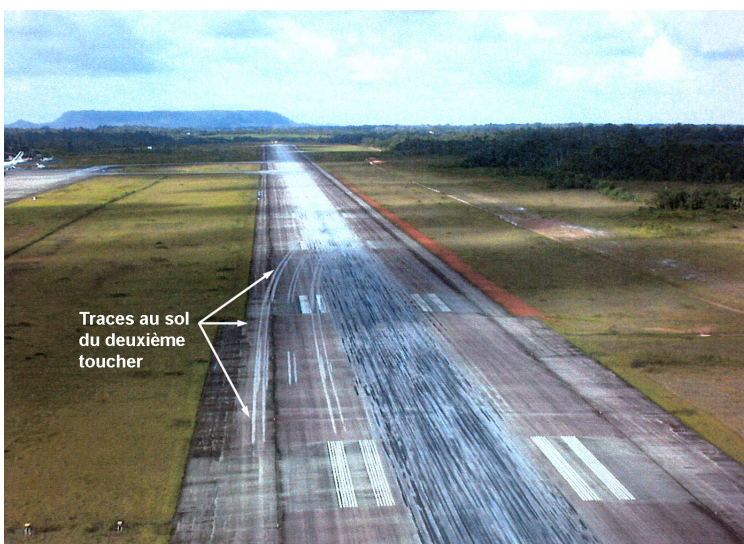
Photographs of marks on the ground

Two series of marks were noted on the ground (see appendix 4). The first, corresponding to the first touchdown was to the left of the runway centreline. It started on the paved area, about thirty metres before the threshold of runway 08. There were, in order of appearance, a mark forty metres long left by the left main landing gear, a mark of thirty-eight metres left by the right main landing gear and one of three metres left by the central gear. The second series corresponded to the second touchdown and started 480 metres after the first marks. The mark left by the gear was on the paved area, located to the left of the runway, measuring 106 metres and curving to the right at the end to return back onto the runway. The mark left by the central gear was on the runway, consisting of a sixteen-metre long mark followed, twenty metres further, by another mark of about thirty metres. The mark left by the gear was 96 metres long and was to the left of the runway centreline.
