**FINAL REPORT ON THE ACCIDENT OCCURRED
ON 25 MAY 2008
AT BRUSSELS AIRPORT ON A BOEING
B747-209F REGISTERED N704CK**

Ref. AAIU-2008-13
Issue date: 10 July 2009
Status: Final

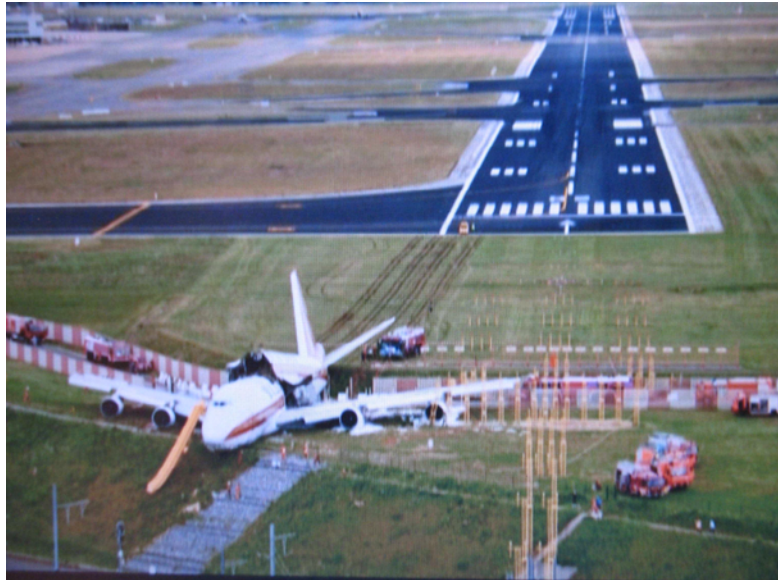
The aircraft reached a first embankment, dropping from a height of 4 m, and broke in three parts. The aircraft came to a stop just above the top of the railroad embankment.

The crew exited the airplane through the service door since the L1 door normally used was blocked due to deformation of the structure.

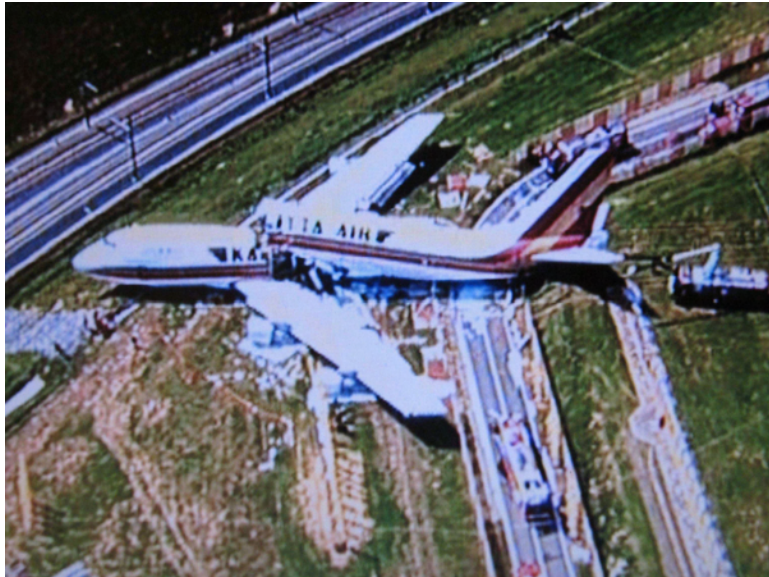
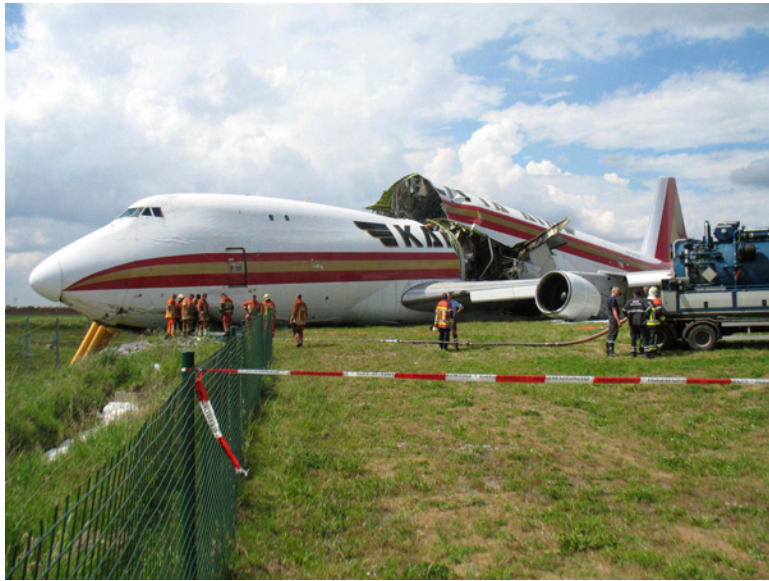
The entire fuselage was right side up at the accident site with severe impact damage and multiple skin, stringer and frame fractures. The fuselage fractured into three sections. The first major fracture of the fuselage – on the RH side – was located at about FS 1100 and the second at FS 2285.

The second section of fuselage, the fuselage skin, stringer, frame pressure deck and overwing longeron structure are raised up approximately 1.5 meter above the wing upper skin panel.

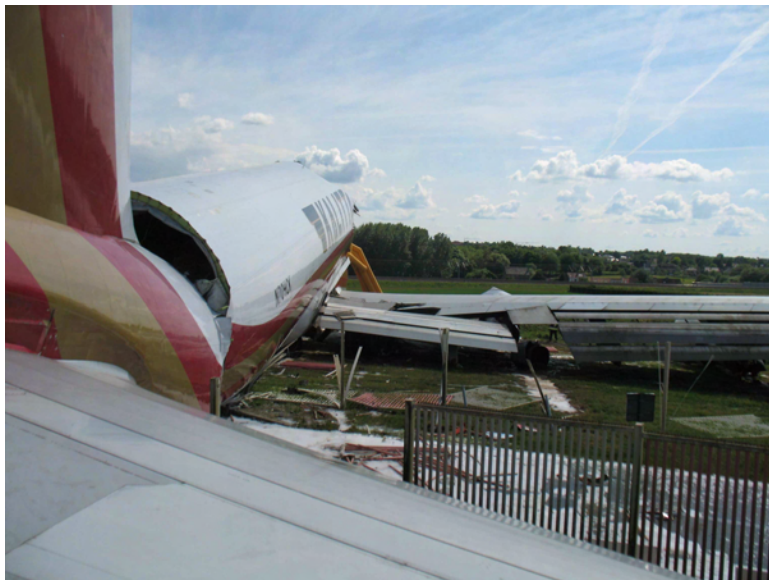
The main keel beam box was fractured just forward of the body landing gear drag brace support fitting. At the fracture, the aft keel beam is lifted up and separated from the forward keel beam.

The aft fuselage fracture was located at the tail section, just in front of the rudder.

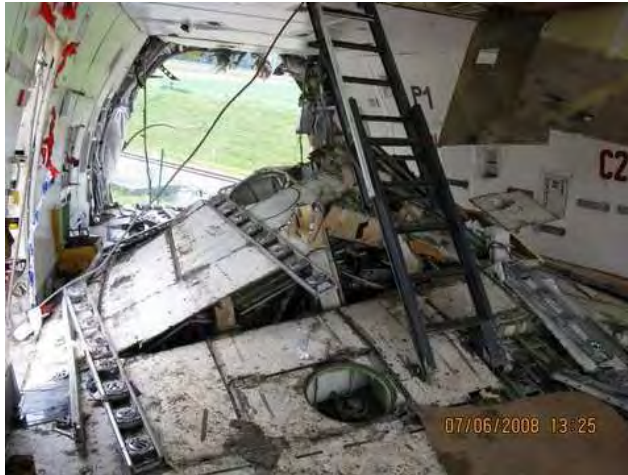
The main cargo deck portion located in the forward section of the fuselage was fractured and pushed up in the area where the nose gear penetrated the lower lobe of the fuselage.

The most forward cargo pallets (P1 and P2) were no longer secured by the cargo locks.

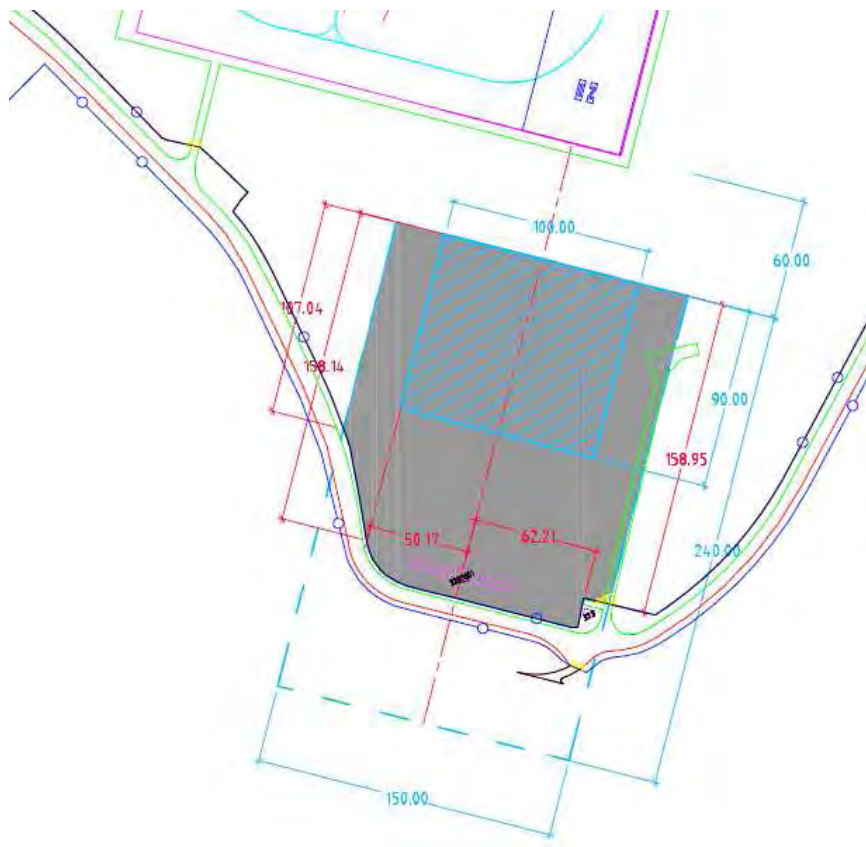
The RESA of runway 20 complies with the requirements of ICAO Annex 14 (min length of 90m, min width of 90m).

However, the same ICAO Annex 14 recommends to extend the length of the RESA to a distance of at least 240m. This recommendation (not mandatory) is not met for runway 20.

We recommend to extend the RESA of Runway 20 of EBBR to the length recommended by ICAO, either thru physical extension, or by the use of the EMAS system discussed in chapter 1.10, or by any other suitable means, and evaluate the need to apply this recommendation to other runways and Belgian airports.

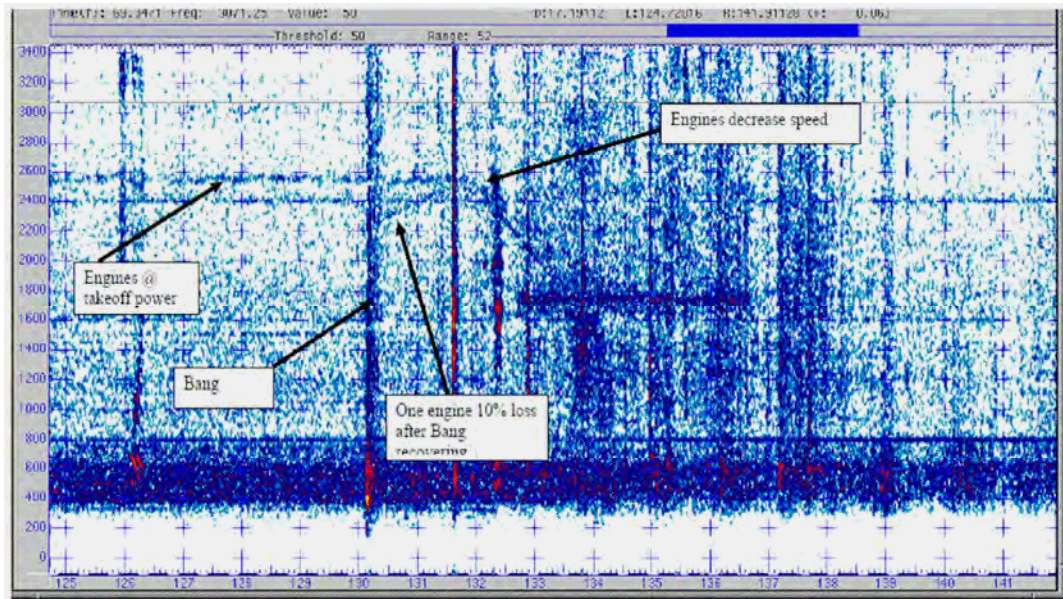
The analysis shows engine operating at take off power, then one (or more) is experiencing a loss of power, followed by a saturation (bang). The sound frequency is then moving to its original value, showing that the involved engine(s) is recovering, until the moment the power is reduced, by the pilot.

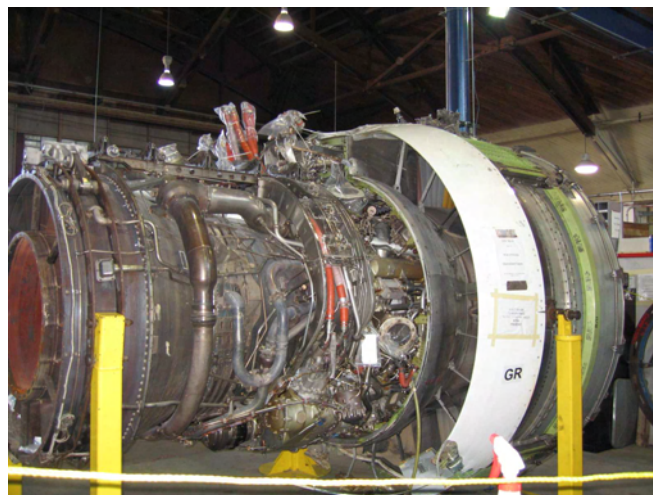
No impact marks or inward deformation of the front or rear spinners were noted. Fan blades Nos. 11, 35, 38 and 42 (86°, 273°, 297° and 328° respectively from index mark) exhibited soft body deformation with the leading edge pushed from the concave towards the convex side. The soft body damage was centered about 3-inches outboard from the platform. No impact marks or inward deformation of the fan exit fairing were noted.

The nine sound absorbing inner rear liner segments were removed from the engine and debris was removed from the inboard side of each screen and individually bagged. The bleed valve assembly was found in the open position (this should be the default position on engine shutdown). A large amount of debris (soil, vegetations, rocks, etc) was found at the 6:00 o'clock position of the fan case as well as in the bottom of the bleed valve linkage support. Centered around the 9:00 o'clock position (aft looking forward), a concentration of the organic material was stuck to the outside of the bleed linkage support, with the rest of the support exhibiting very little.

Organic debris was gathered from all nine sound absorbing inner rear liner segments, from each stage of the LPC stages, from fan blades 8, 9, 10, 19 and 20 and from bleed valve linkage support.

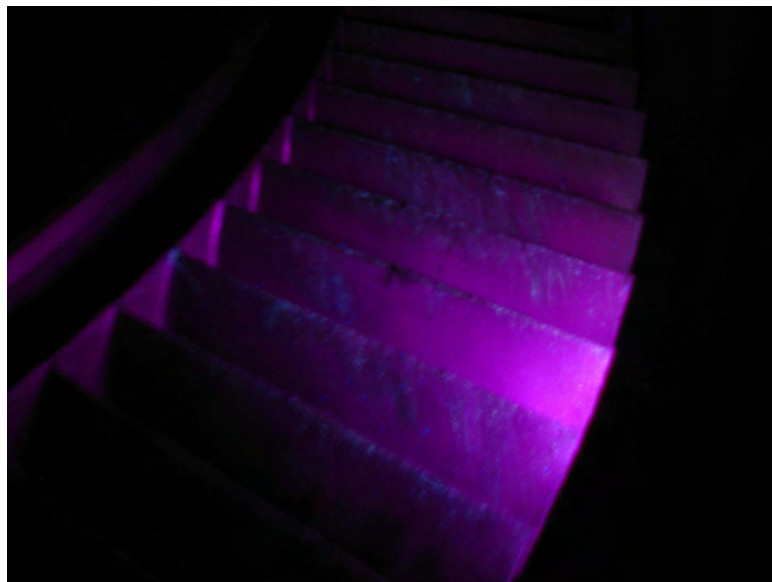
The fan blades were inspected using a black light with the blades still installed in the fan disk. A **heavy and concentrated** organic smear and splatter in the axial direction on the concave side of the fan airfoils was observed at the platform between blades Nos. 31 & 32 and 32 & 33 (convex side) (242° from index mark). Blades No. 42 and 43 (329° from index mark) exhibited a light and more spread out organic smear and splatter on the airfoil concave with the smear flowing towards the blade tips. The blade numbering used are the blade numbers used during the initial installation and they sequentially increase clockwise forward looking aft.

Organic speckled material with no directional orientation was noted on the fan exit fairing around the 6:00 o'clock position. A black light inspection of the stage 1.5 low pressure blades revealed an organic smear of 6 consecutive blades on the concave side (pressure).

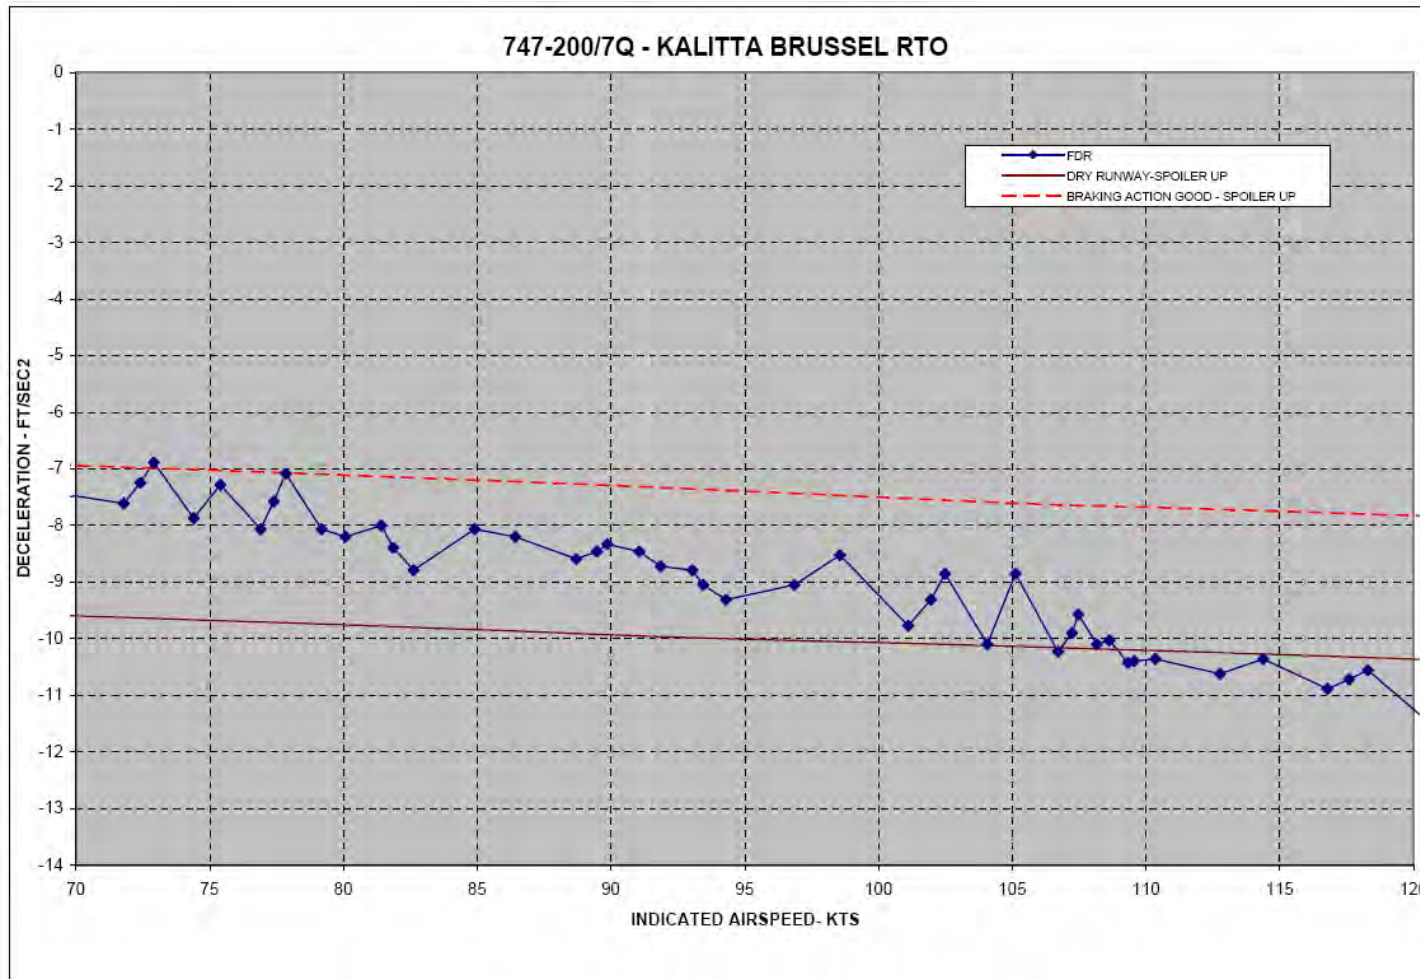
The FDR deceleration with airspeed is greater than calculated. The estimated deceleration is based on a constant airplane braking coefficient, which for spoilers extended are 0.2810 and 0.20 for dry and wet runway respectively. The greater rate of change of the FDR deceleration at lower airspeed when compared to the calculated rate of change may be explained by variable runway friction, i.e. the runway texture may contain more moisture or a combination of runway rubber deposit and moisture closer to the end of the runway.

Figure 1: FDR deceleration in ft/sec2 as a function of indicated airspeed along with the estimated deceleration as a function of airspeed with spoilers extended for both dry and wet runway.

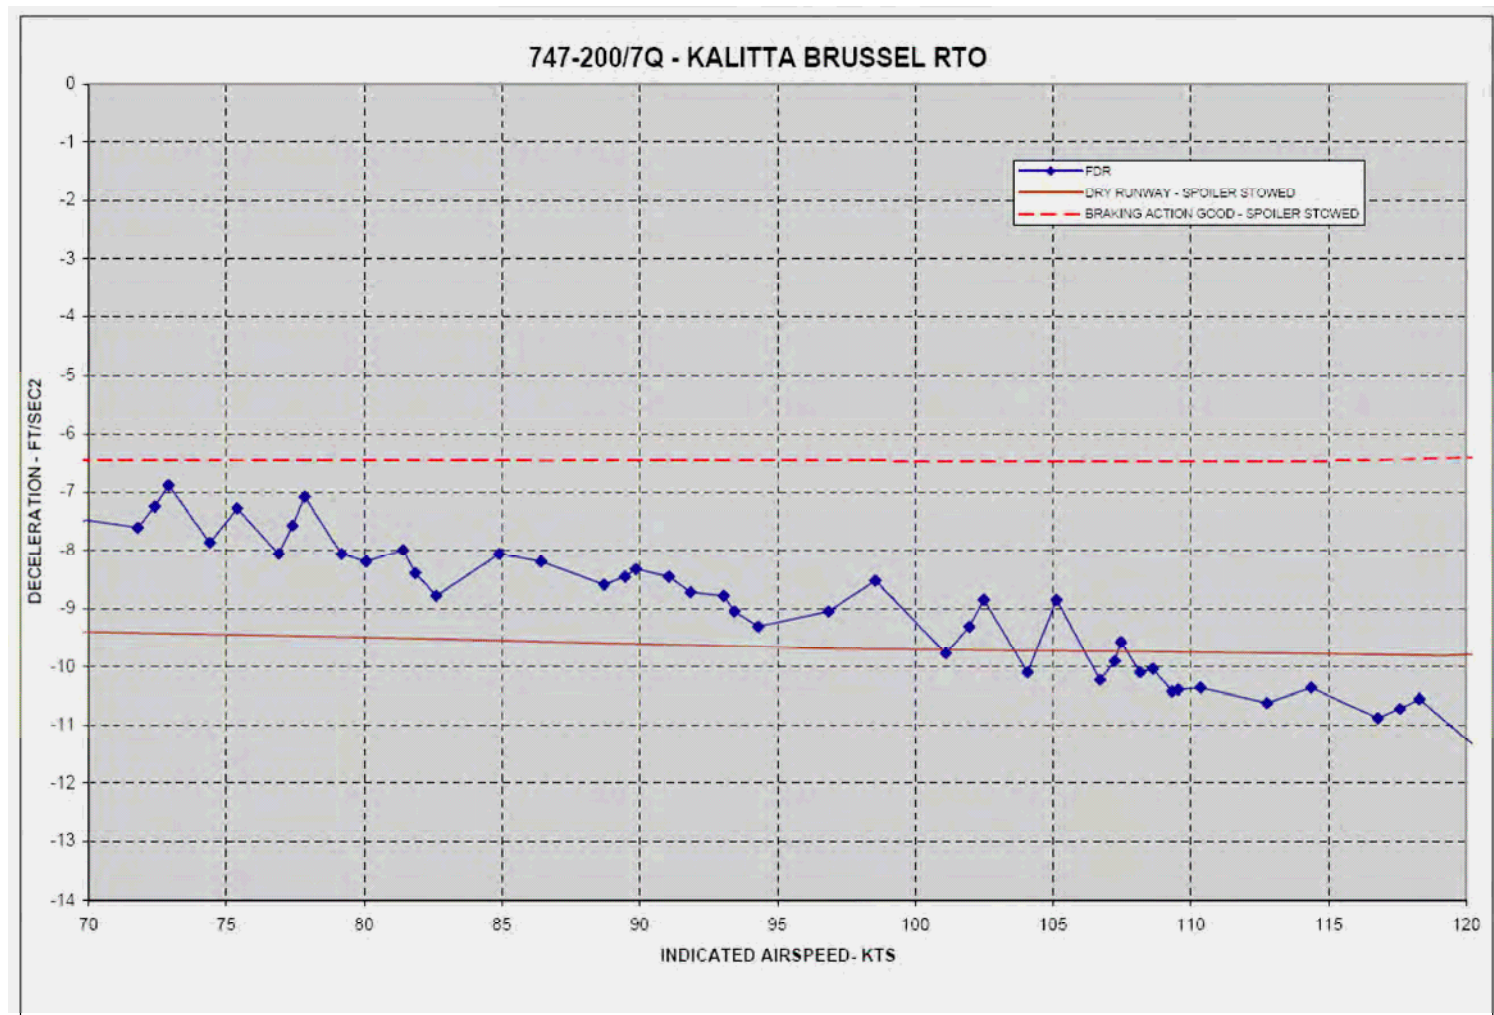
Figure 2: FDR deceleration in ft/sec² as a function of indicated airspeed along with the estimated deceleration as a function of airspeed with spoilers stowed for both dry and wet runway.
