Accident  
on 22 June 2003  
at Guipavas (21)  
to the Bombardier Canadair  
CL-600 2B 19  
registered F-GRJS  
operated by Brit Air

REPORT TRANSLATION  
**f-js030622a**

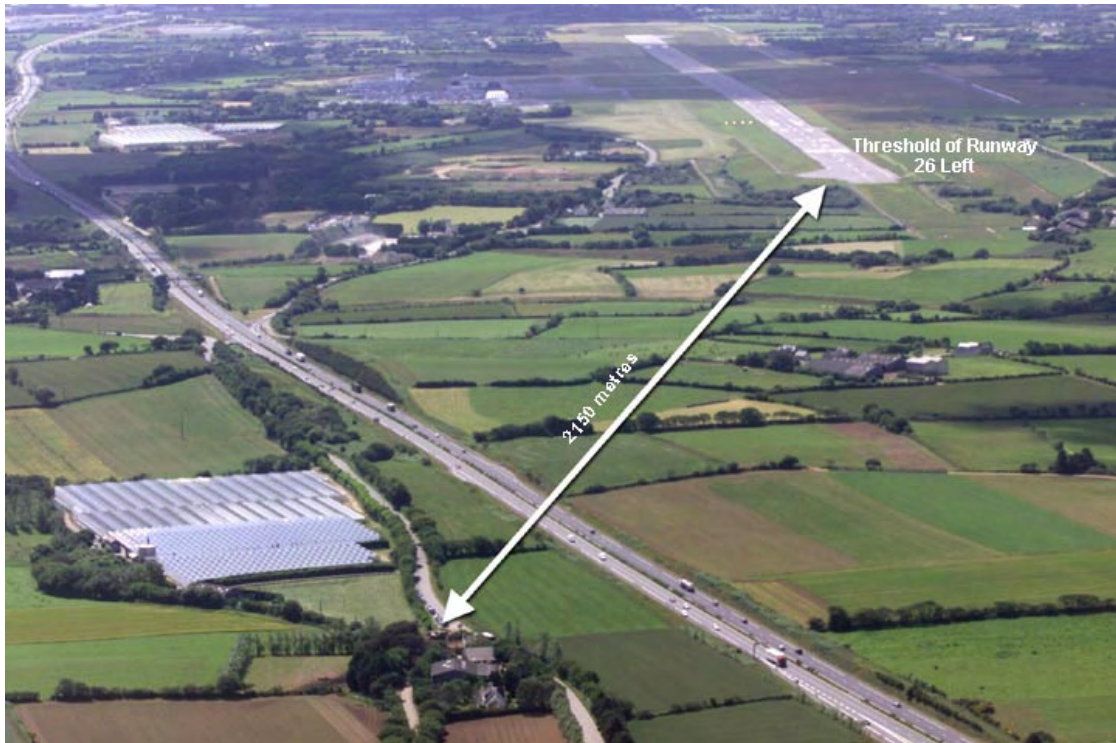
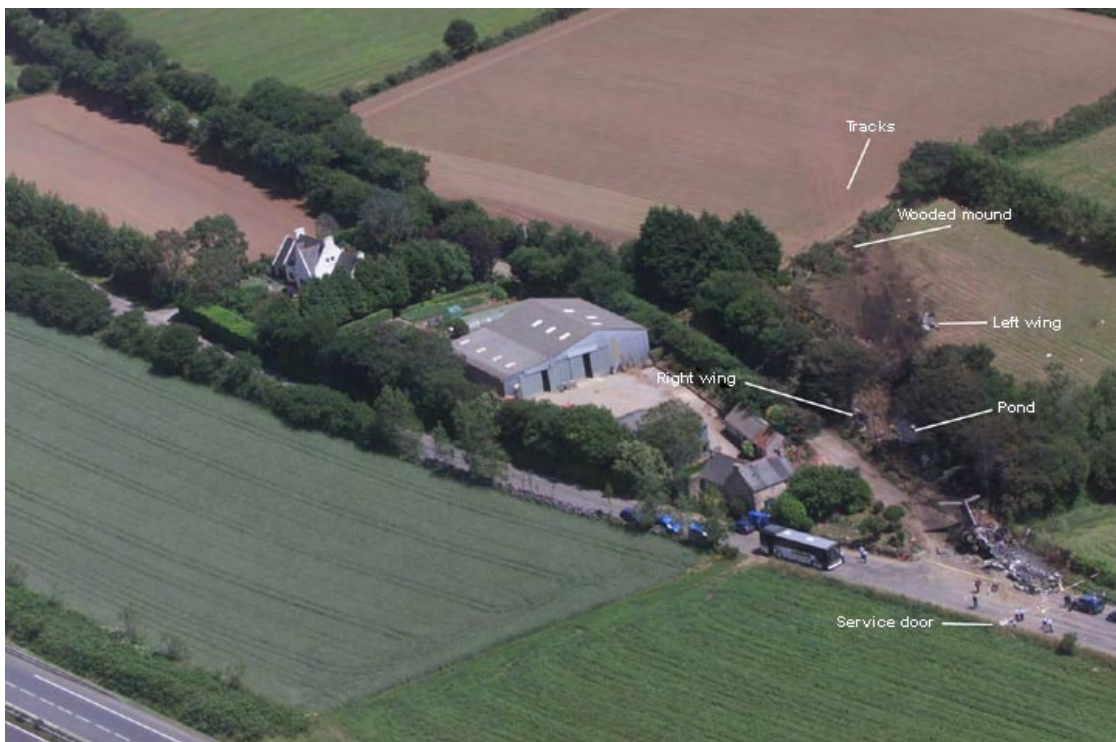
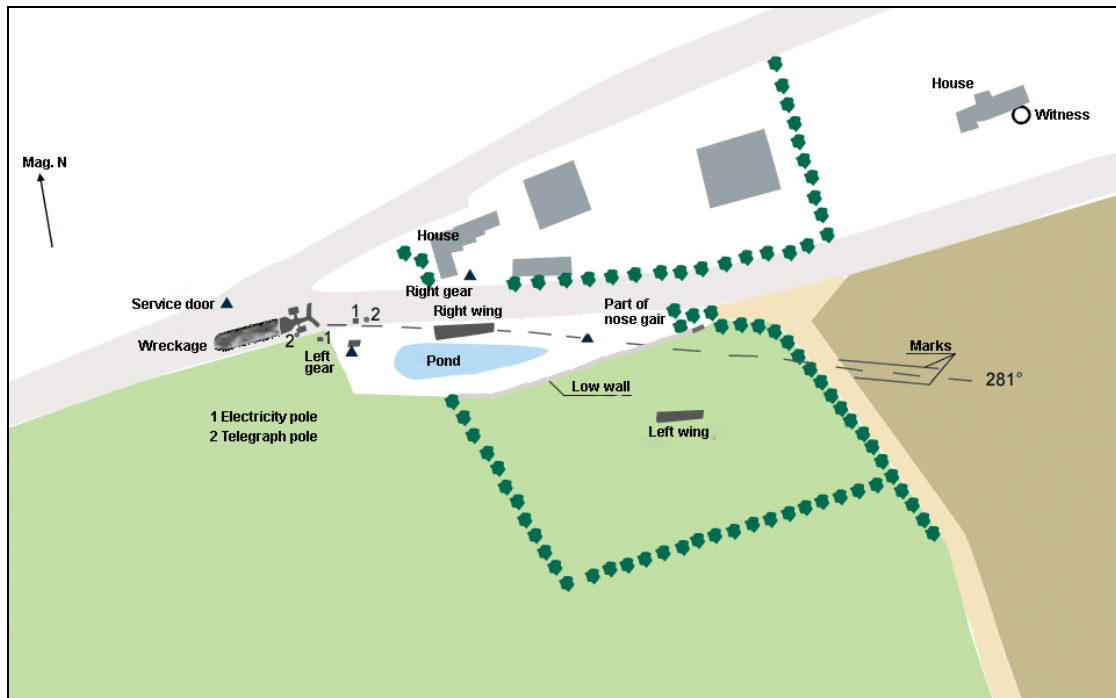
**Wreckage distribution plan**

The accident occurred in the commune of Guipavas, at Kéritin, at a topographic altitude of one hundred and twelve meters (367 feet).

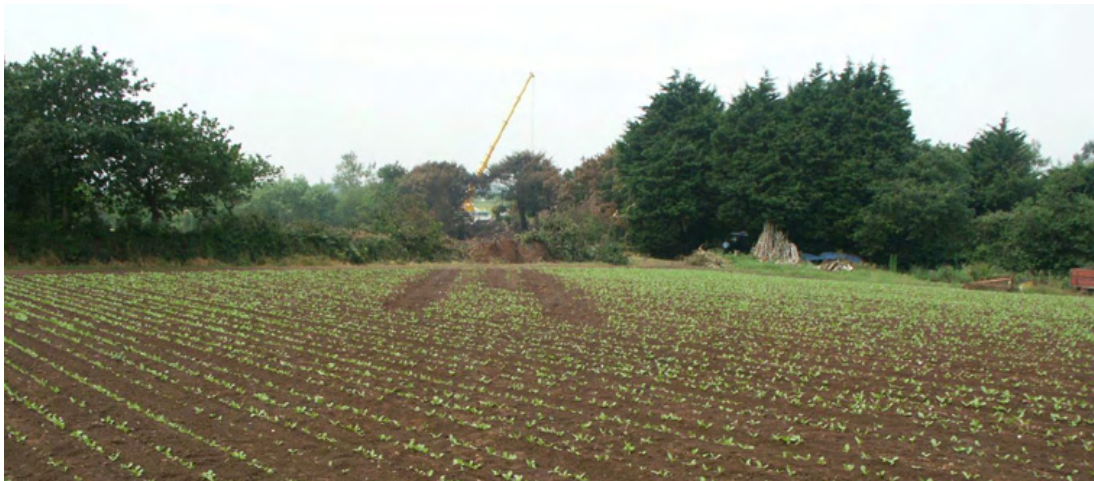
**Marks left by the main landing gear wheels**

First contact with the ground occurred in a mud field with a slight slope (about 3%). The main landing gear wheels left marks oriented along a 281° heading, without any marked furrowing, which indicates that the contact was not violent, with a low vertical speed.

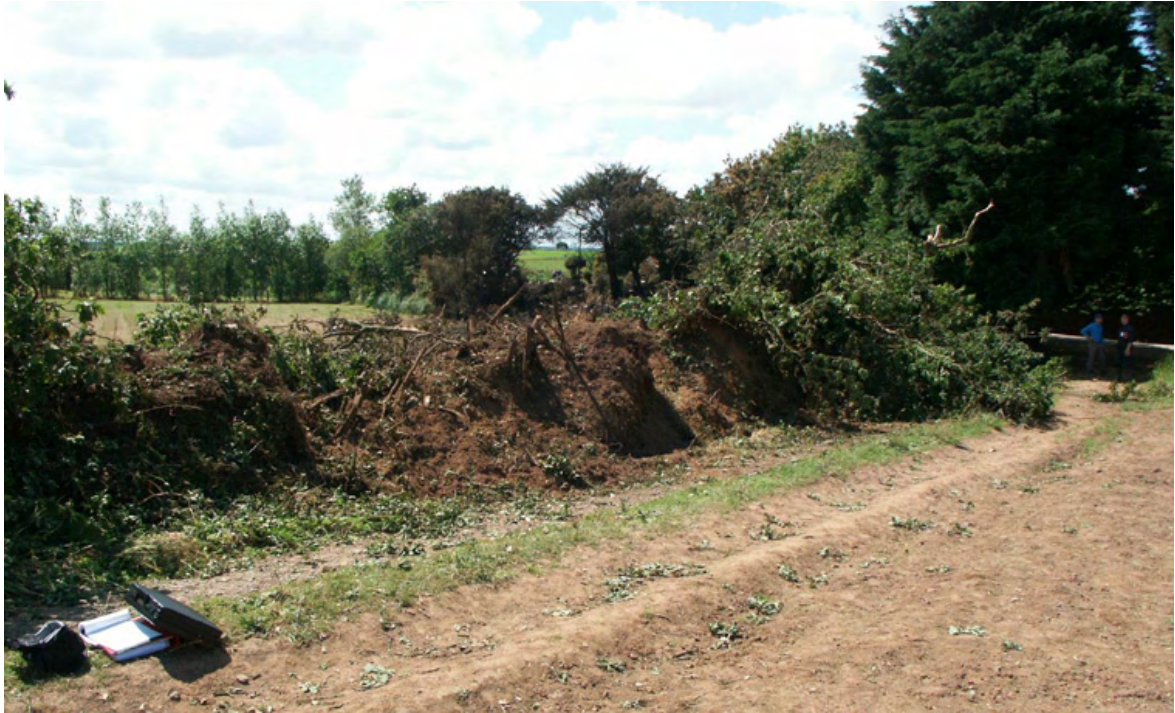
**Wooded embankment**

Thirty-four meters from the beginning of the marks left by the left main landing gear and forty-one meters from those left by the right main landing gear, the aeroplane struck a wooded embankment about one meter fifty high, oriented 45° to its path. On the embankment, the trees were cut off over a width of about twenty meters. In the middle of the damaged area, there were marks left by the two main landing gears. There were no marks attributable to the nose gear. The tip of the left wing, cut off at about one-third of span, was found about thirty-five meters from this point.

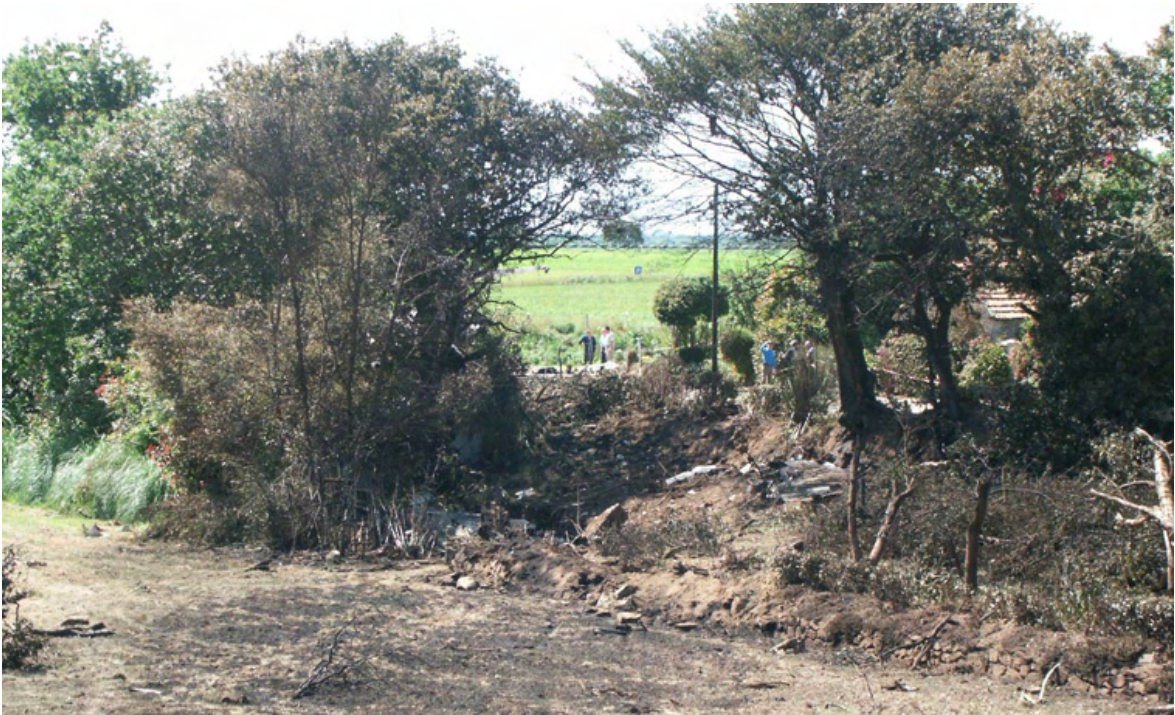
**Stone wall**

After the embankment, the aeroplane slid into a mown field. This was blackened by the fire. About fifty-five meters after the embankment, the aeroplane struck a stone wall about sixty centimetres high.

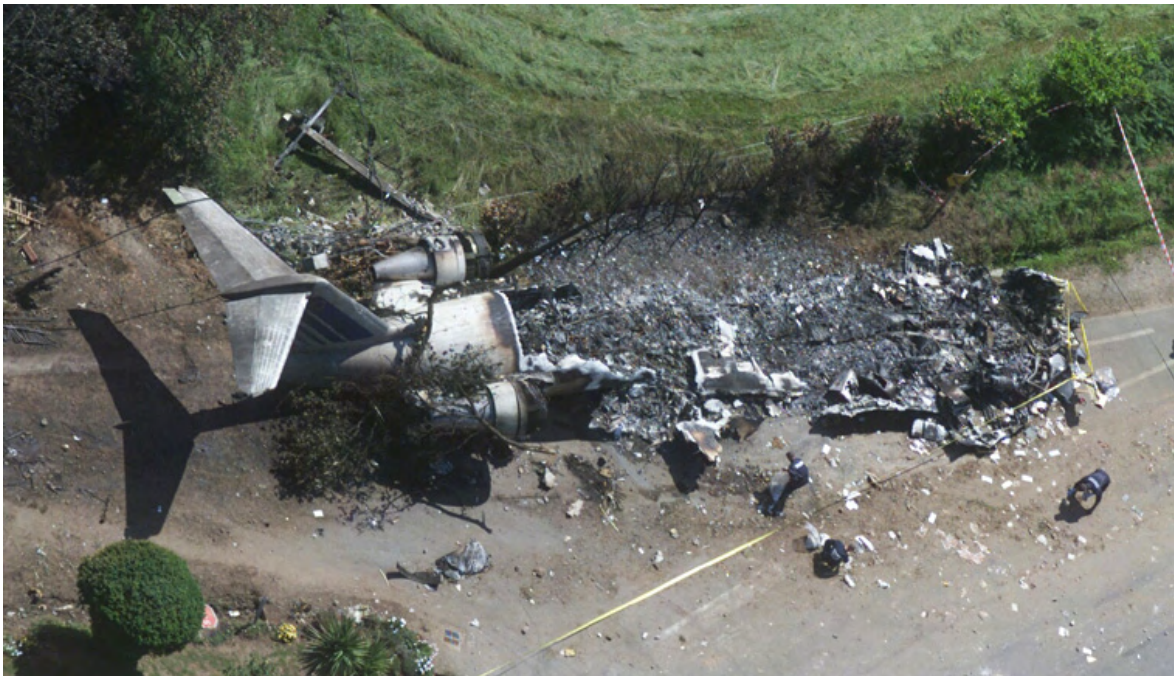
**Wreckage**

A few meters after the wall, some large trees were damaged. The tip of the right wing, cut off and with its winglet, was resting at the foot of a tree, about six meters from a shallow pond. The right wing, from the inboard flaps to the tip, was resting flat on the ground to the right of the pond in relation to the aeroplane's general path.

The left wing root and the left landing gear were on the other side of the pond, at the foot of a large tree, damaged. The inboard flaps were turned over but still attached to their hinges.

The right landing gear was cut off at the level of the main oleo strut and the end of the wing-side actuating cylinder. It was on the edge of the road, about fifteen meters from the right wing.

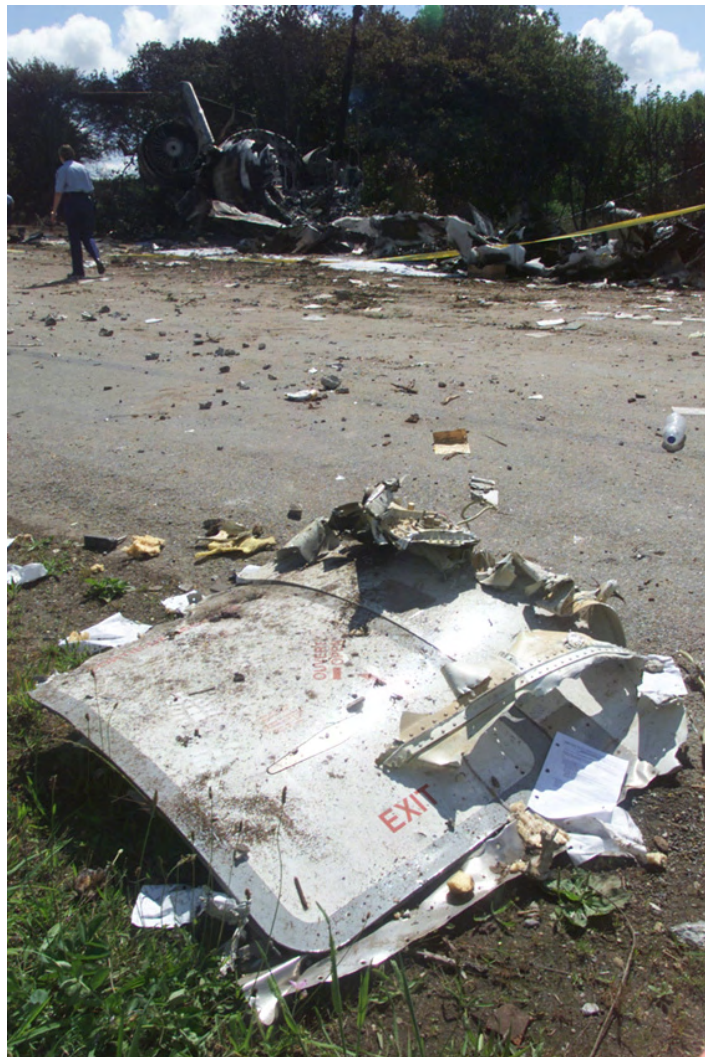
**Forward right service door**

The forward right service door, still attached to its frame, was partially cut off in the upper quarter. The handle was in the locked position. The tumblers and the control mechanism operated when the handle was moved. The door showed no traces of fire.
