Report

Serious incident on **22 July 2011**
in cruise at FL350, north Atlantic Ocean
to the **Airbus A340-313**
registered **F-GLZU**
operated by **Air France**

Bureau d'Enquêtes et d'Analyses
pour la sécurité de l'aviation civile

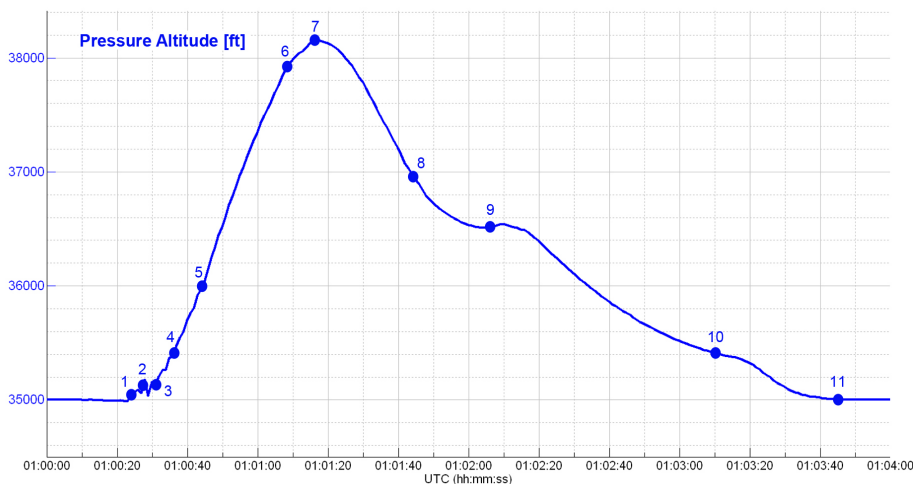
Figure 1 - Vertical flight path

At 1 h 00 min 24 (point n°1 on Figure 1), about 2 NM after passing coordinates 18N 60W, the aeroplane entered a zone of moderate turbulence. The overspeed warning ("OVERSPEED") was triggered⁽³⁾ and the "Master Warning" warning light came on. The crew stated that they were very surprised by this warning. Mach reached 0.87.

At 1 h 00 min 27 (point n°2), the PNF manually disengaged the AP by pressing the takeover pushbutton on the side-stick. A pitch-up input on the PNF's side-stick going as far as $\frac{3}{4}$ to stop was recorded for 6 seconds. This input was accompanied by an input to bank to the right then left. The PNF stated that he did not remember these inputs.

At 1 h 01 min 08 (point n°6), while the aeroplane was at 37,950 ft in climb, the PF disengaged the A/THR and moved thrust levers forward to the TO/GA detent.

At 1 h 01 min 17 (point n°7), altitude reached maximum: 38,150 ft. Mach was 0.66.

At 1 h 02 min 06 (point n°9), the aeroplane descended past 36,520 ft. The PF then became aware of the disengagement of the AP and made a pitch-down input on his sidestick. Pitch attitude began to decrease 2 seconds later.

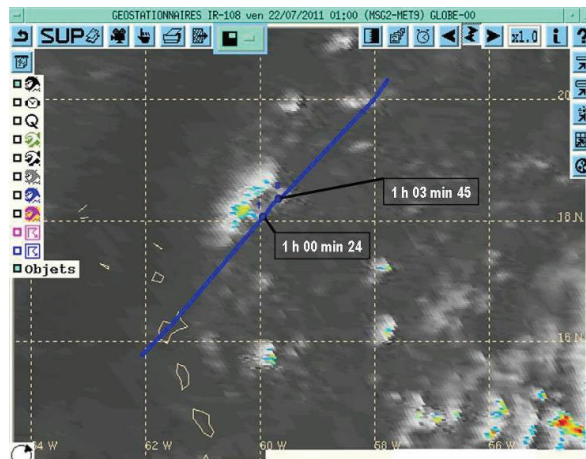
Figure 2 – Trajectory on IR image at 1 h 00

However, infra-red satellite images obtained by the BEA from Météo-France showed the presence of isolated cumulonimbus of moderate intensity between 0 h 30 and 1 h 30 in the area around point 18N 60W, with the top situated at FL380⁽⁷⁾. The recorded trajectory showed that the aeroplane flew close by these clouds during the event.

It should be noted that this type of isolated cloud in an inter-tropical zone is beyond forecasting abilities other than immediate or very short term forecasts.

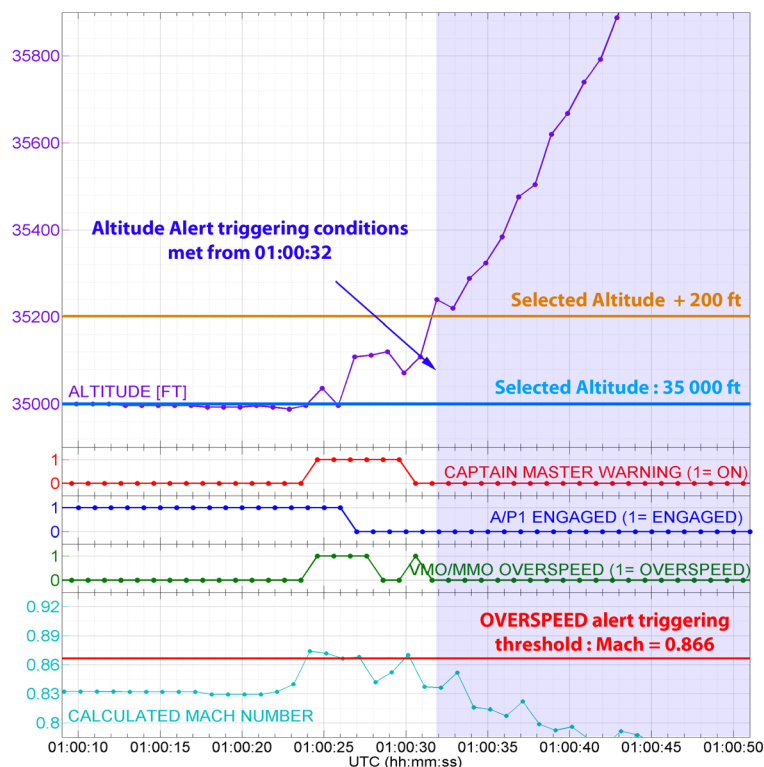
Figure 5 - Warnings recorded

The recorded data showed that there was initially an OVERSPEED warning, which generated a CRC aural warning. This warning was active as long as the Mach was greater than 0.866.

Three seconds later, the AP was disengaged, but as the CRC was still active, the “Cavalry Charge” aural warning was not generated, as it was masked by the CRC. While it was not generated, it could not be cancelled by a possible 2nd press on the sidestick takeover pushbutton.

The moment the 1st OVERSPEED stopped corresponded to the end of the 1.5 second maximum sounding of the “Cavalry Charge”, which was therefore not activated. The “Master Warning” continued to be active between the 1st and the 2nd OVERSPEED as the disengagement of the AP generates a “Master Warning” of 3 seconds if it is not cut off.

The moment of theoretical triggering of the “C-chord” warning, at 35,200 ft, was one second after the end of the 2nd OVERSPEED. Pressing the “Master Warning” warning light, at 36,900 ft, the PNF cancelled the “Altitude alert” about 20 seconds after it appeared. In the absence of a CVR recording, it was not possible to confirm what the real duration of the “C-chord” warning was.

- **EASA evaluate the possibility of requiring that the autopilot disengagement aural warning for all aeroplanes of a maximum mass on take-off of more than 5.7 t be triggered in compliance with paragraphs AMC 25.1322 and AMC 25.1329(j) of the CS-25. [Recommendation FRAN-2012-022]**

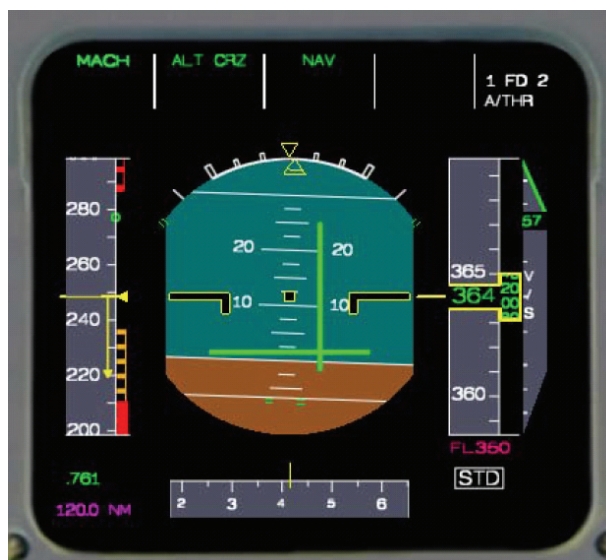
Figure 6 - Reconstitution of display on the PFD during climb at 01 h 00 min 49

modifying the range of his ND. The PNF's attention was drawn to the announcement to the cabin crew. This prioritisation occurred at the expense of monitoring essential parameters such as pitch angle, altitude and the FMA strip during the climb phase. Neither pilot was aware that the AP had been disengaged. The following visual displays were not detected (see Figure 6):

- ❑ Nose-up attitude, which had reached 12° pitch up,
- ❑ High vertical speed, which had reached 5,700 ft/min,
- ❑ The flashing frame around the altitude display on the PFD when the altitude passed 35,200 ft,
- ❑ The position of the FD cross bars,
- ❑ Altitude until it reached more than 38,000 ft,
- ❑ The "AP1" display which had disappeared from the FMA strip,
- ❑ The amber ECAM "AP OFF" message which remained displayed for 9 seconds after the AP disengagement.

It should be noted that perception of these displayed items was made more difficult due to the absence of specific corresponding aural warnings and the level of turbulence which made instrument reading more difficult.

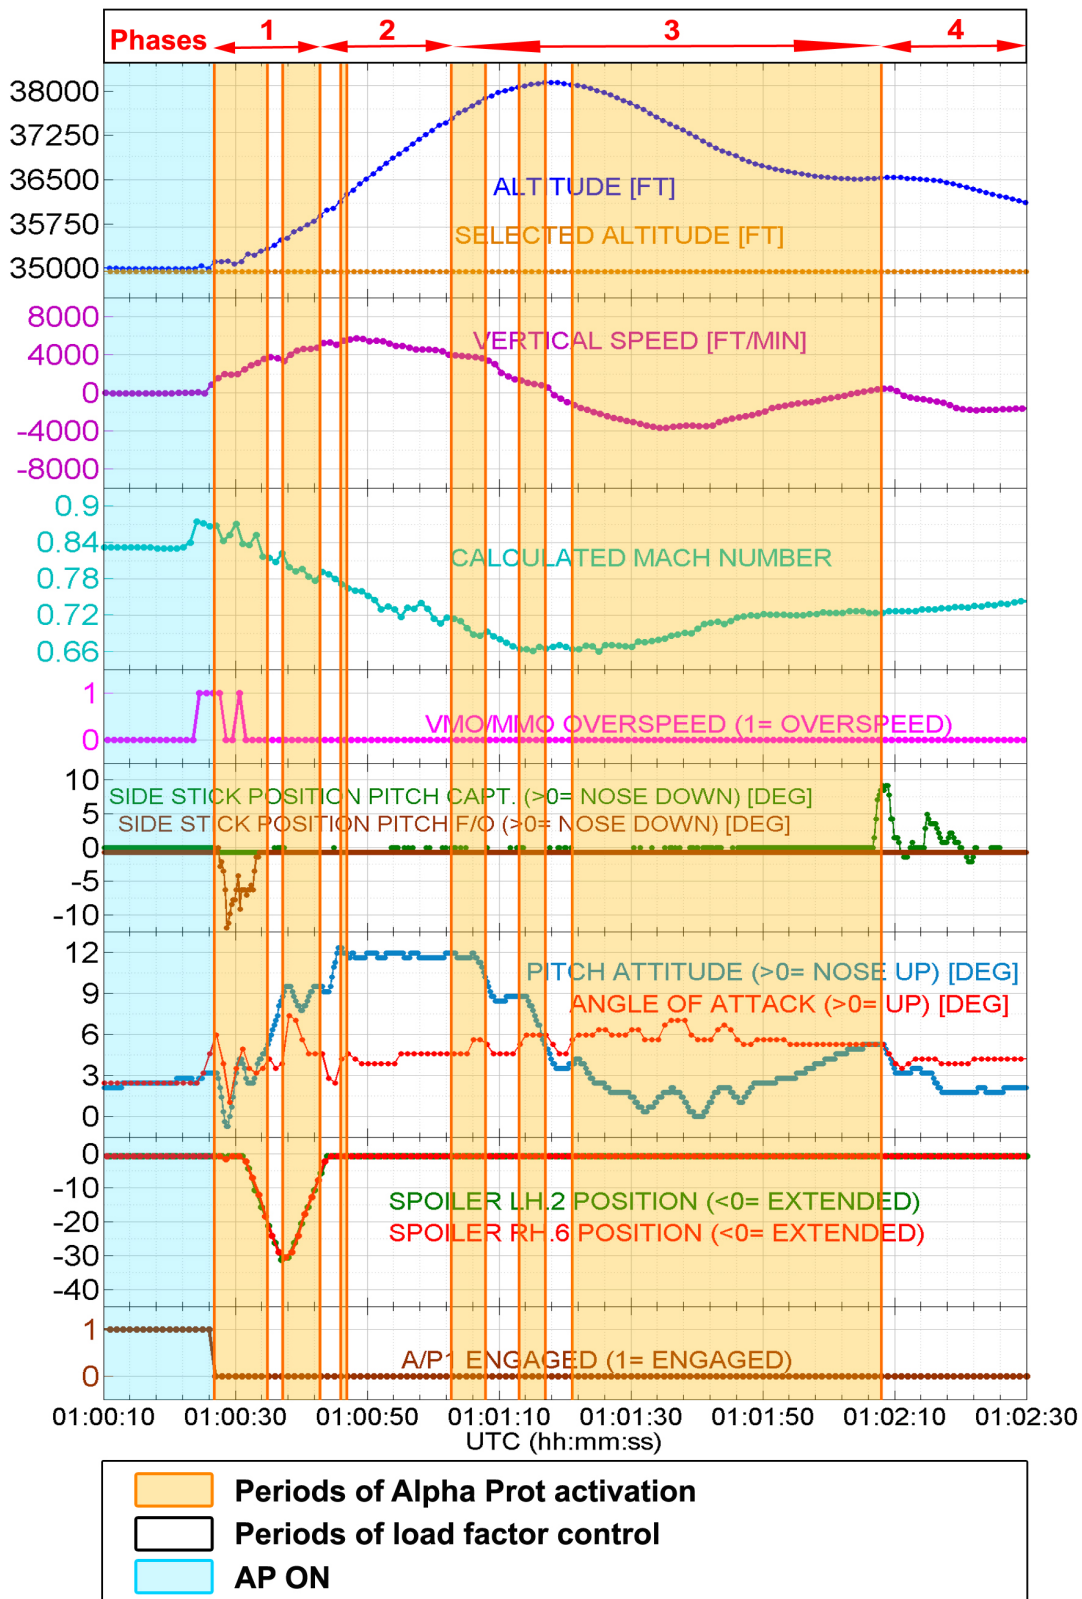
The level bust can be divided into 4 phases:

- ❑ Phase 1: Initially, a gust of headwind⁽¹⁾ generated overspeed and the activation of the “OVERSPEED” warning. A few seconds later, a rising gust caused an increase in the angle of attack and vertical speed. Then, the PNF disengaged the autopilot and made a pitch-up input for 6 seconds while the PF extended the speedbrakes. From the start of the pitch-up input, the angle of attack being greater than Alpha Prot, the high angle of attack protection was activated. Then, for 2 seconds, the angle of attack moved briefly below Alpha Prot, with the sidestick in neutral, which meant it exited the protections. The combined effects of turbulence, sidestick input and the extension of the speedbrakes led to increases in pitch, vertical speed and altitude. An angle of attack spike greater than Alpha Prot activated the high angle of attack protection again. The angle of attack continued to increase and passed Alpha MAX, which caused the automatic retraction of the speedbrakes.

- ❑ Phase 2: The intensity of the turbulence decreased and the angle of attack again became less than Alpha Prot (except for 2 seconds). In the absence of sidestick input, the high angle of attack protection deactivated. The load factor control law then maintained the rising trajectory of the aeroplane. During the climb, since the vertical speed exceeded the capacity to climb at constant speed, the aeroplane speed decreased. When lift became less than weight, the pitch decreased. Maintaining the load factor at 1 g induced a slight increase in the angle of attack.

- ❑ Phase 4: The angle of attack was equal to Alpha Prot therefore less than Alpha MAX. Consequently, the PF’s pitch-down input for more than one second on the sidestick caused the high angle of attack protection to be exited and the longitudinal control law returned to load factor. The pitch attitude decreased then stabilised until the crew re-engaged the autopilot.
