**AERONAUTICAL ACCIDENT INVESTIGATION  
AND PREVENTION CENTER**

**FINAL REPORT  
A-00X/CENIPA/2008**

**ACFT REGISTRATION:      PR-GTD and N600XL**

**MODELS:      B-737 8EH and EMB-135 BJ LEGACY**

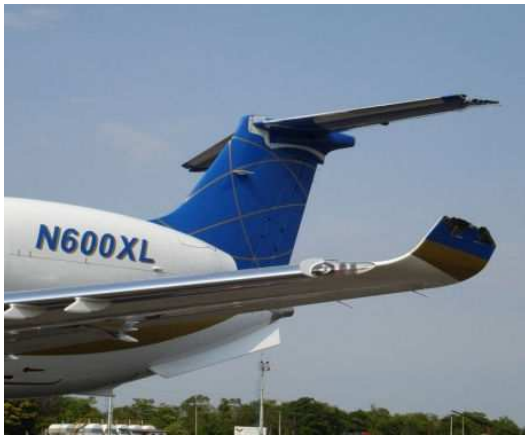
Figure 1

On the occasion, an external inspection was made so as to observe the structural damage sustained by the N600XL airplane. In summary, the following damages were seen: break of the left wing winglet (Figure 1), varied deformations on the left wing and a cut on the fairing of the left tip of the horizontal stabilizer, both on the left side (Figure 2).

Damaged tail and winglet, N600XL

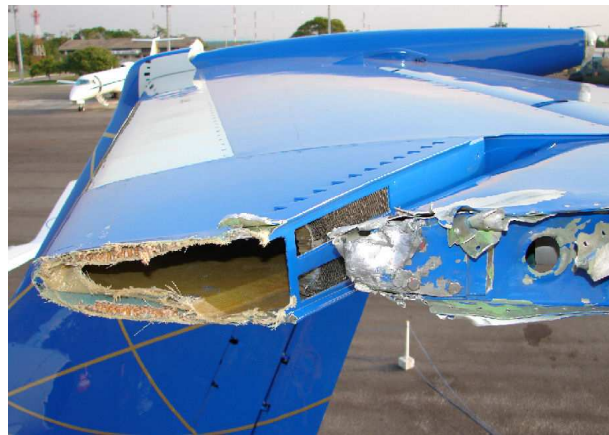
Figure 2

Damaged horizontal stabilizer, N600XL

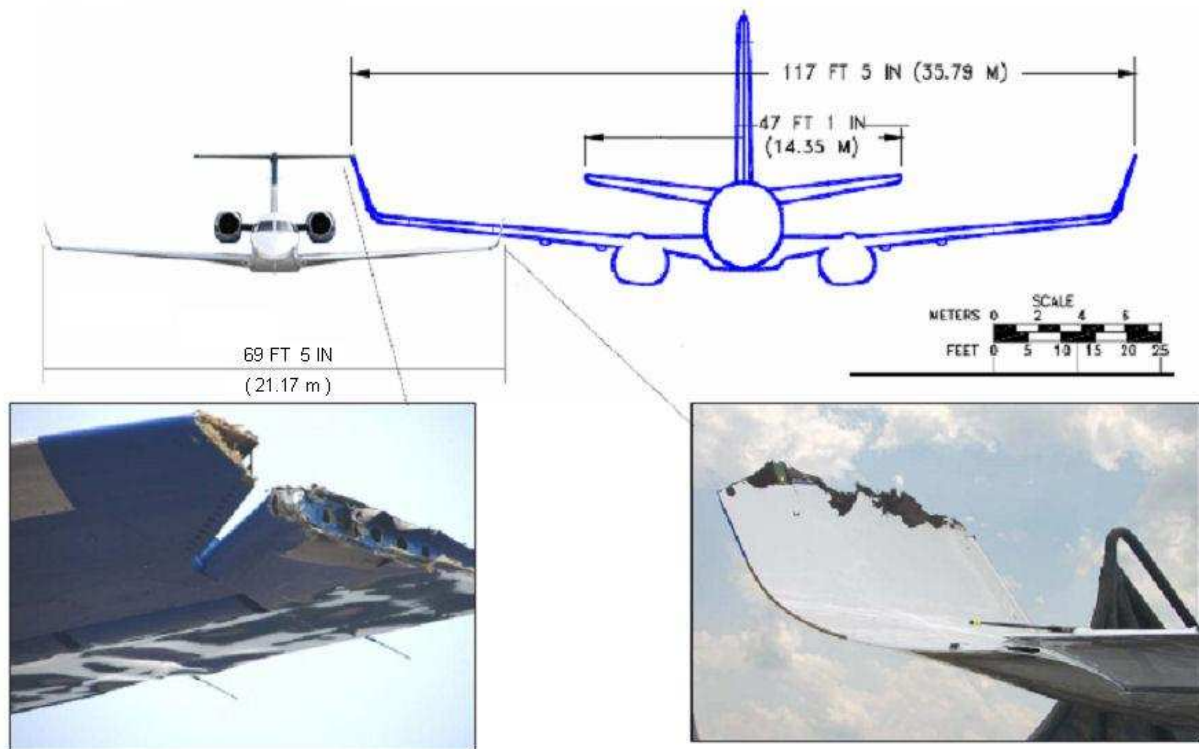
Figure 3

The evaluation of the damages sustained by the N600XL and PR-GTD airplanes allowed the elaboration of a representation of the probable relative position of the two aircraft at the moment of the collision, as shown in figure 3.

Geometry of the collision between the Legacy-600 N600XL and the 737-8EH PR-GTD

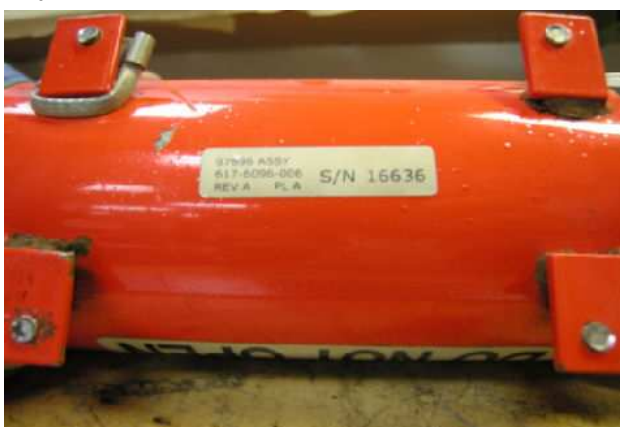
The direct impact of the SSVR unit against a tree trunk or branch was sufficient for the protected cylinder containing the data (Figure 19) to detach from the rest of the set (Figure 20).

**Figure 19:** SSCVR protected cylinder, PR-GTD

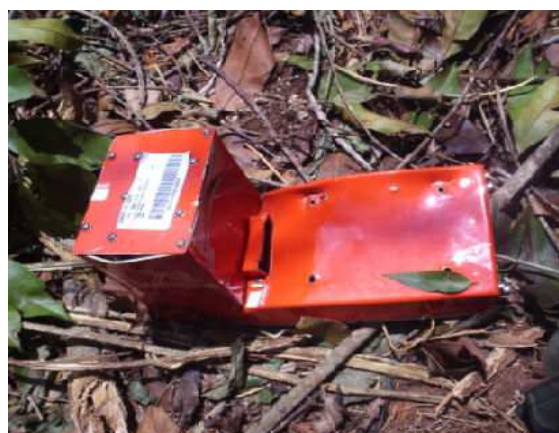
**Figure 20:** Base of the SSCVR unit, PR-GTD

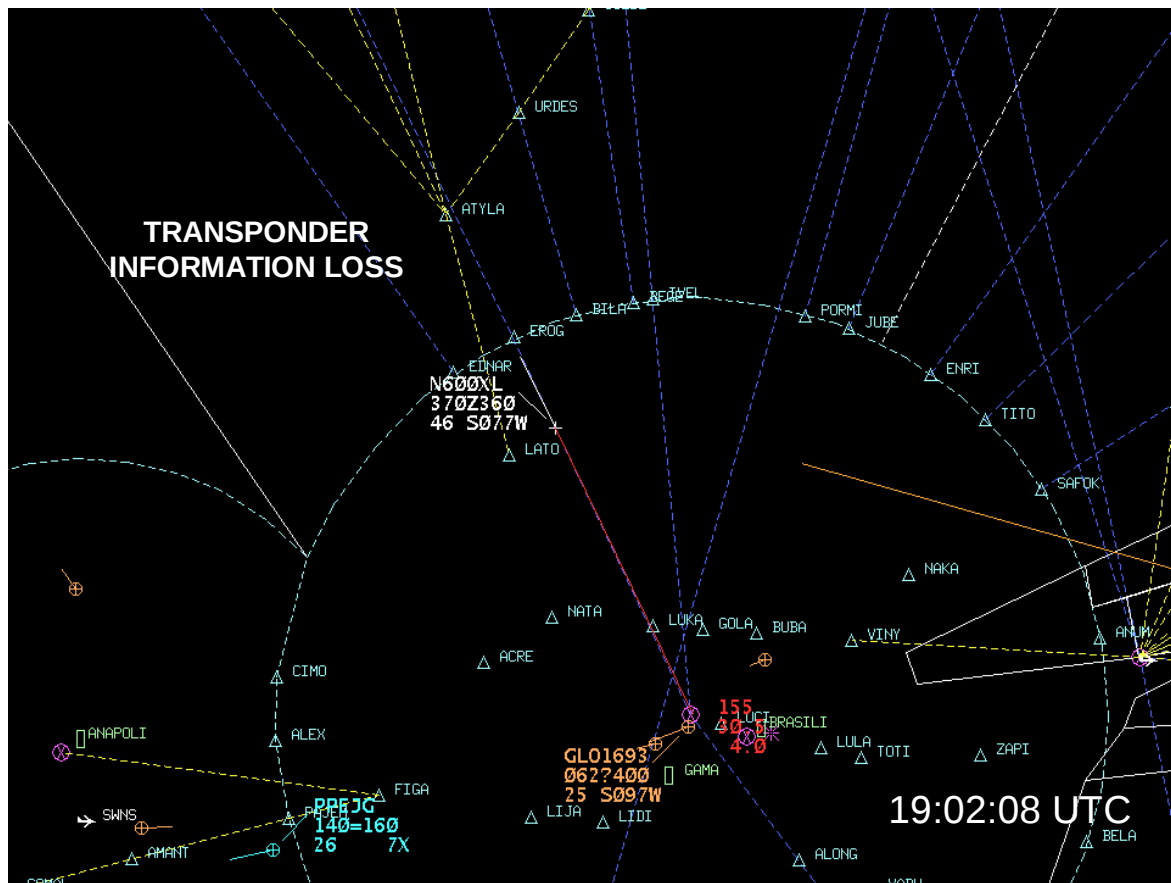
Figure 73 depicts the change in the presentation of the N600XL data block, with the addition of the letter Z after the aircraft measured altitude.

**Figure 73** – Presentation of the N600XL data block, after the transponder transmission discontinuance.
