**INTERSTATE AVIATION COMMITTEE
AIR ACCIDENT INVESTIGATION COMMISSION**

**INTERIM REPORT
(PRELIMINARY REFERENCE INFORMATION)
ON ACCIDENT INVESTIGATION**

Reporting organization	Interstate Aviation Committee
Type of occurrence	Accident
Aircraft	Airplane, Boeing 737-800
Registration	A6-FDN
Owner	Celestial Aviation Trading 38 Limited, Shannon, County Clare, Ireland
Operator	Flydubai, United Arab Emirates
Place of occurrence	Russia, Rostov Region, Rostov-on-Don Airport, coordinates: N 47° 15' 54.7"; E 039° 49' 43.8"
Date and Time	19.03.2016 00:42 UTC, nighttime

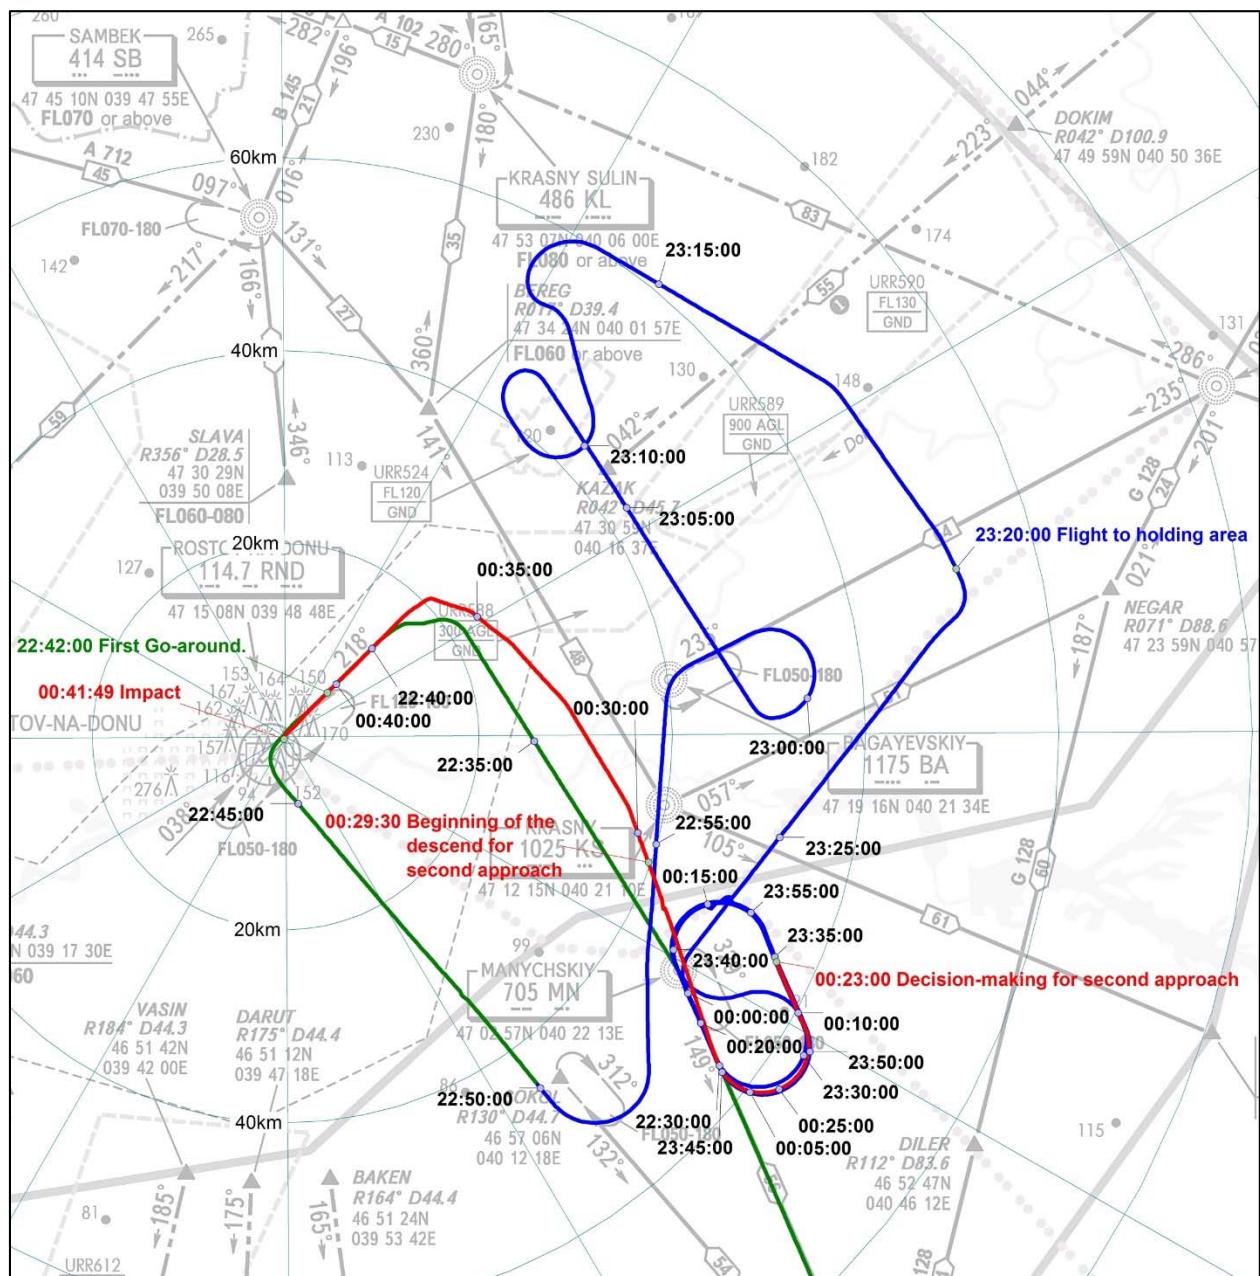
Figure 1. Aircraft flight path.

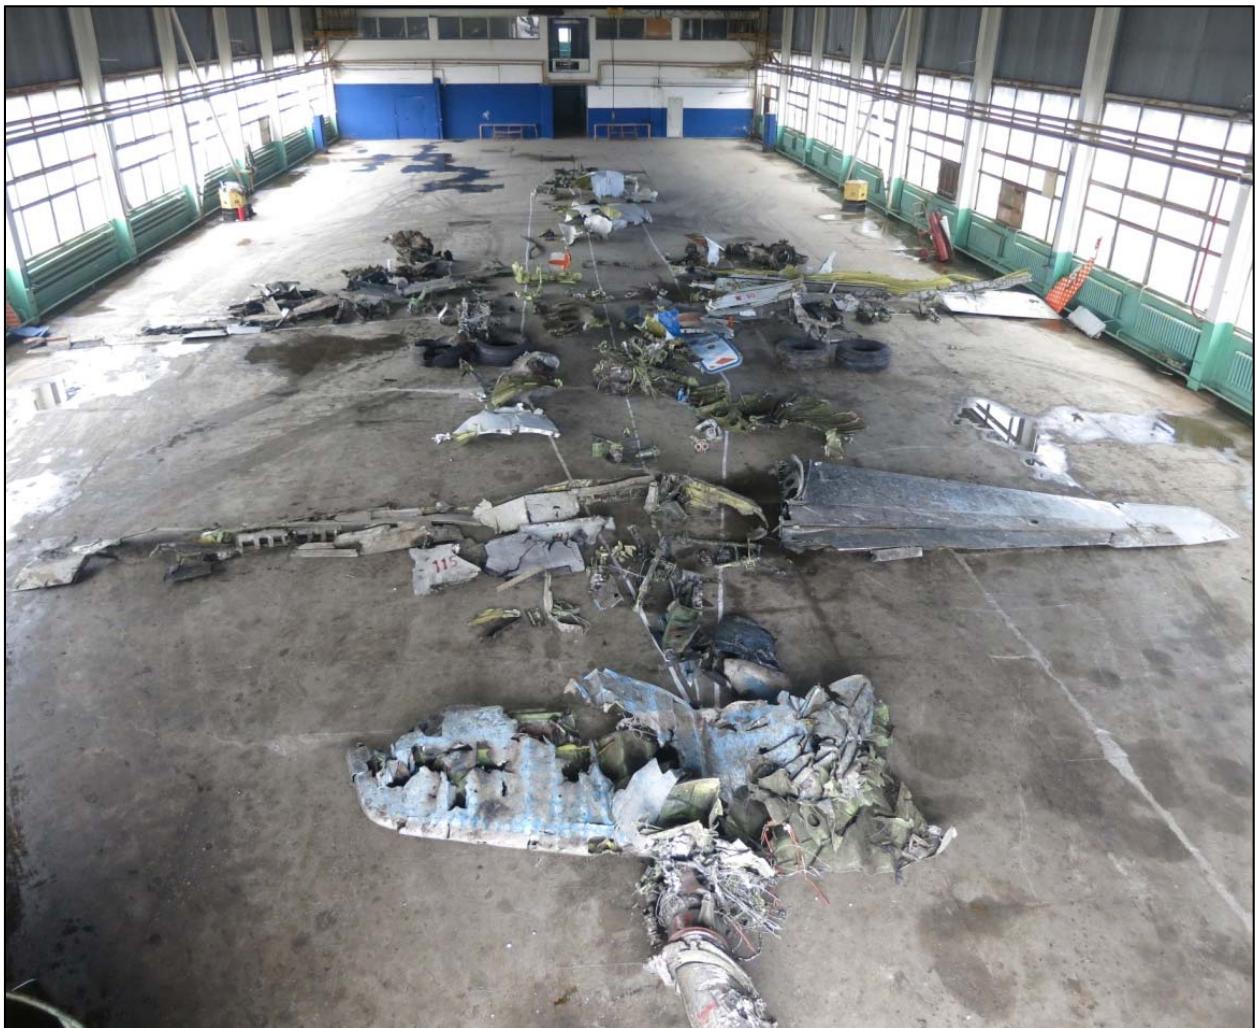
The aircraft was totally destroyed on impact. The majority of airframe structures were highly fragmented.

The 2-d mockup made of the remaining aircraft fragments is shown in Figure 2. The mockup is being made in a hangar at the facilities of Rostov Civil Aviation Plant № 412.

Figure 2. Aircraft mockup in the hangar.

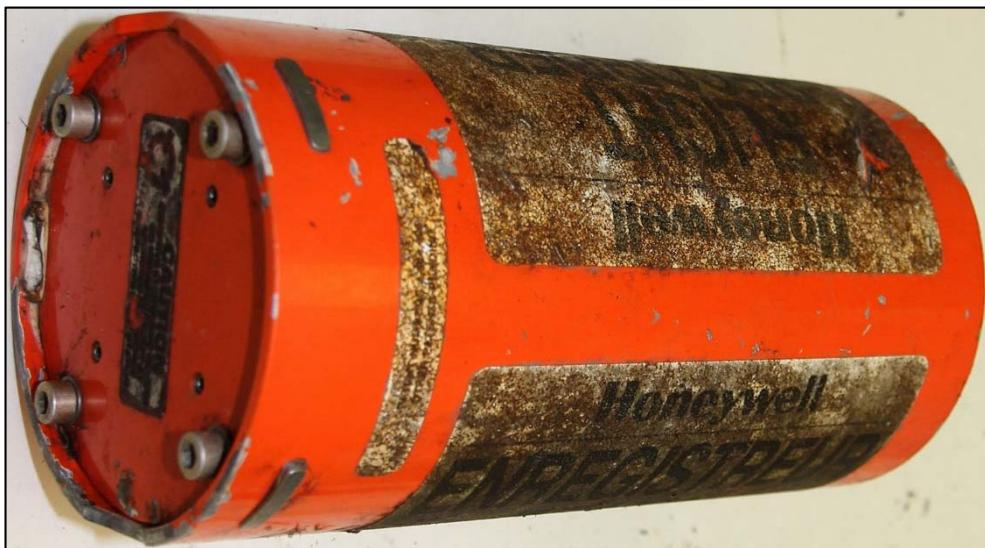
The flight recorders were found at the accident site with substantial mechanical damage (Figures 3, 4). The flight recorders were delivered to IAC where they were examined and the status of memory modules was assessed including X-ray examinations.

Figure 3. FDR picture.

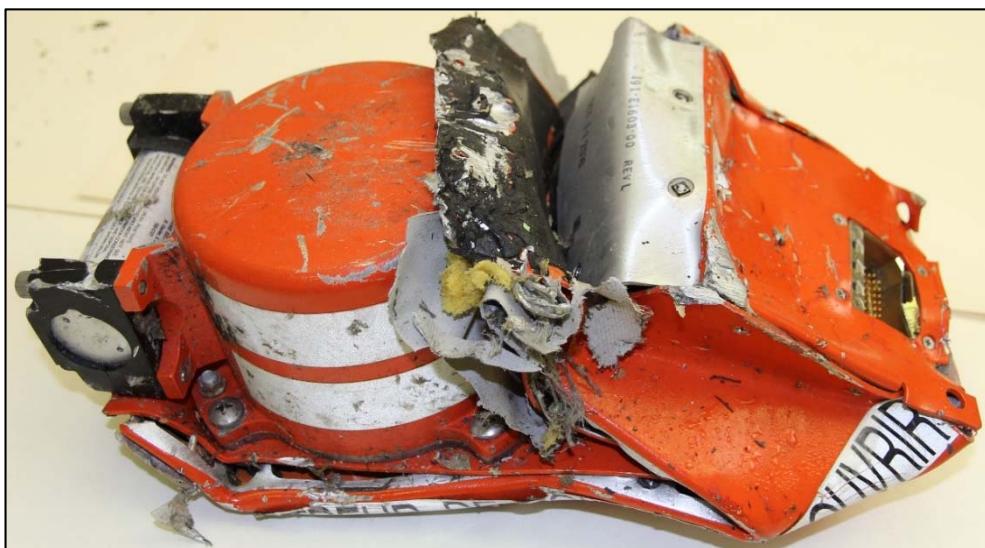
Figure 4. CVR exterior.

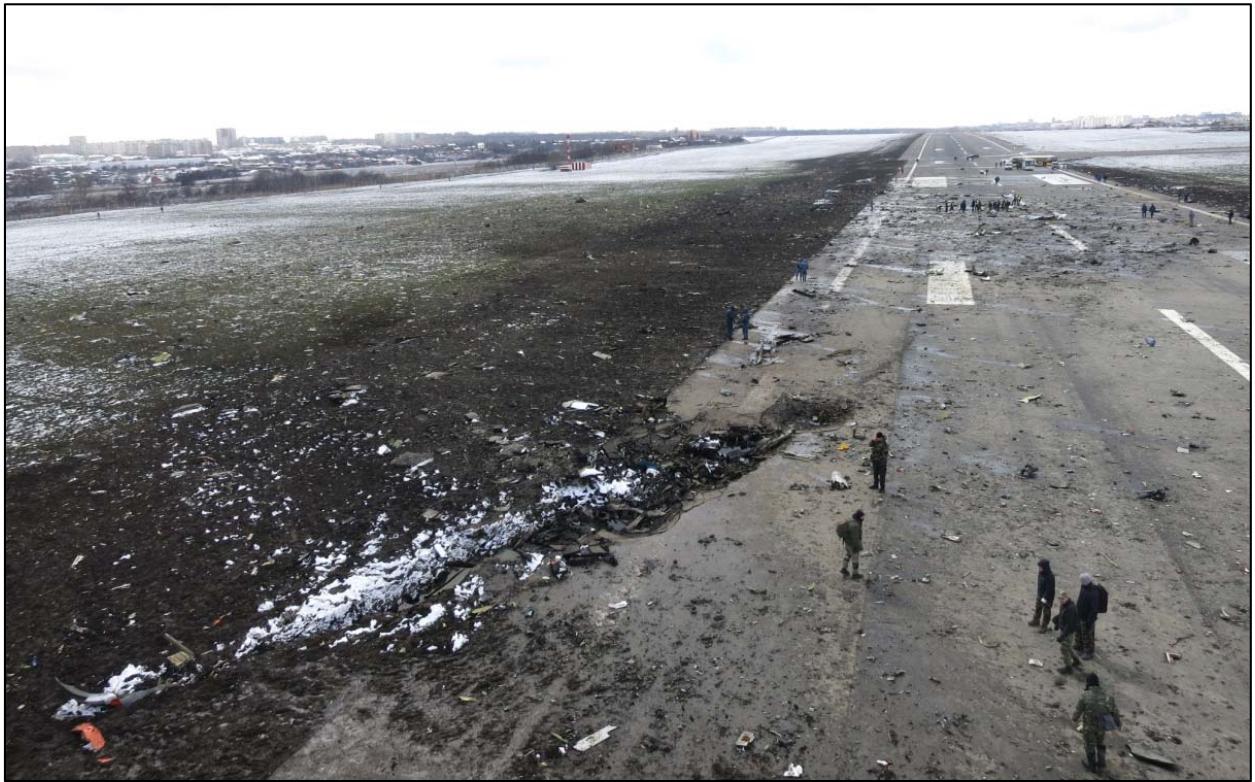
The aircraft was totally destroyed as a result of the accident (Figure 5). The aircraft wreckage pattern was spread along the runway. The maximum spread distance was 904,5 meters length and 185 meters width (Figure 6). The investigation team has prepared a detailed wreckage plot.

Figure 5. A general view of the accident site with the marks of initial touchdown.
