## **SAFETY INVESTIGATION REPORT**

**Malaysia Airlines Boeing B777-200ER (9M-MRO)  
08 March 2014**

**The Malaysian ICAO Annex 13 Safety Investigation Team for MH370**

Issued on 02 July 2018  
MH370/01/2018

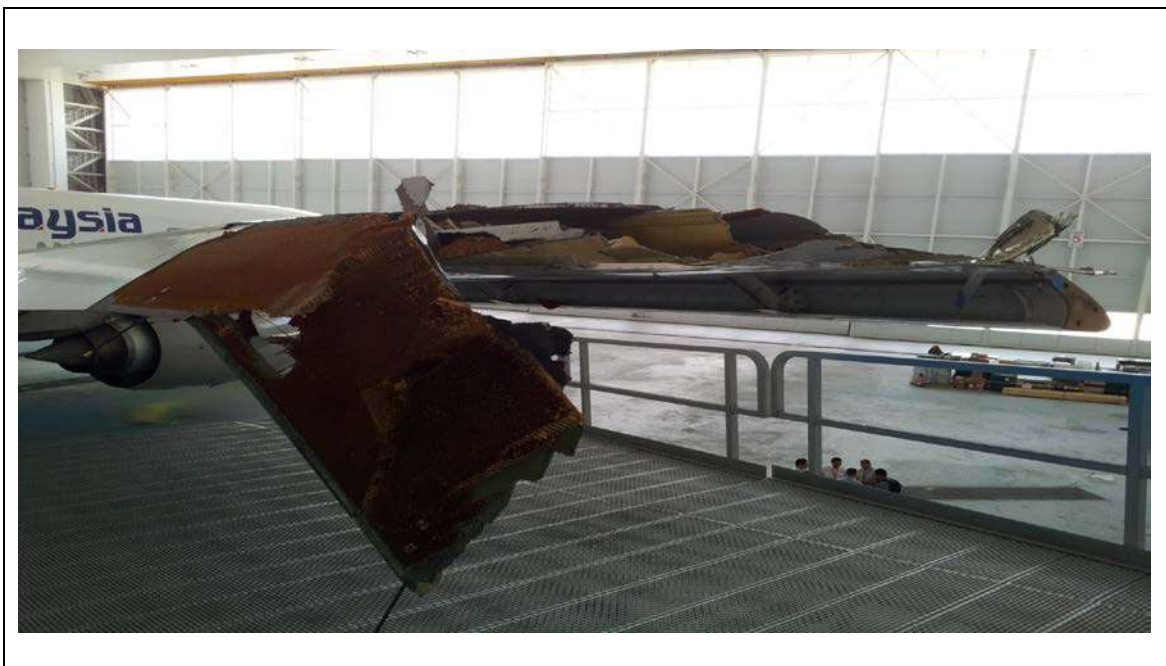
*Figure 1.6A - Right Wing Tip Damage*

There was an entry in the Aircraft Log Book on 09 August 2012 that the aircraft right wing tip was damaged during taxiing at Pudong, Shanghai Airport. The aircraft collided with a China Eastern Airlines A340-600, registered B-6050. The right wing tip of 9M-MRO ran into the left horizontal stabilizer of B-6050. Part of the aircraft wing tip was ruptured and stuck at the left elevator of the B-6050. *Figures 1.6A and 1.6B (below) show the wing tip damages.*

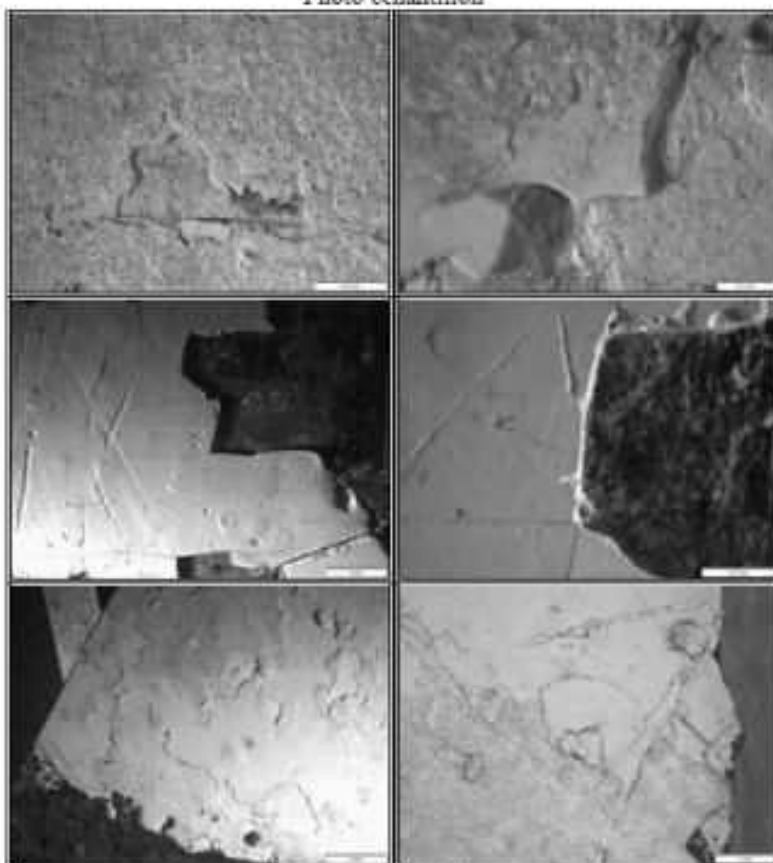
On constate une forte dégradation du système, la couche superficielle est par endroit suffisamment dégradée pour apercevoir les couches profondes plus granuleuses (aspect granité), on observe trois couches distinctes : primaire, intermédiaire, finition.

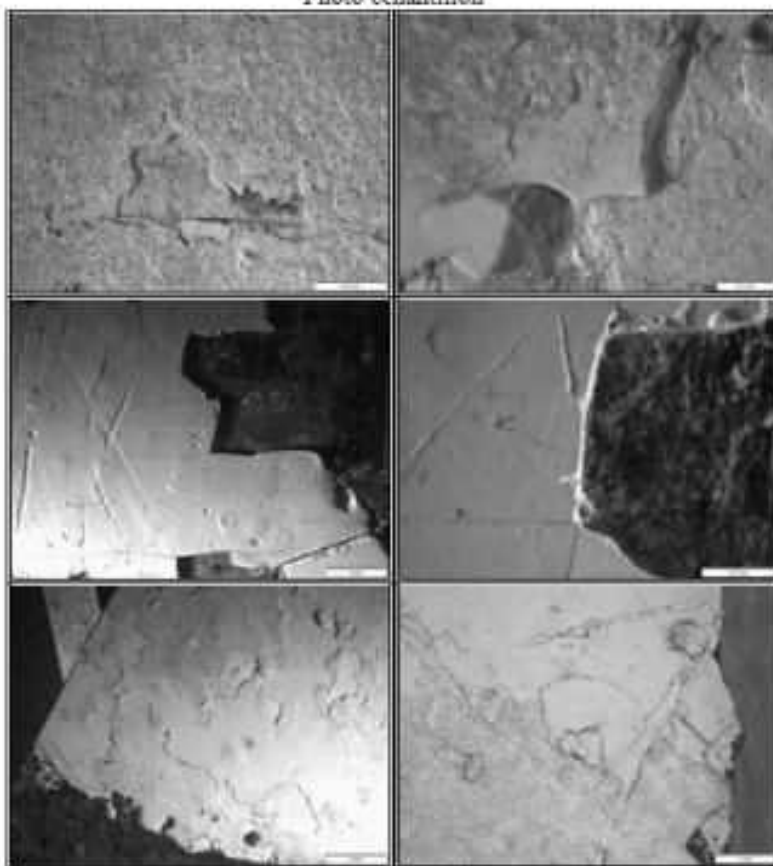
On constate une forte dégradation du système, la couche superficielle est par endroit suffisamment dégradée pour apercevoir les couches profondes plus granuleuses (aspect granité), on observe trois couches distinctes : primaire, intermédiaire, finition.

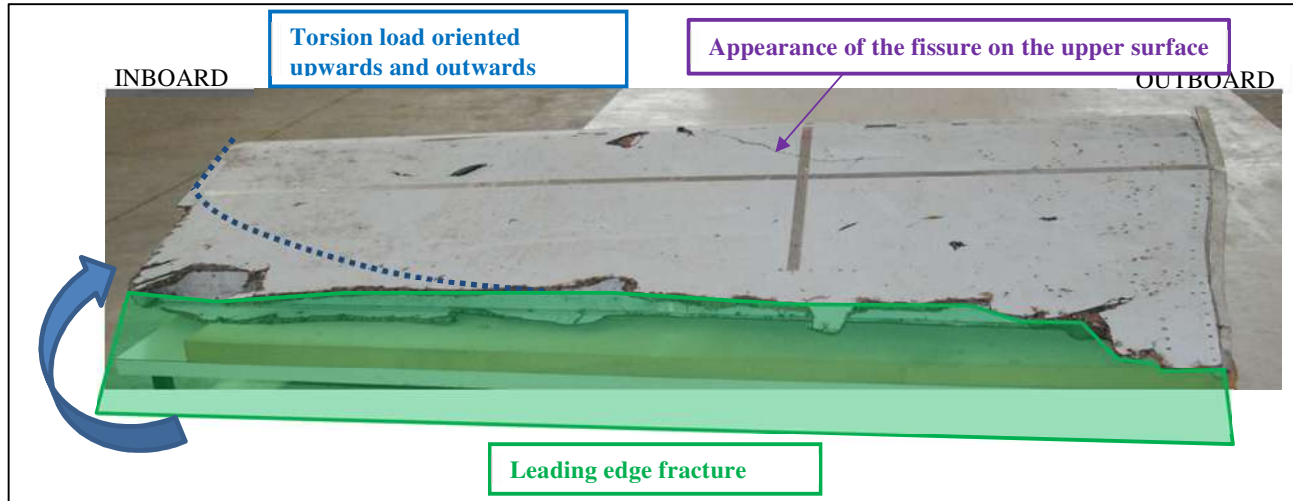
- Fracture of the trailing edge and appearance of the crack on the upper surface-

have generated bowing near the forward spar and a shearing fracture in more in the centre of the flaperon.

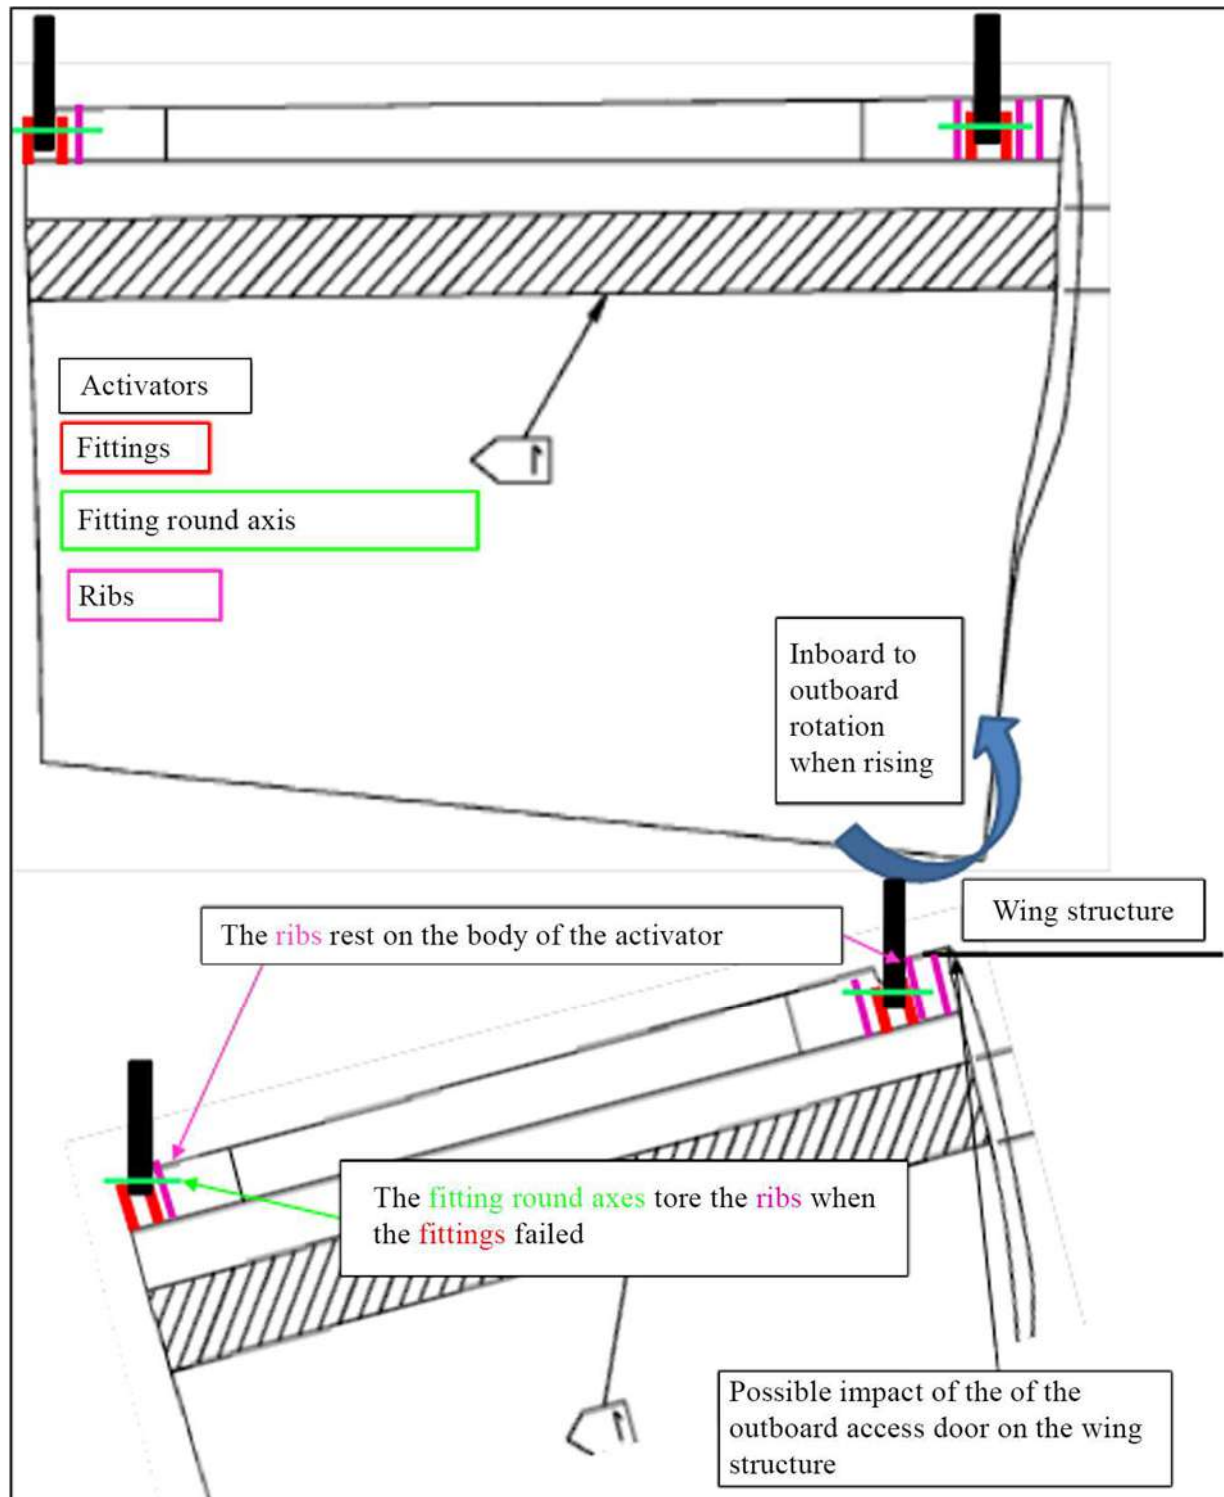
- Ribs and lugs fracture damage sequence: separation of the flaperon -

5. The flaperon pivoted from the inside towards the outside around the outboard hinge fitting (anticlockwise direction). This caused the fracture of the lower part of the outboard hinge fitting as well crushing the fairing of leading edge and pushing the of leading edge ribs onto the actuating cylinders, which would explain their being crushed. The inboard then the outboard lugs, which the activators are attached to, broke off and the flaperon detached. The moment when the fracture of the lugs occurred during this sequence is not clearly definable, in particular the fracture of the inboard lug before that of the lower part of the outboard hinge fitting.

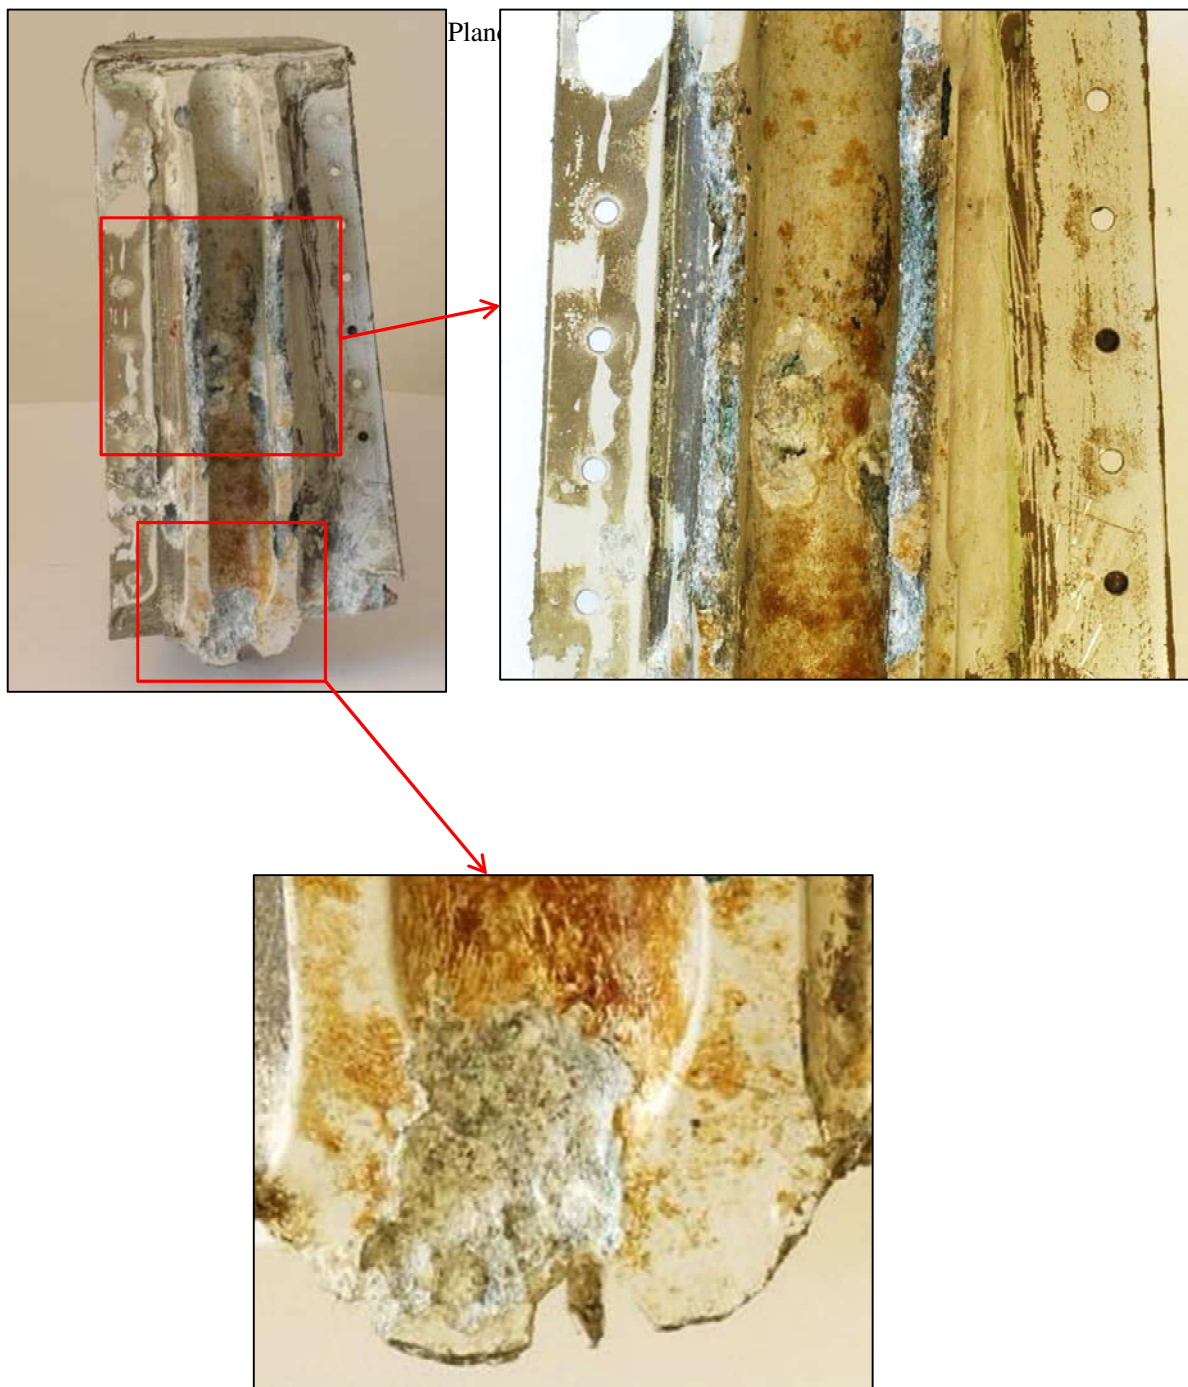
Planche 29 :            **Leading edge outboard side hinge fitting fracture**

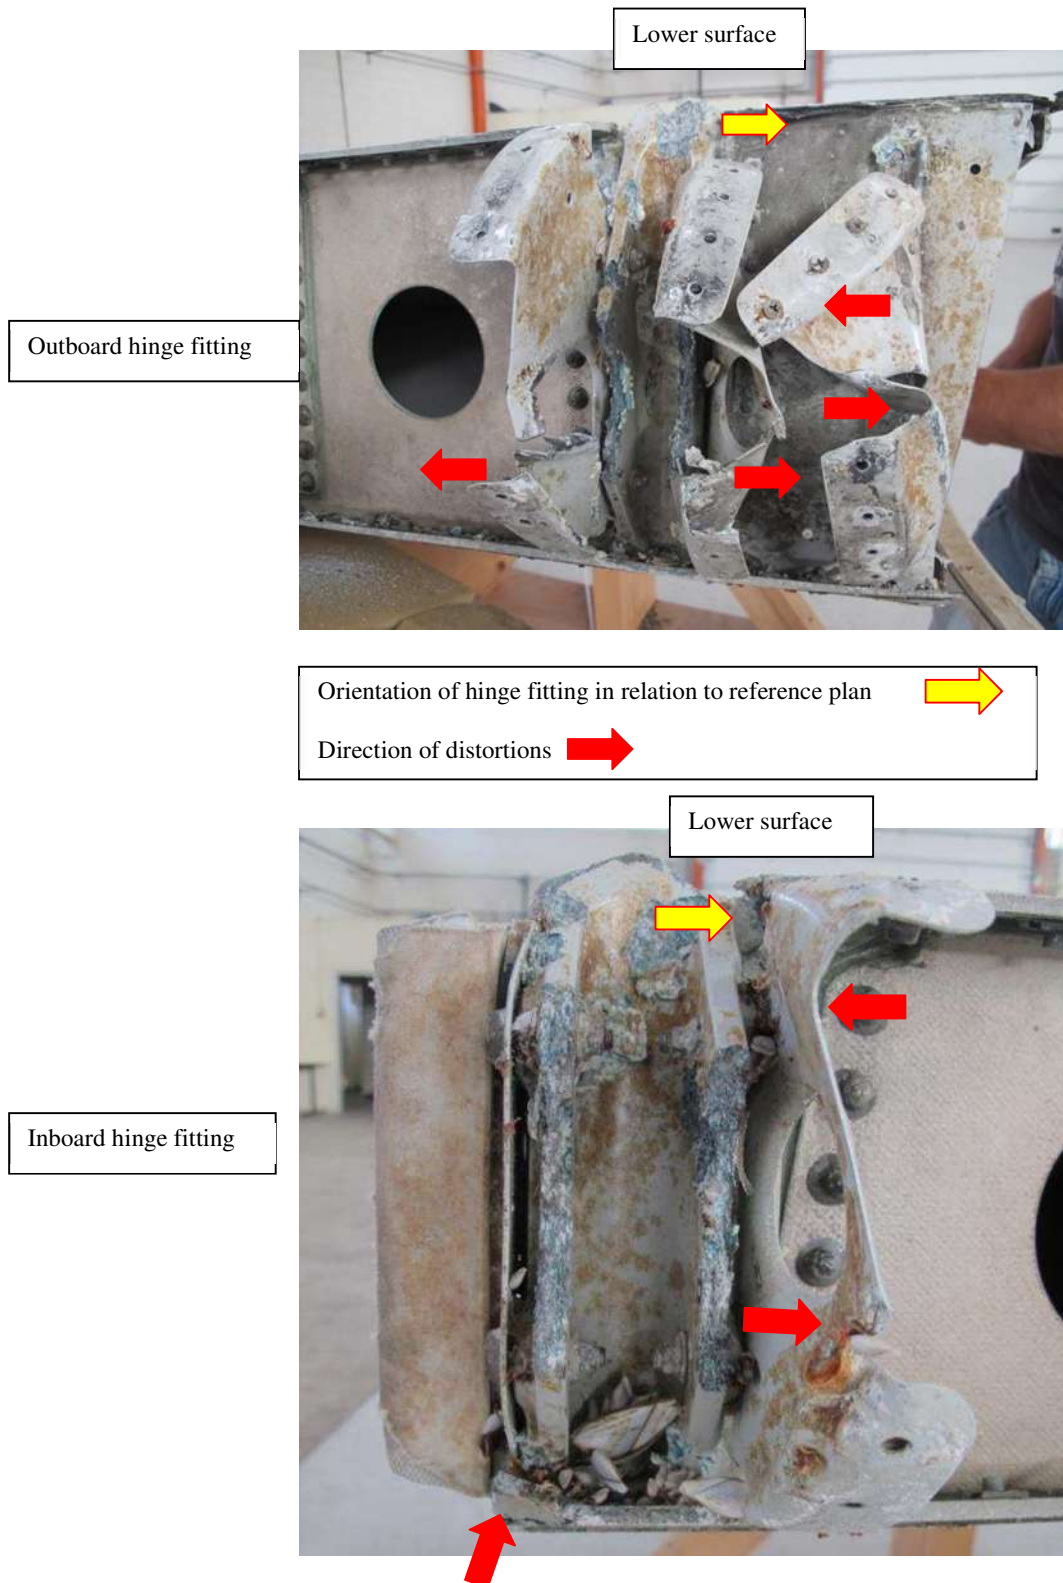
Planche 43 : Summary of the distortions and fractures of the leading edge hinge fittings and ribs

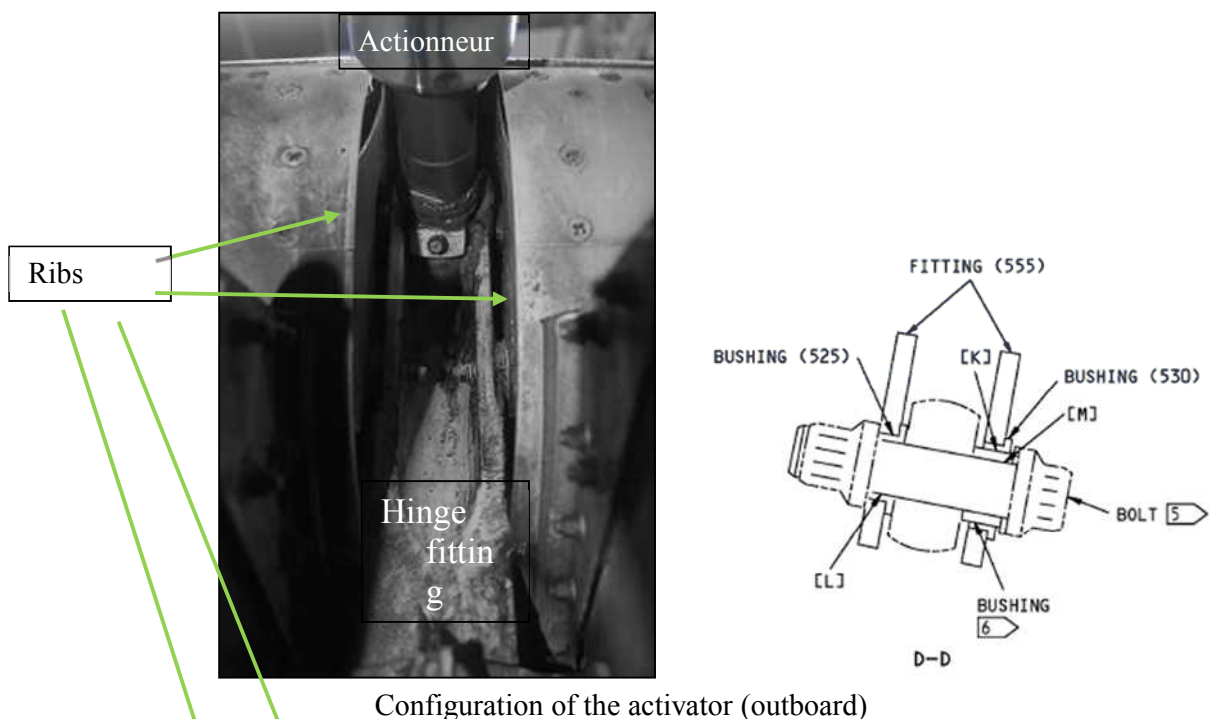
Planche 44 : **Possible explanation of the distortions and fractures of the outboard side leading edge ribs**

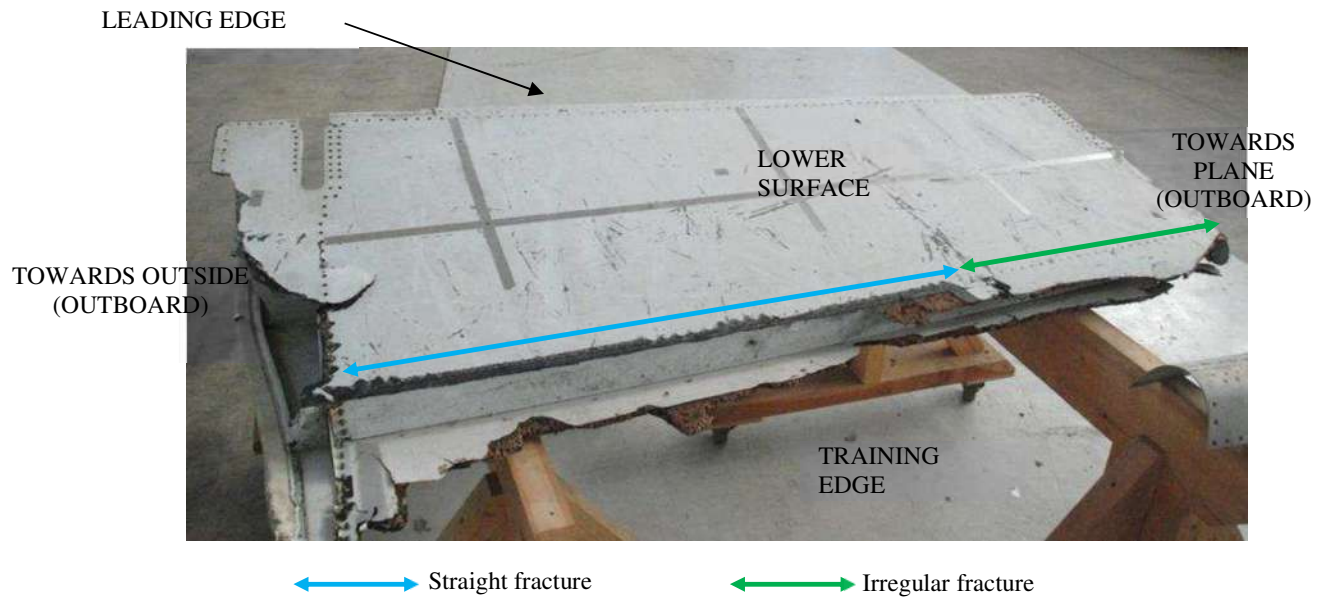
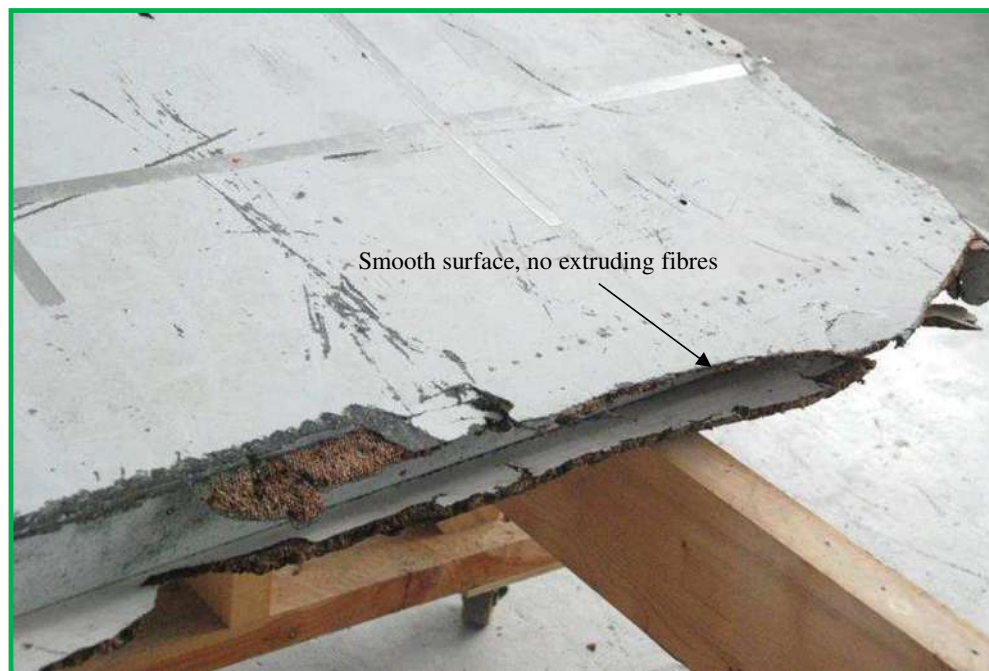
Planche 50 : Lower surface: irregular fracture on trailing edge

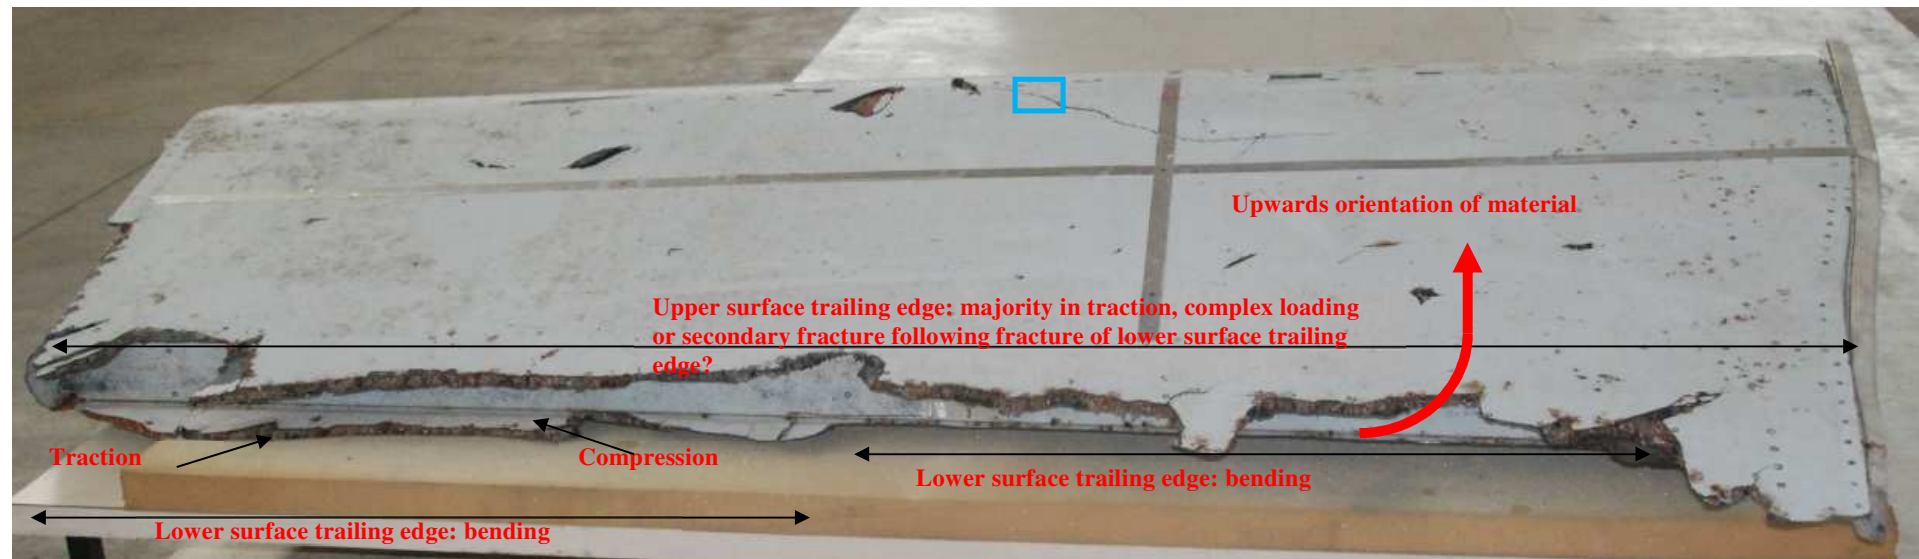
Planche 62 : Summary of the deductions made based on the observations and examinations on the composite structure of the flaperon

Non-protruding crack : **bending**  
fracture : **skin bowing.**
