### Accident Investigation Final Report

All Engines-out Landing Due to Fuel Exhaustion

Air Transat  
Airbus A330-243 marks C-GITS  
Lajes, Azores, Portugal  
24 August 2001

22 / ACCID / GPIAA / 2001

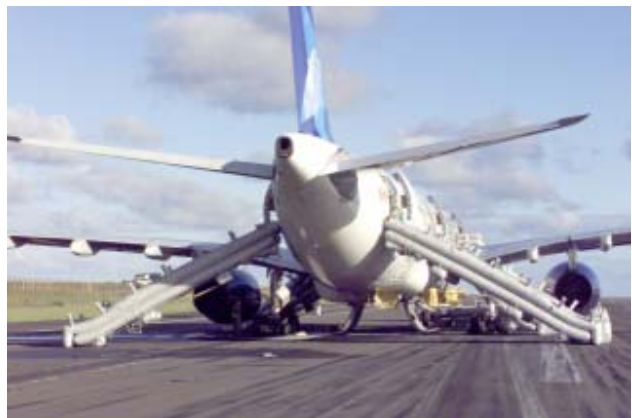
**Figure 1 - Aircraft After Landing**

At 06:45, the aircraft crossed the threshold of runway 33 at about 200 knots, touched down hard 1 030 feet down the runway, and bounced back into the air. The second touchdown was at 2 800 feet from the approach end of the runway, and maximum braking was applied. The aircraft came to a stop 7 600 feet from the approach end of the 10 000-foot runway. After the aircraft came to a stop, small fires started in the area of the left main-gear wheels, but these fires were immediately extinguished by the crash rescue response vehicles that were in position for the landing<sup>6</sup>. The Captain ordered an emergency evacuation. Fourteen passengers and two cabin-crew members received minor injuries, and two persons received serious injuries during the emergency evacuation. The aircraft suffered structural damage to the fuselage and to the main landing gear.

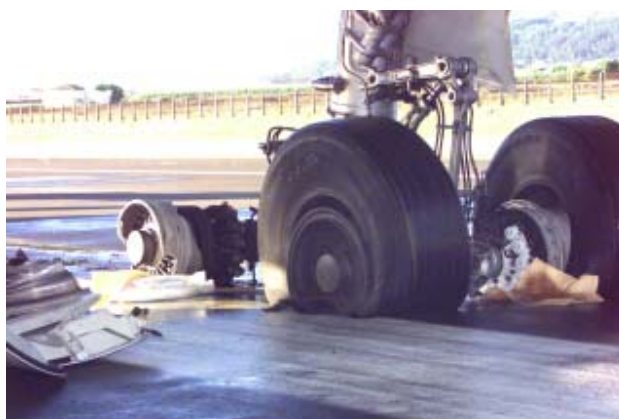
**Figure 2 - Left-main Boogie**

Due to the engines-out condition, the landing was conducted without the brake anti-skid and normal braking systems. Because the emergency brake accumulator only provides for a limited amount of brake applications, full braking was applied and retained at the second touch down, resulting in the main wheels locking up. The tires quickly abraded and deflated at a point between about 300 and 450 feet beyond the second and final touch down. The segments of the main wheels contacting the pavement were worn down to the bearing journals, the left, rear, inboard wheel detached from the axle. Both left and right brake anti-torque links attachment horns on the bottom segments of the main oleos also contacted the pavement; the horns were abraded to the point that some of the links separated from the oleo resulting in the rotation of at least one brake carrier.

Shedding of brake and wheel components during the landing run also resulted in a combination of punctures and impact damage to the airframe and left engine nacelle.

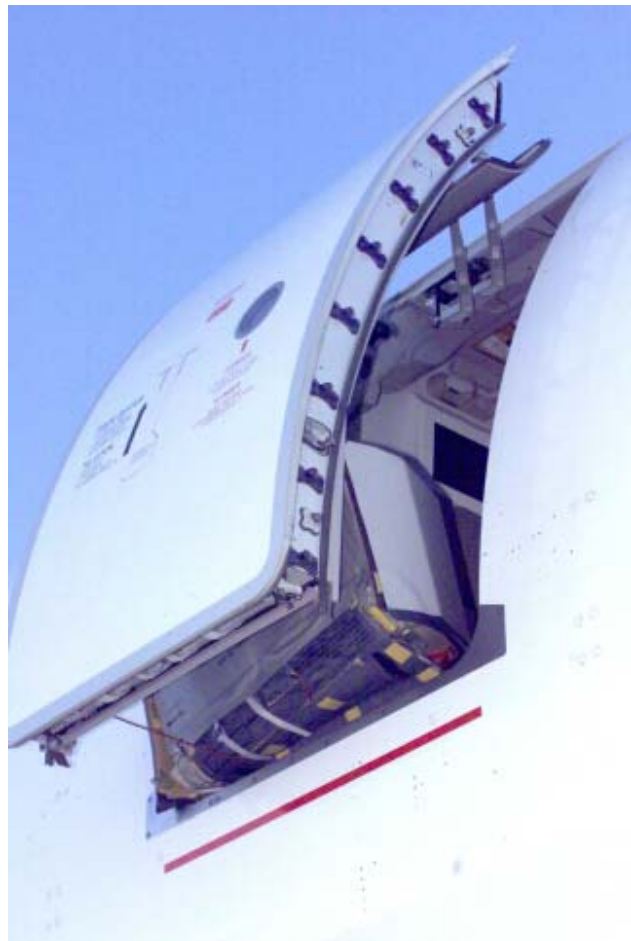
**Figure 6 - Door L3 Jammed**

The L3 flight attendant reported that, prior to departure, door L3 had been armed and that the indicator at the door indicated that the door was properly armed. The indicator at the FD's panel also indicated that the door was armed. Following the evacuation, the L-3 attendant examined the door and the slide appeared to be partially attached to the exit door. A photo taken of the door from outside the aircraft showed the L3 door partially opened and the escape slide slightly askew and apparently connected to both the floor and the door.

Sometime after the landing, fire-rescue crews, in attempting to eliminate the hazard of the escape slide inflating within the cabin, used a pry-tool to release the slide and open the door. Reportedly, when the door was opened, the slide fell out the door and only inflated partially.

Inspection of the L3 exit did not reveal any damage to the door or frame, other than minor scratches and minor damage to the plastic panel in the area where the pry bar was used. When operated by investigators, the door opened and closed without any restriction and no mechanical distortion or malfunction was found either with the arming system or with the locking/unlocking of the girt bar. An examination of the power-assist unit indicated that it had been activated.

Conclusive finding as to the cause of the door jam could not be made, primarily because of the missing components. Notwithstanding, interviews and photos confirm that the slide had not released completely from the door, and that the bustle rails/rail adapters may have jammed.
