FINAL ACCIDENT INVESTIGATION REPORT

AIRBUS A321-211

G-VOLH

REPORT NR 07/ACCID/2001

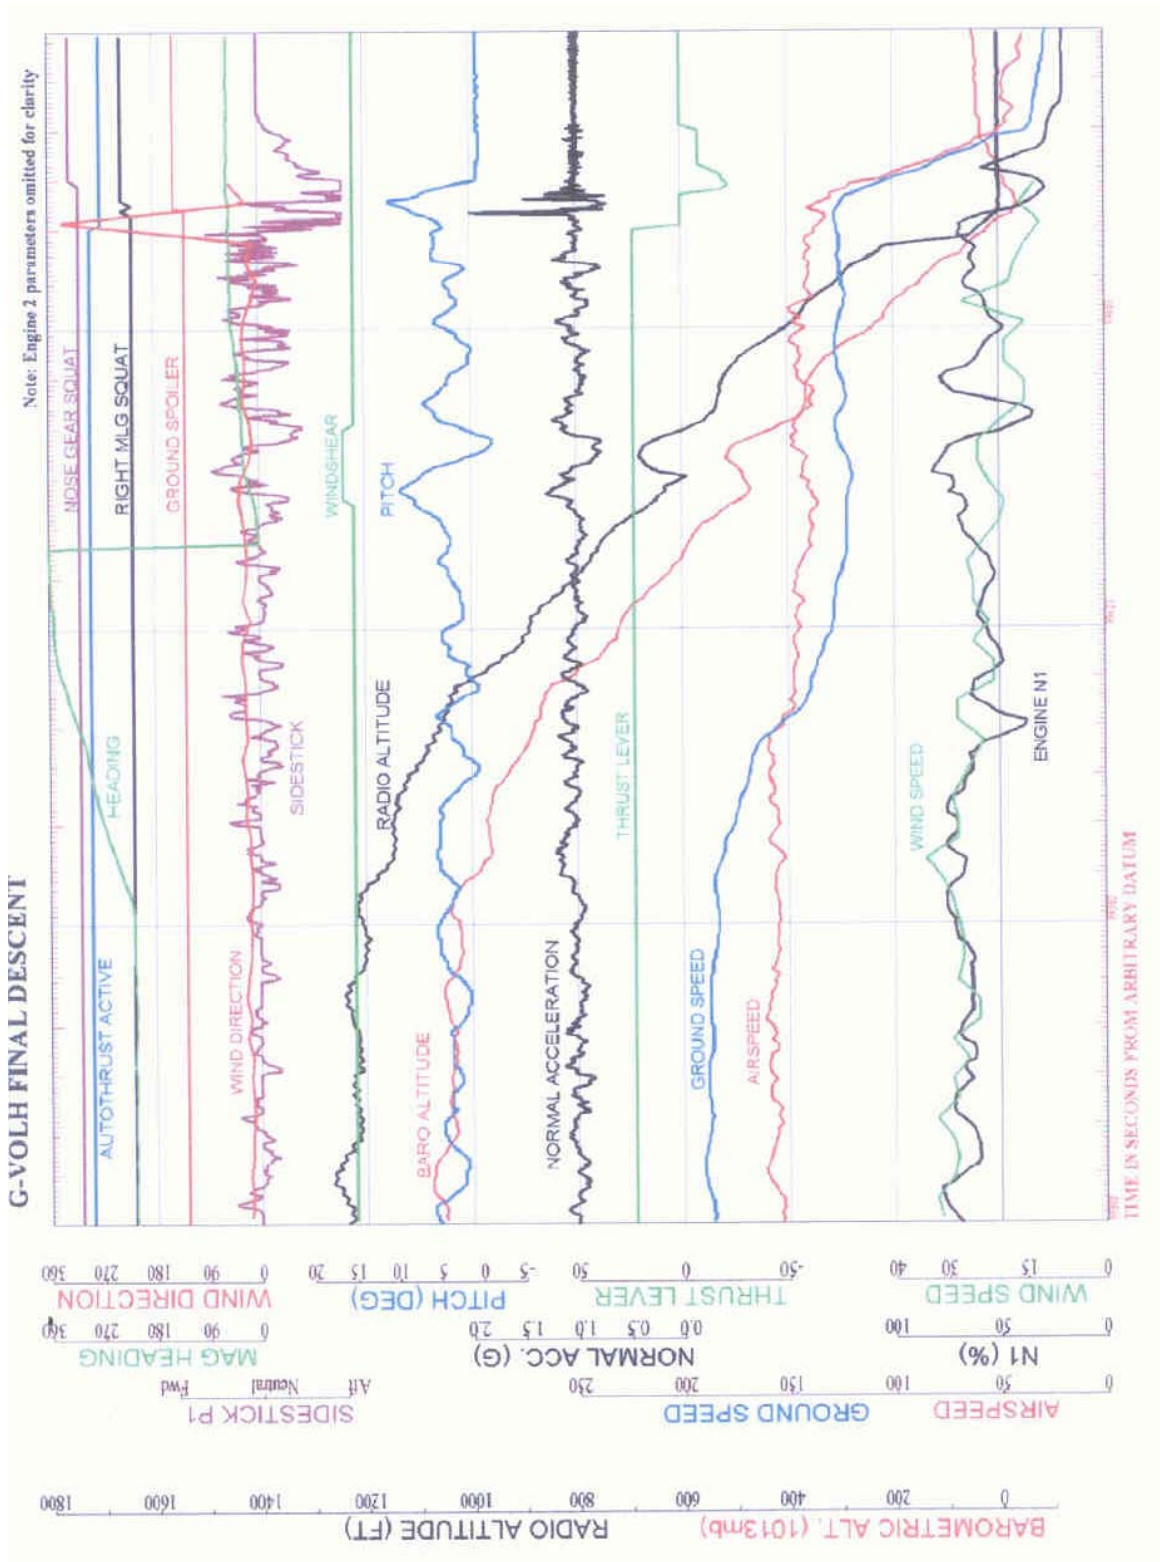
Figure 3

Graphical traces of pertinent parameters recorded during the approach and landing are shown in Figures 3 and 4.

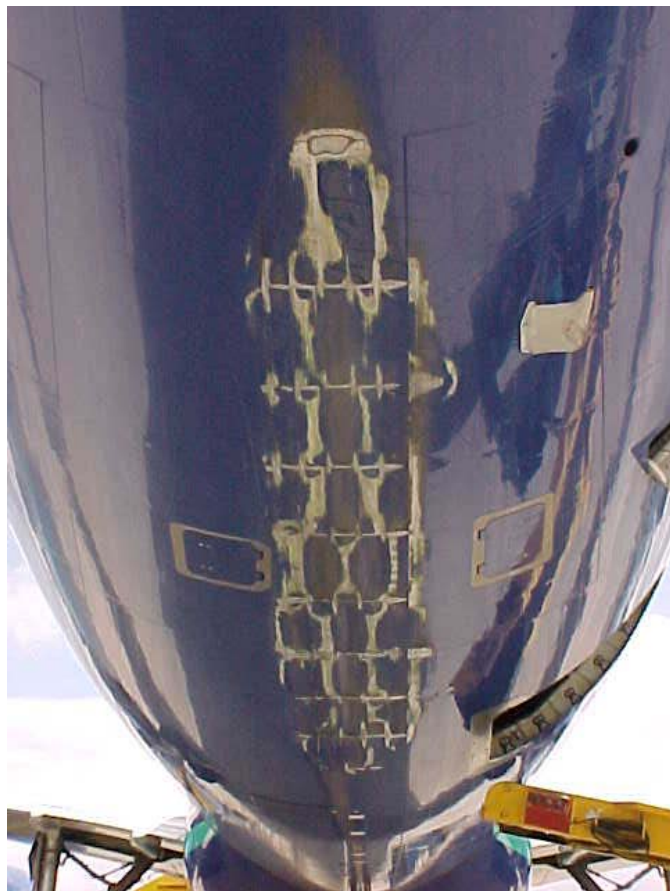
Figure 5 – Lower fuselage

Examination of the aircraft at Funchal showed extensive damage to the lower fuselage over a distance of some 5 metres. The lower skin was deeply abraded from Frame 61 (near the bulk cargo door) to around Frame 70 (rear pressure bulkhead). Within this area of abrasion a number of the fuselage frames (61 to 69) had suffered structural damage from the vertical loads applied in the contact with the runway. The abrasion marks were parallel with the fuselage axis, showing that there was negligible aircraft yaw at contact.

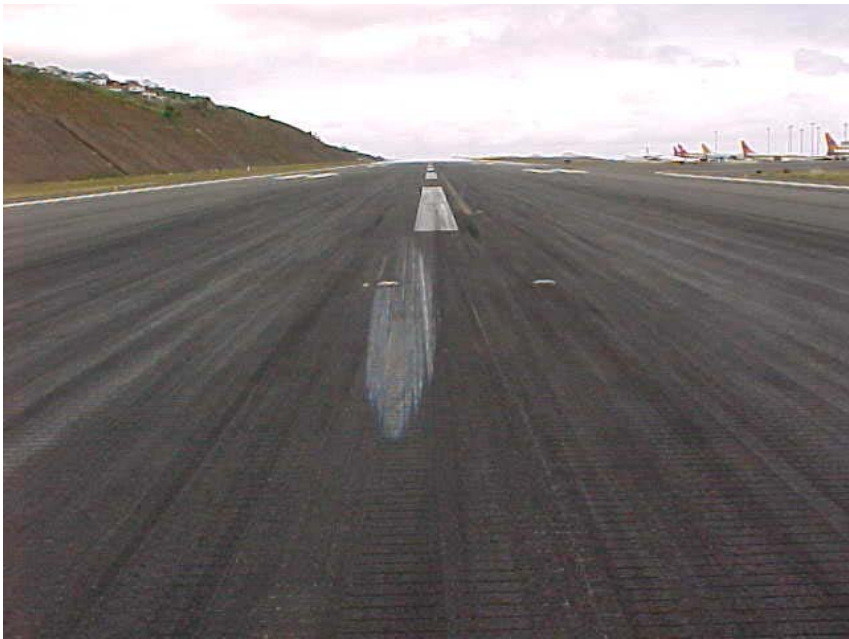
Figure 7

The examination of the runway showed a single mark from the contact with G-VOLH, some 13 metres long, within the normal touchdown zone and close to the runway centre line (Figures 7, 8 & 8-A).

From the geometry of the impact damage, the aircraft pitch attitude would have been between 10° and 11° relative to the runway.

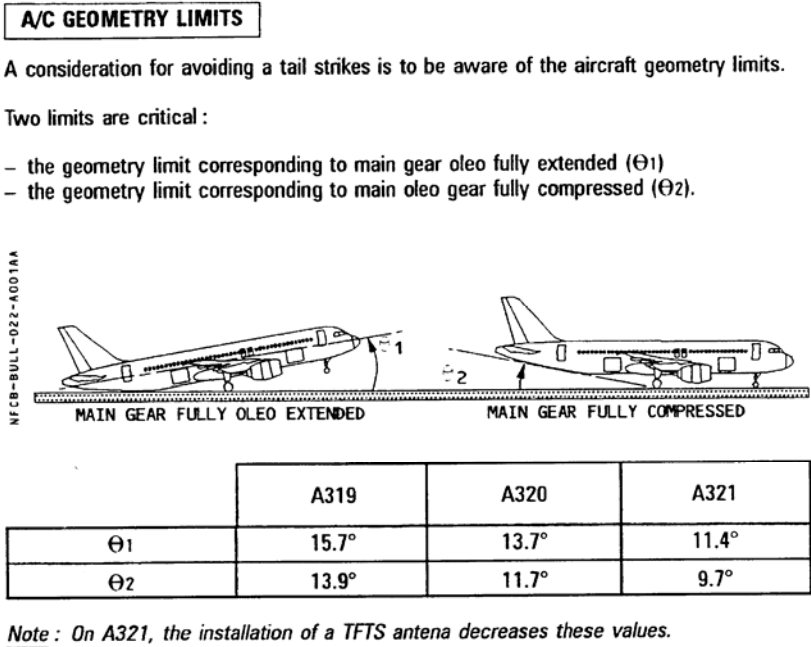
Figure 9

The FCOM Bulletin (Nr. 22/2 April 99) from Airbus Industries shows the corresponding tail contact angles, with oleos fully compressed, to be 9.7° for the A321 and 11.7° for the A320.
