Federal Democratic Republic of Ethiopia
Ministry of Transport
Aircraft Accident Investigation Bureau

Aircraft Accident Investigation Preliminary Report
Ethiopian Airlines Group
B737-8 (MAX) Registered ET-AVJ
28 NM South East of Addis Ababa, Bole International Airport
March 10, 2019

Report No. AI-01/19

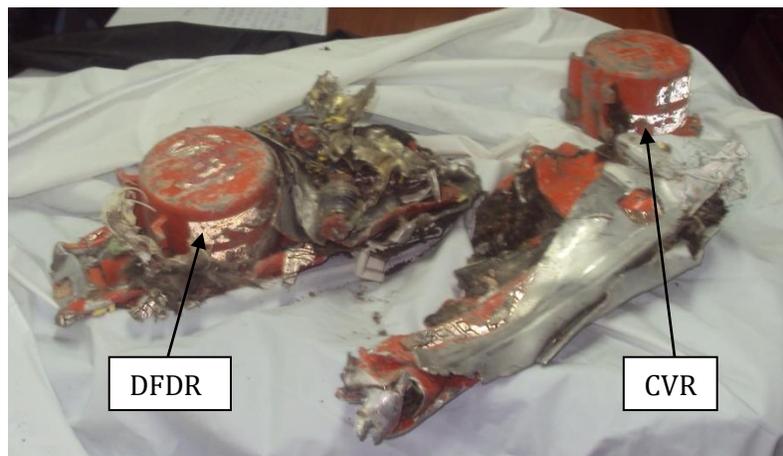
DFDR and CVR as discovered on the accident site.

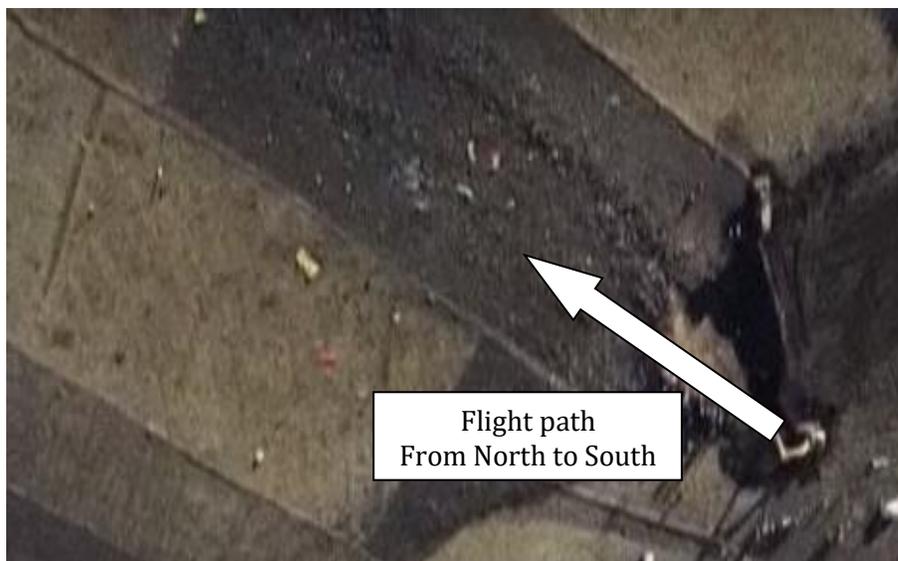
The Aircraft impacted in a farm field and created a crater approximately 10 meters deep (last aircraft part found) with a hole of about 28 meters width and 40 meters length. Most of the wreckage was found buried in the ground; small fragments of the aircraft were found scattered around the site in an area by about 200 meters width and 300 meters long.

The damages to the aircraft are consistent with a high energy impact.

Top view of the crater

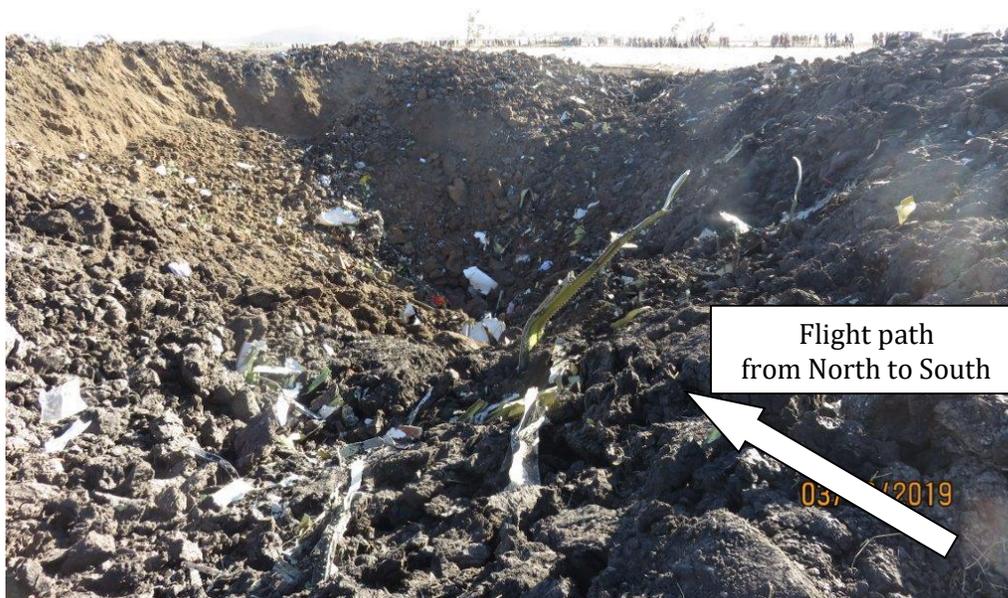
Close view of the crater before excavation

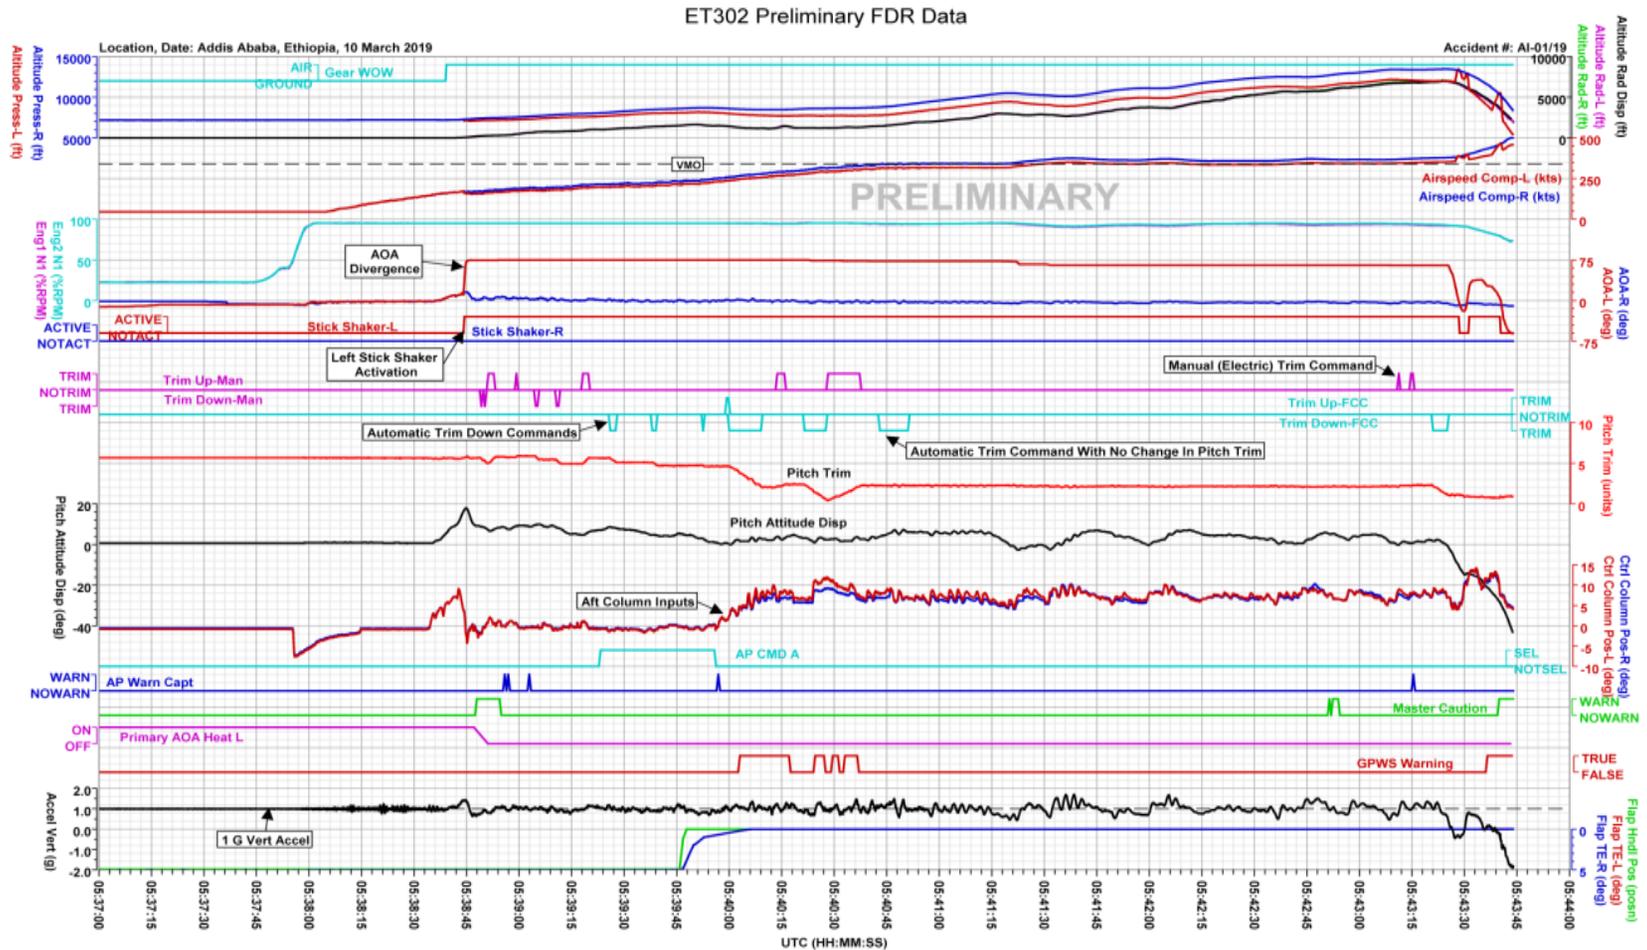
APPENDIX 1

At 05:38:44, shortly after liftoff, the left and right recorded AOA values deviated. Left AOA decreased to 11.1° then increased to 35.7° while value of right AOA indicated 14.94°. Then after, the left AOA value reached 74.5° in $\frac{3}{4}$ seconds while the right AOA reached a maximum value of 15.3°. At this time, the left stick shaker activated and remained active until near the end of the recording. Also, the airspeed, altitude and flight director pitch bar values from the left side noted deviating from the corresponding right side values. The left side values were lower than the right side values until near the end of the recording.

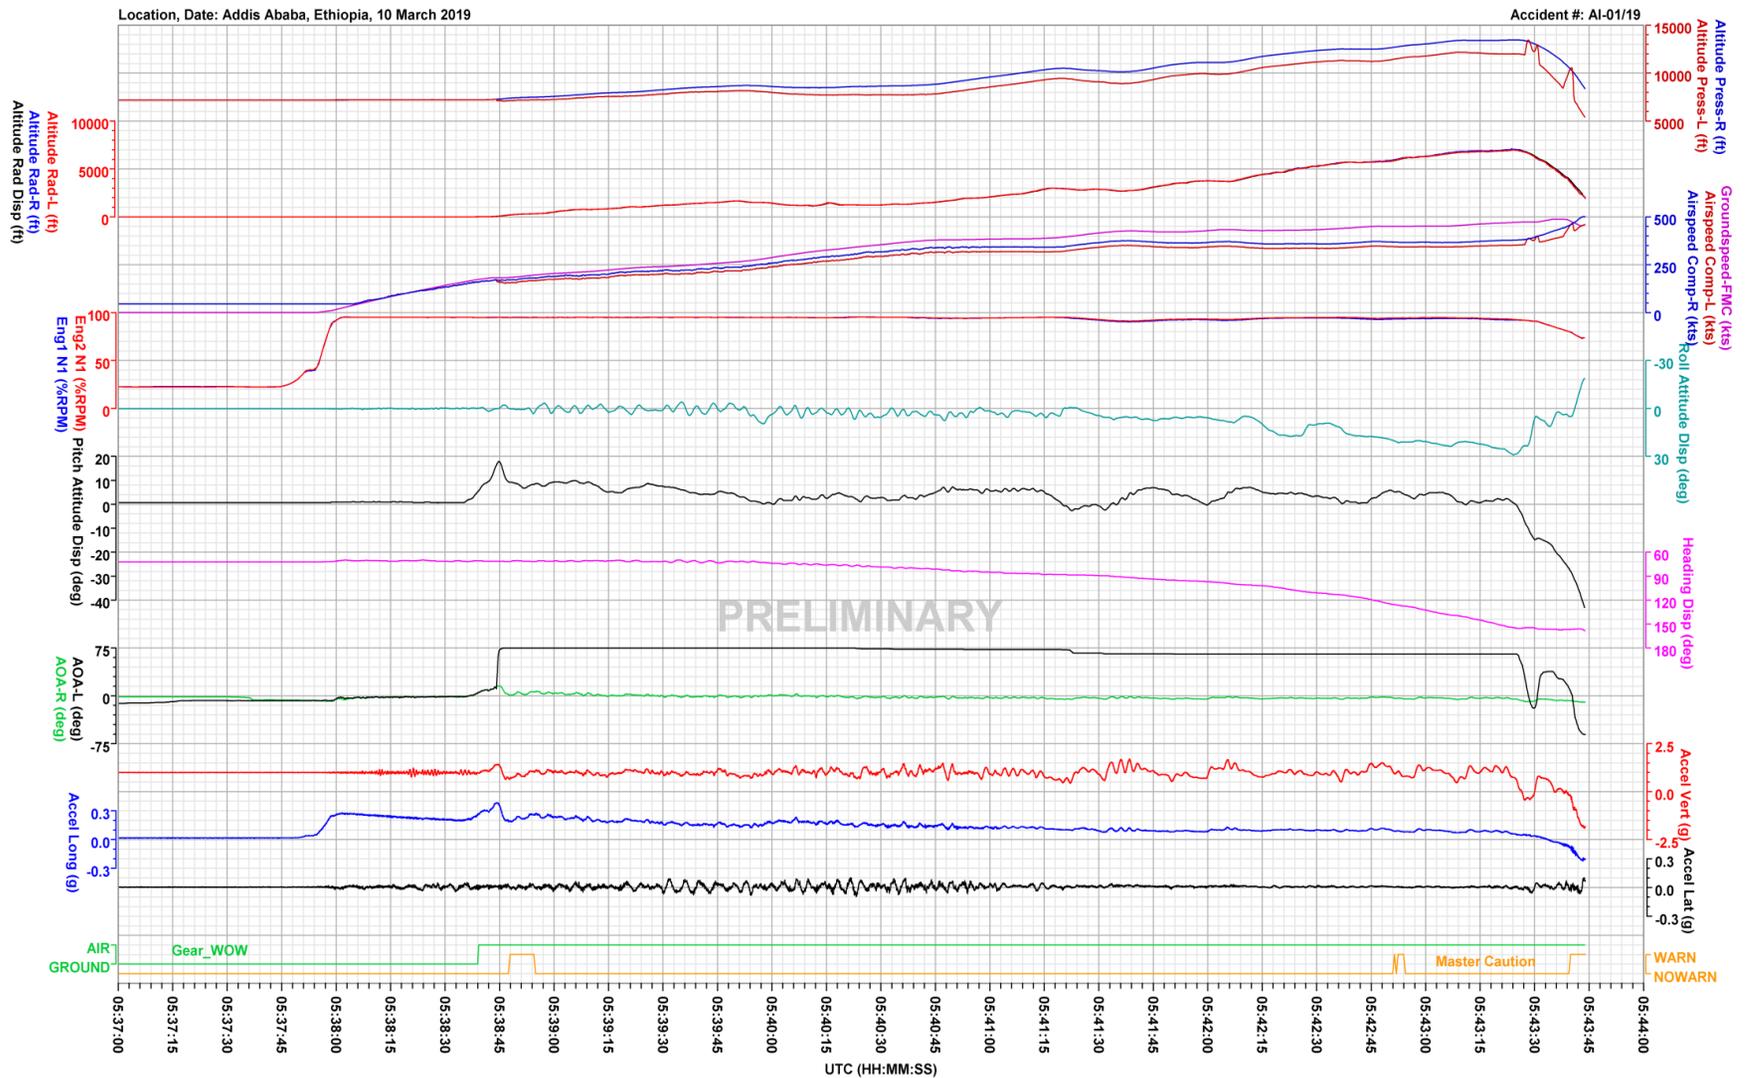
General Overview of Flight

At 05:40:00 shortly after the autopilot disengaged, the FDR recorded an automatic aircraft nose down (AND) activated for 9.0 seconds and pitch trim moved from 4.60 to 2.1 units. The climb was arrested and the aircraft descended slightly.

At 05:40:20, approximately five seconds after the end of the ANU stabilizer motion, a second instance of automatic AND stabilizer trim occurred and the stabilizer moved down and reached 0.4 units.
