**Aircraft Accident Investigation Bureau**

**Interim Investigation Report on**

**Accident to the B737-8 (MAX) Registered ET-AVJ operated by  
Ethiopian Airlines**

**On 10 March 2019**

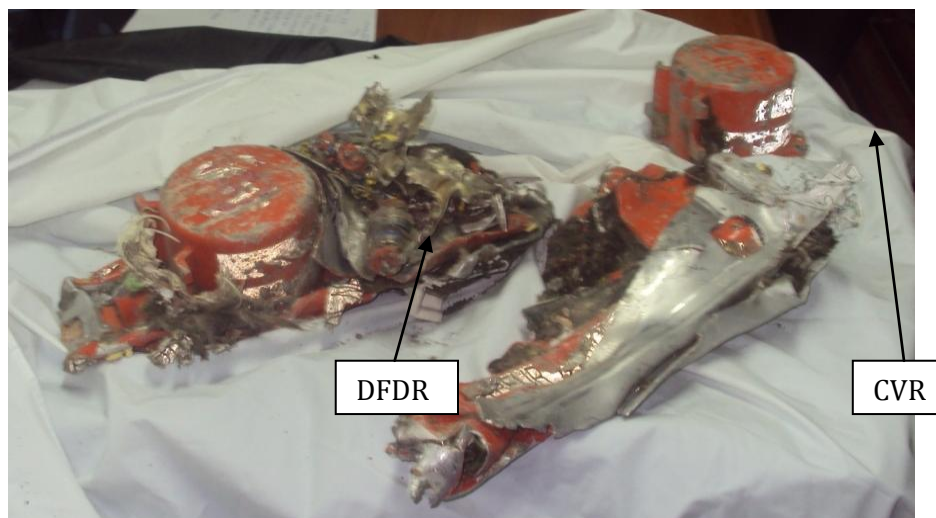
FIGURE 24: DFDR AND CVR AS DISCOVERED ON THE ACCIDENT SITE.

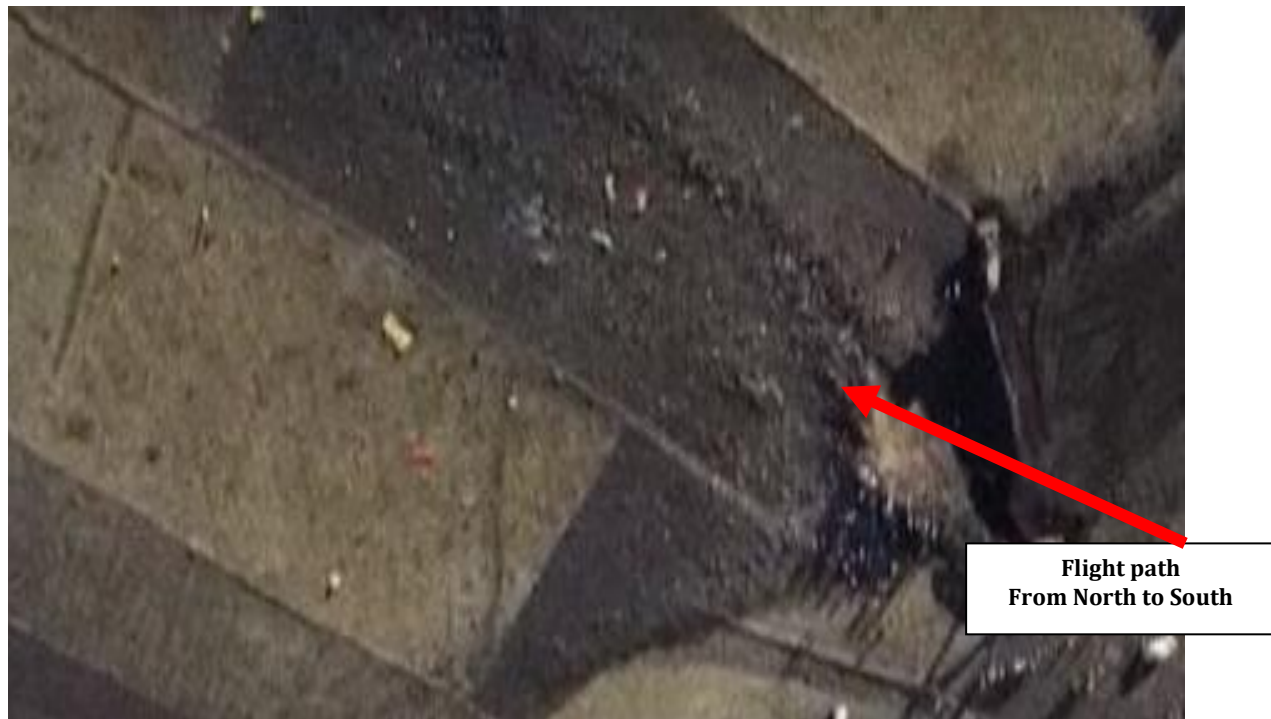
scattered around the site in an area by about 200 meters width and 300 meters long. The damages to the aircraft are consistent with a high energy impact.

FIGURE 32: TOP VIEW OF THE CRATER

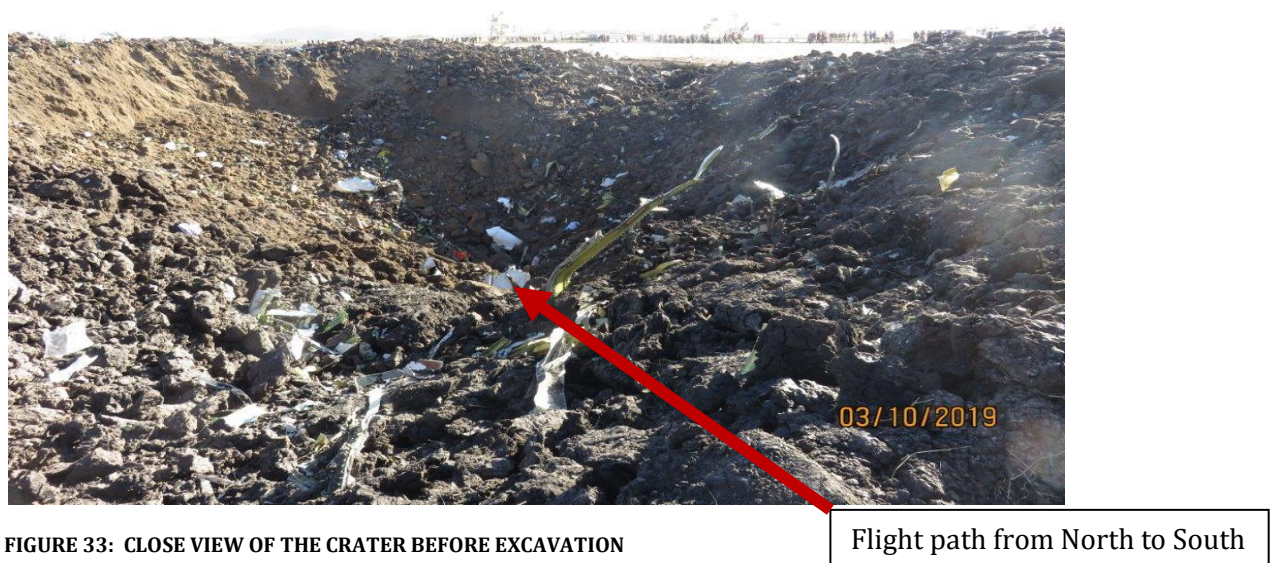
FIGURE 33: CLOSE VIEW OF THE CRATER BEFORE EXCAVATION

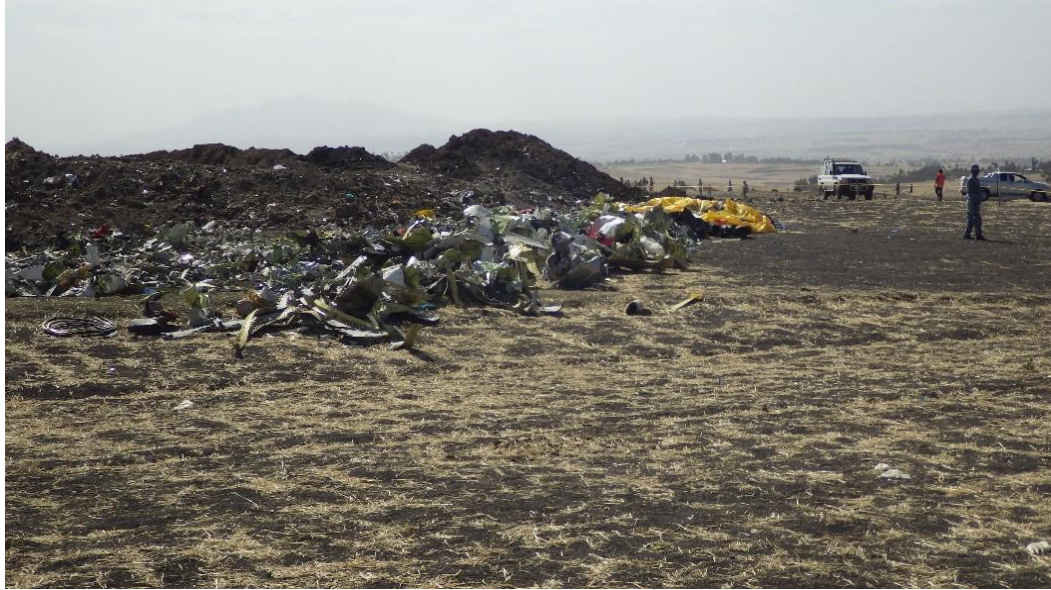
FIGURE 34: ACCIDENT SITE

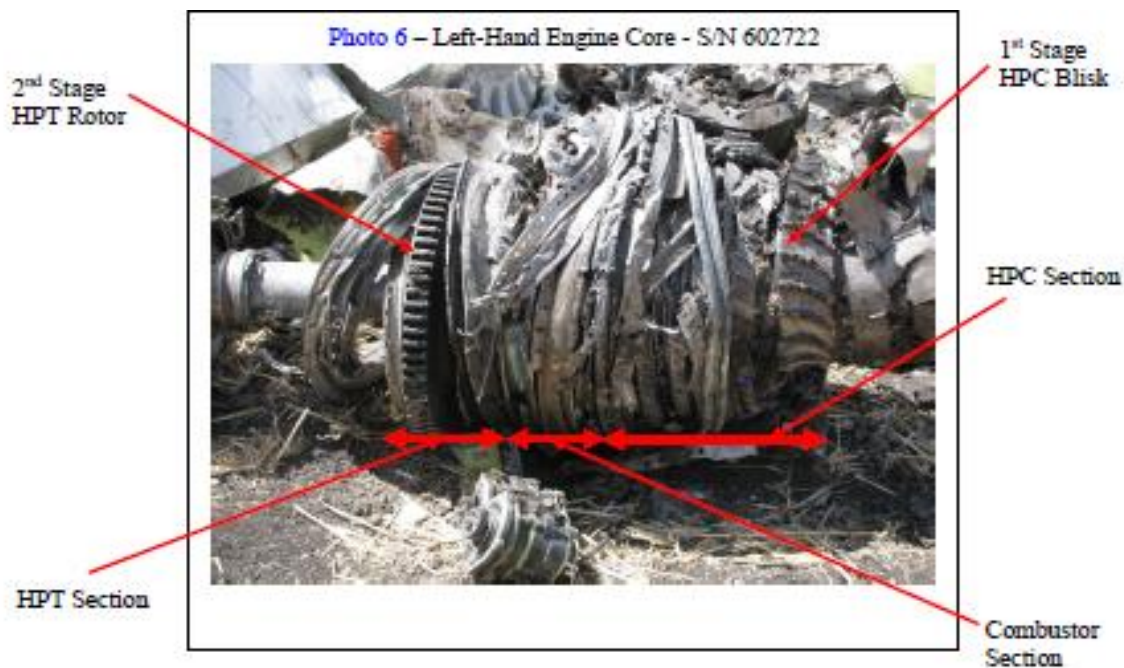
The left engine core was recovered from the site and examined by the group. The engine was reportedly recovered at a depth of approximately 10 to 15 meters depth on the left side of the excavation site. The predominant feature of the deformation of the entire remaining core was axial deformation.

FIGURE 35 : LEFT HAND ENGINE SECTION

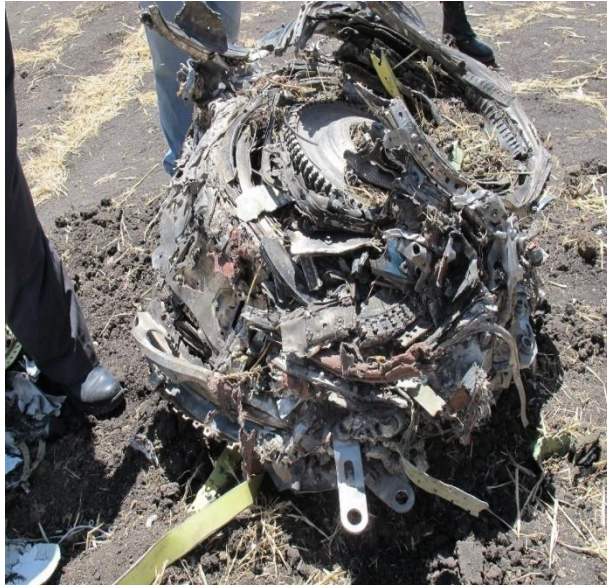
The predominant feature of the deformation of the entire remaining core was axial deformation.

FIGURE 36: R/H ENGINE - S/N 602695 - CORE

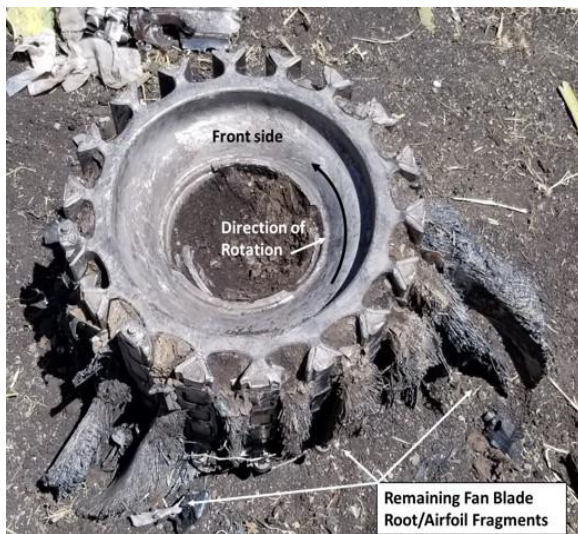
FIGURE 38: R/H ENGINE - S/N 602695 - FAN DISK  
FRACTURED

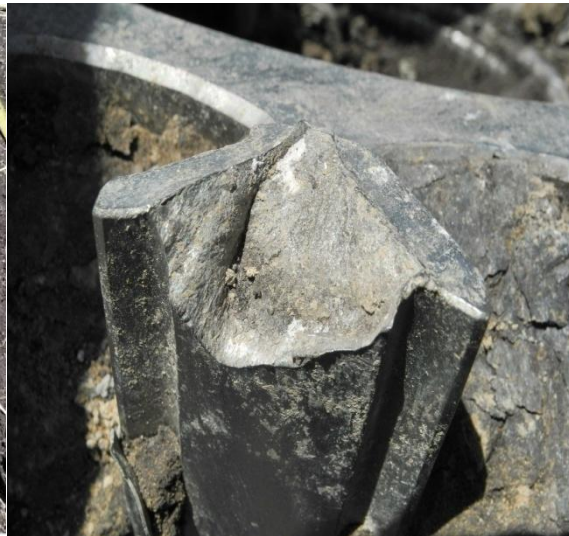
FIGURE 39: R/H ENGINE - S/N 602695 - RETENTION LUGS -  
FRACTURED

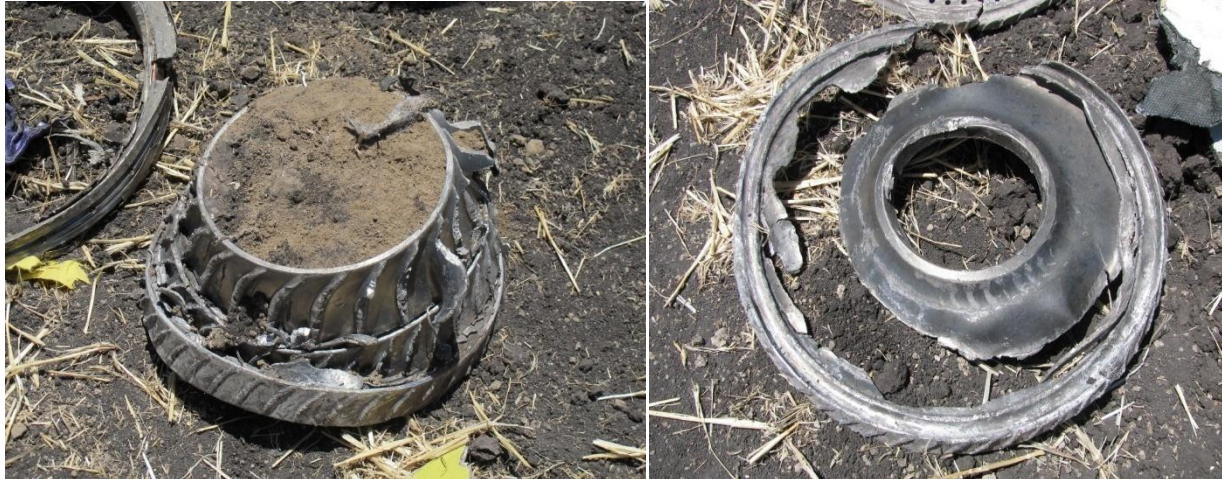
The HPC case was fractured and a portion of it remained with the core and the HPC stages were separated from the core. The 1<sup>st</sup>, 2<sup>nd</sup> and 3<sup>rd</sup> stage blisks were found together and were missing their airfoils. The 4<sup>th</sup>, 6<sup>th</sup>, and the 8<sup>th</sup> to 10<sup>th</sup> stages were not found. The 5<sup>th</sup> stage was found separately, and it was also missing its airfoils. The 7<sup>th</sup> stage web was fractured circumferentially. The stator sections could not be identified.

FIGURE 40: - R/H ENGINE - S/N 602695 – HPC STAGES 1 TO 3    FIGURES 41:- R/H ENGINE - S/N 602695 – HPC STAGE 7

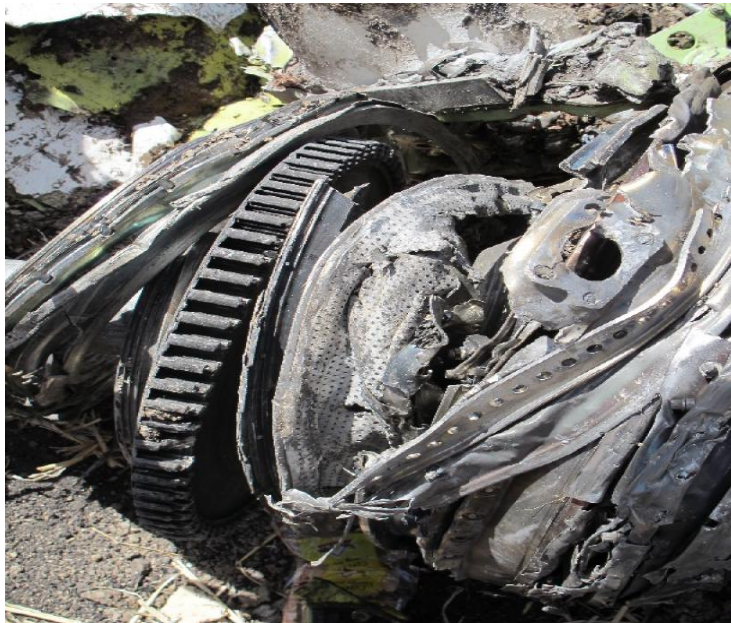
The combustor was severely crushed and most of it was missing into pieces.

FIGURE 42 : COMBUSTOR CRASHED

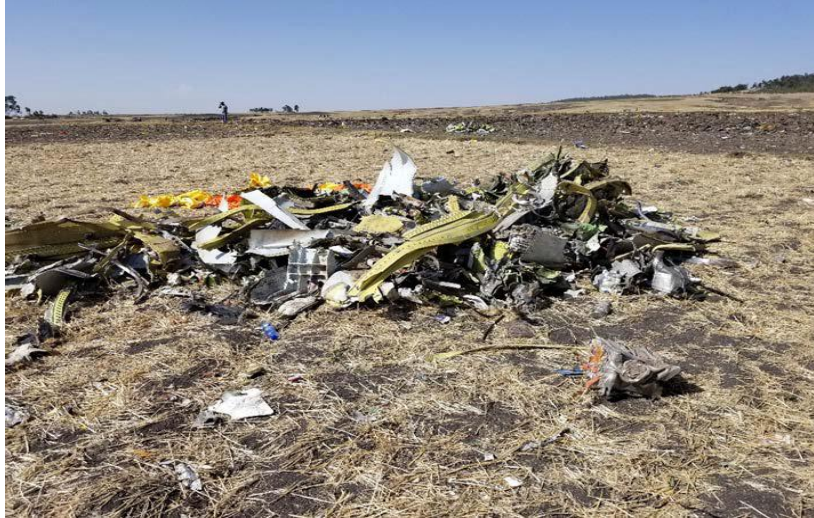
**FIGURE43: RECOVERED WRECKAGE PILE ON THE SITE**

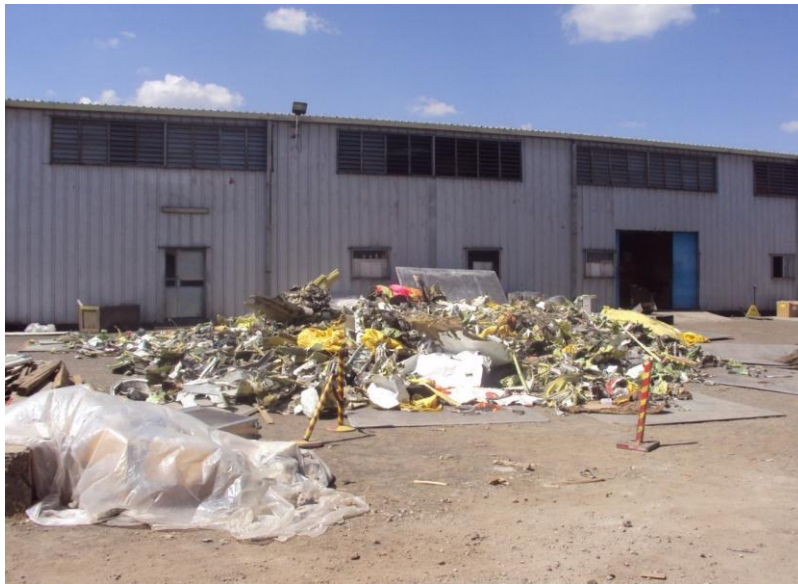
**FIGURE 44: RECOVERED WRECKAGE PILE**

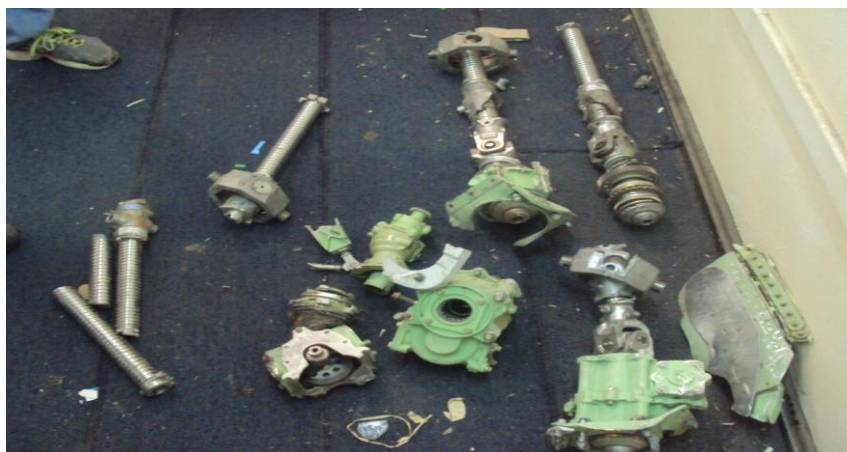
During the examination of the wreckage pile located at the Addis Ababa airport AIB store, the Airworthiness group identified a total of 4 (including the ones identified at the impact site) trailing edge flap transmissions (there are 8 total); three of these had the ball nut and gimbal still attached.

**FIGURE47: TRAILING EDGE FLAP TRANSMISSIONS AND BALL SCREWS**

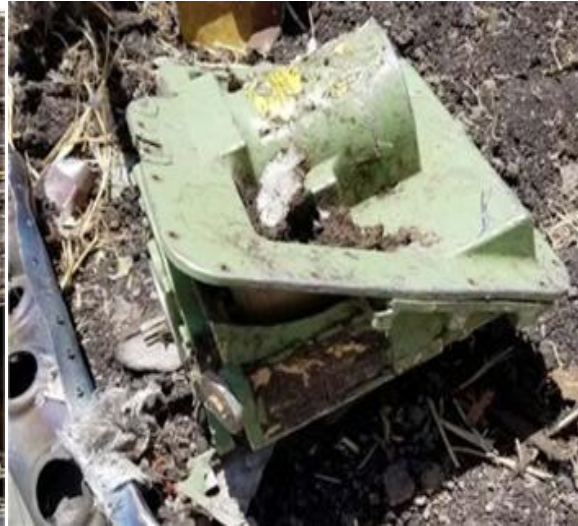
FIGURE 51:STAB TRIM ELECTRIC MOTOR HOUSING

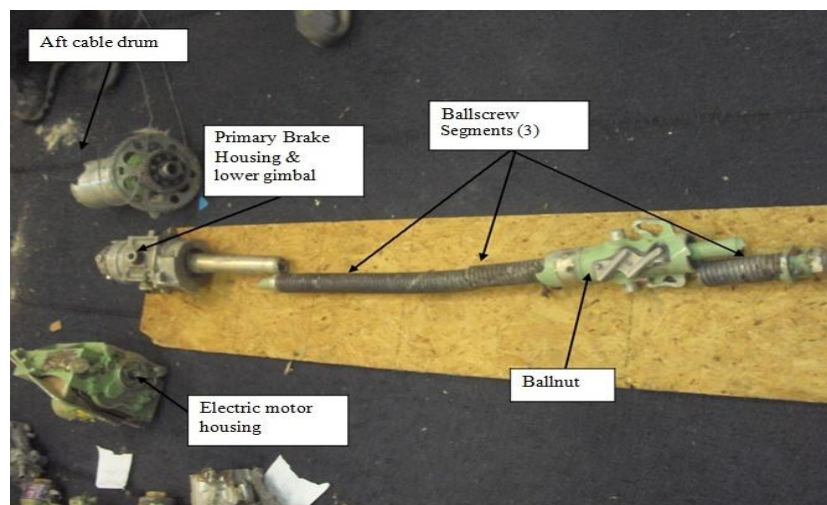
The figure below shows the relationship of the ballnut position along the ball screw. There is a safety rod which acts as a secondary load path should the ball screw fracture in service for any reason. It is attached to a separate set of secondary gimbals below the primary support gimbals on the primary brake housing and to the top of the ball screw. Figure 54 shows the safety rod and that it protrudes out from the ball nut. However, the fracture faces on the 5" long upper screw portion (note the measurement in Figure 53) match those found near the ballnut upper stop. This is consistent with the safety rod being pulled out several inches prior to final fracture.

Figure52 : recovered Stabilizer Trim components

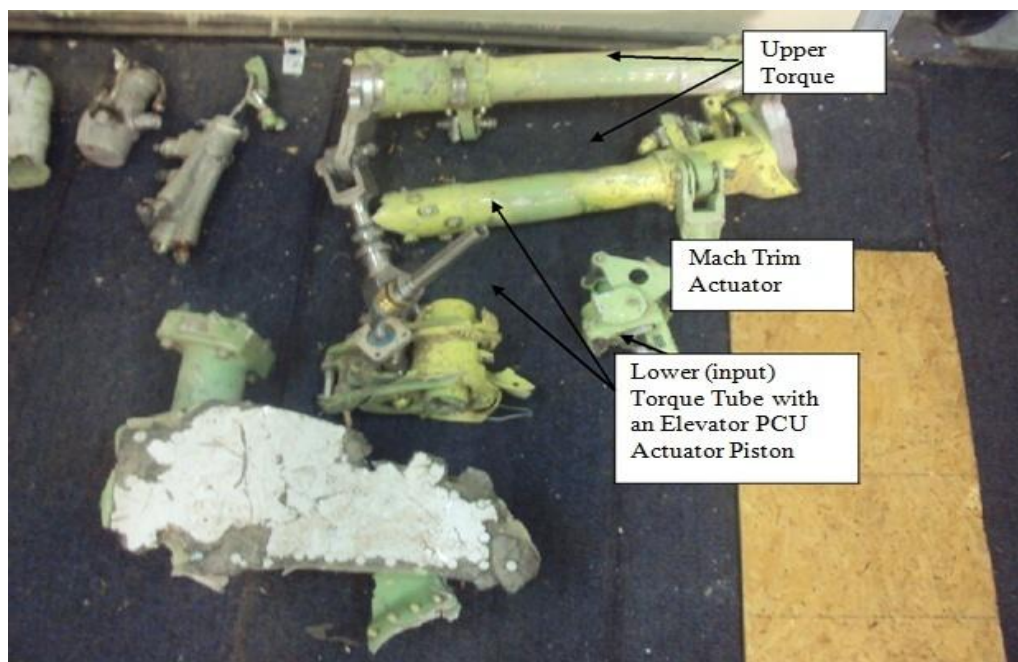
FIGURE55: ELEVATOR PCU ACTUATOR PISTON

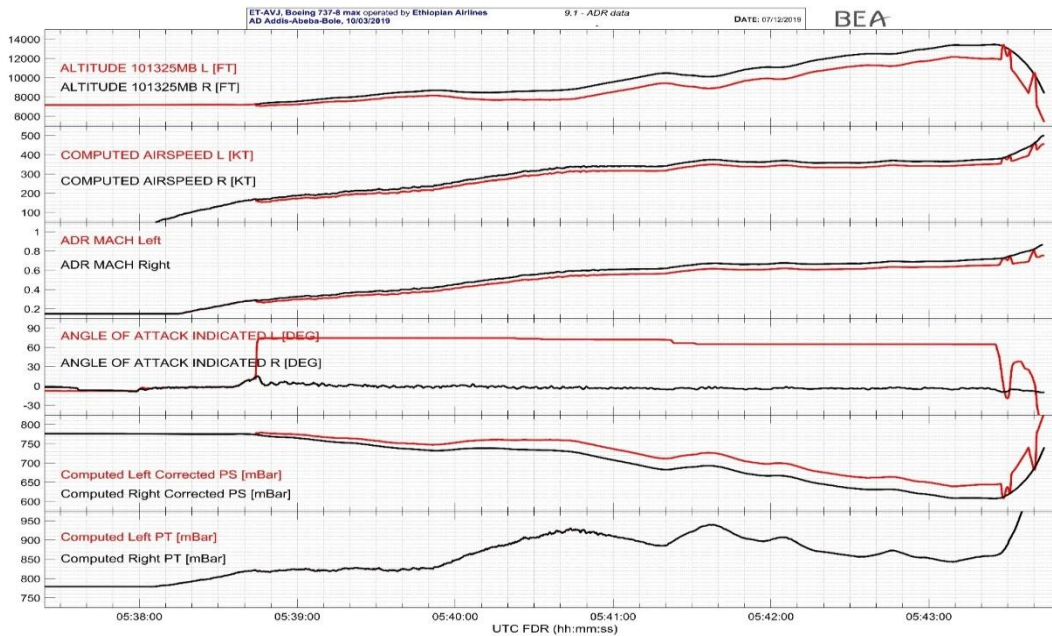
During the flight of the event, the recorded altitude values, the recorded CAS values and the recorded Mach numbers diverged after LH and RH AOA values divergence.

FIGURE 57: AIR DATA PARAMETERS

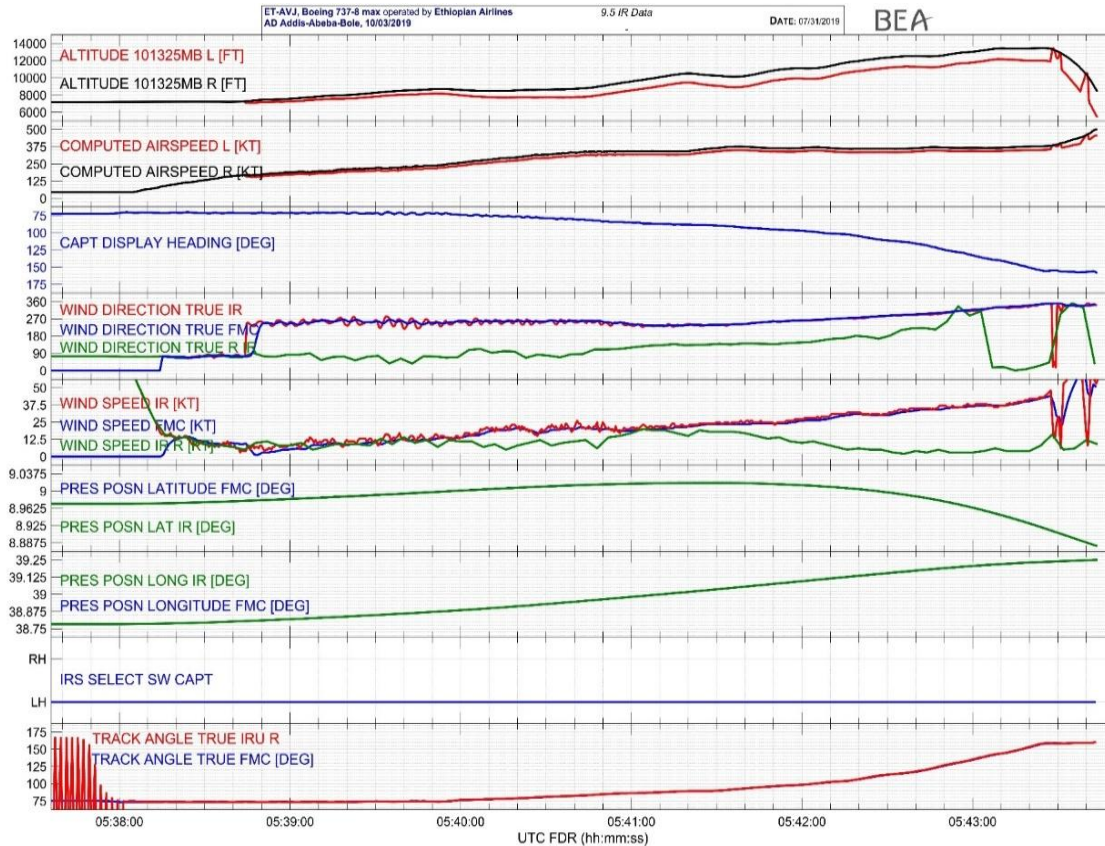
Most of the recorded IRS parameters did not show any variation following the AOA failure. On the contrary, the computed wind, on the left side, was clearly affected by that failure.

FIGURE 59: IMPACT OF AOA FAILURE ON THE WIND COMPUTED VALUES
