# FINAL REPORT

AAIU Synoptic Report No: 2006-028

<b>Aircraft Type and Registration:</b>	B737-800, EI-DHX
<b>No. and Type of Engines:</b>	Two, CFM 56-7
<b>Aircraft Serial Number:</b>	33585
<b>Year of Manufacture:</b>	2005
<b>Date and Time (UTC):</b>	23 March 2006 @ 18.20 hrs
<b>Location:</b>	Ireland West Airport, Knock, Co. Mayo
<b>Type of Flight:</b>	Public Transport
<b>Persons on Board:</b>	Crew - 6      Passengers - 138
<b>Injuries:</b>	Crew - Nil      Passengers - Nil
<b>Nature of Damage:</b>	None
<b>Commander's Licence:</b>	ATPL
<b>Commander's Details:</b>	Male, aged 39 years
<b>Commander's Flying Experience:</b>	7,998 hours (of which 295 were on type) Last 90 days – 261 hours Last 28 days – 62.27 hours Last 24 hours – 5.33 hours
<b>Information Source:</b>	AAIU Field Investigation

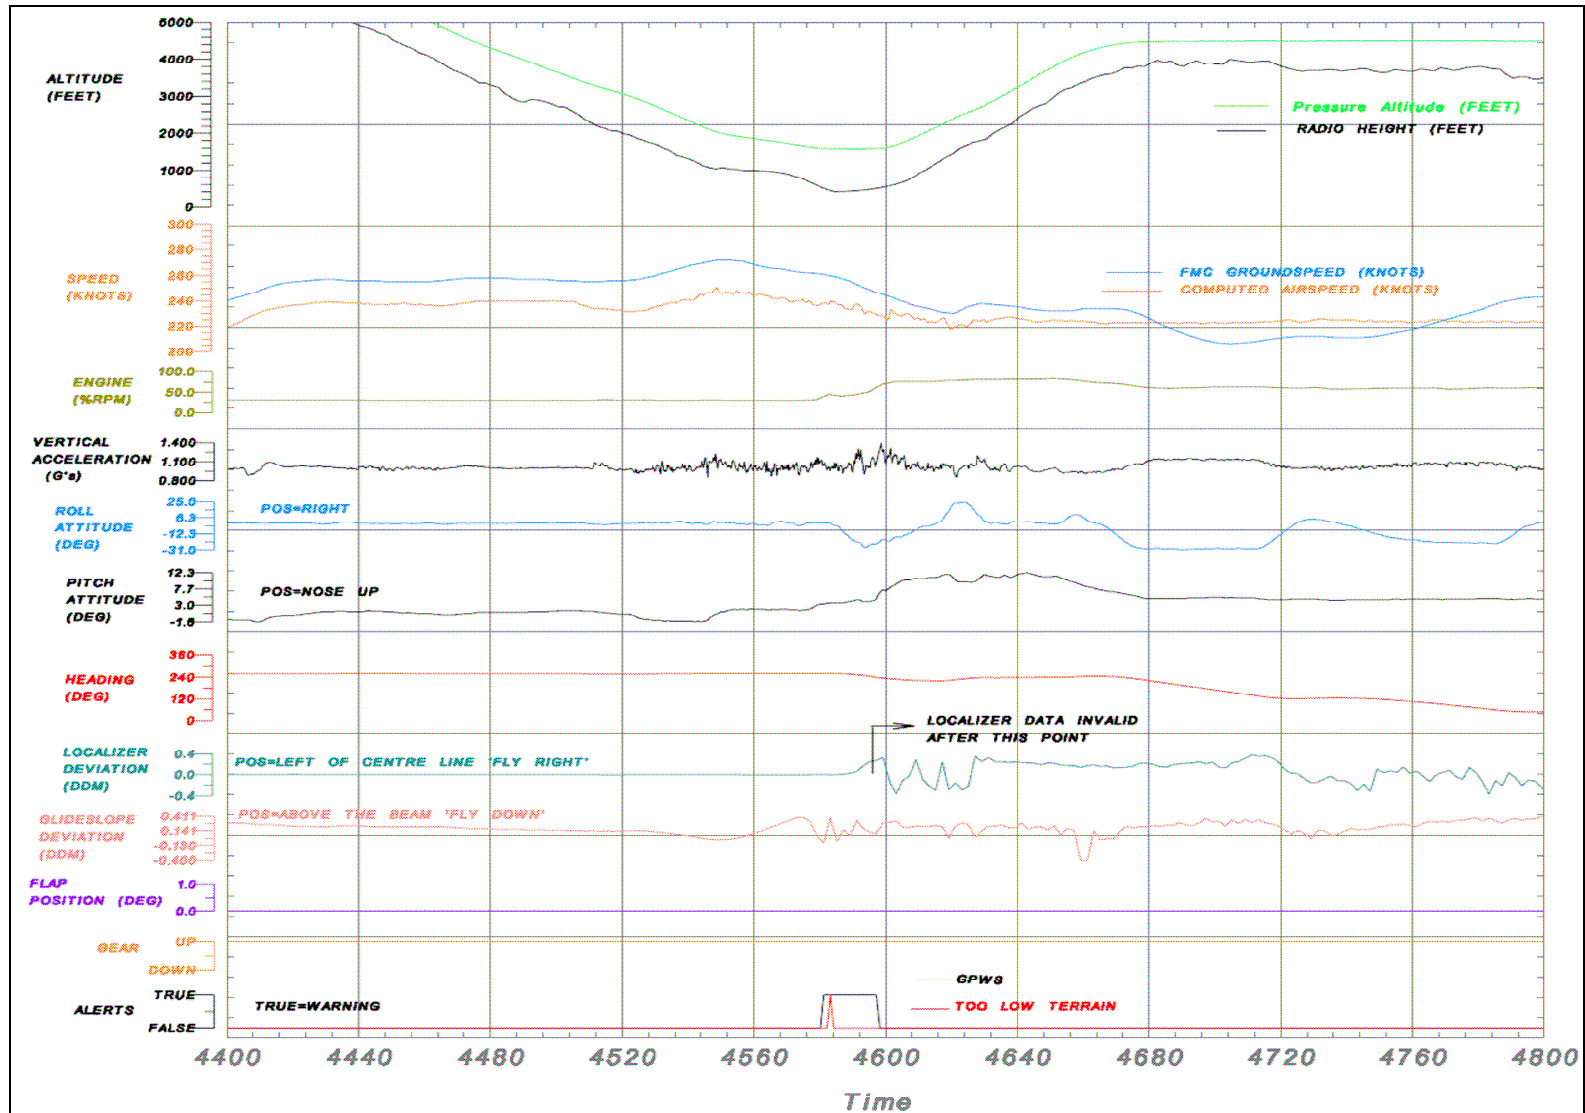
## APPENDIX C

Information derived from the Operational Flight Data Monitoring (OFDM) System (**APPENDIX C**) showed that a high energy first approach was carried out to EIKN which contravened many of the Operators Standard Operating Procedures (SOP's), including the non deployment of flaps, landing gear, speed brakes, too high on glideslope (G/S) and culminating in an Enhanced Ground Proximity Warning System (EGPWS) Mode 4A alert, as the aircraft turned port in a Go-around (G/A) non-procedural manoeuvre. The System had triggered a, "*too low terrain*" alert. Mode 4A is active during the cruise and approach with gear and flaps up. It also provides alerting for protection against an unintentional gear up landing.
