**FINAL REPORT**

**the ACCIDENT of the FALCON 900B**

**registered SX-ECH,**

**- 14 September 1999 -**

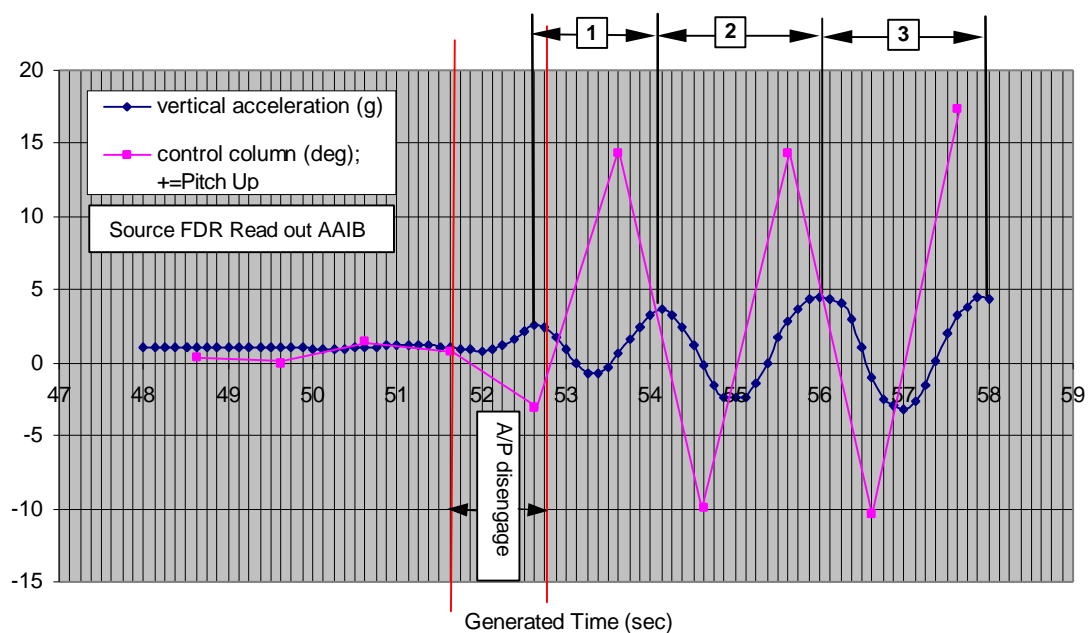
Figure: Oscillations 1-10

- the control column inputs were anti-phase with aircraft oscillations
-

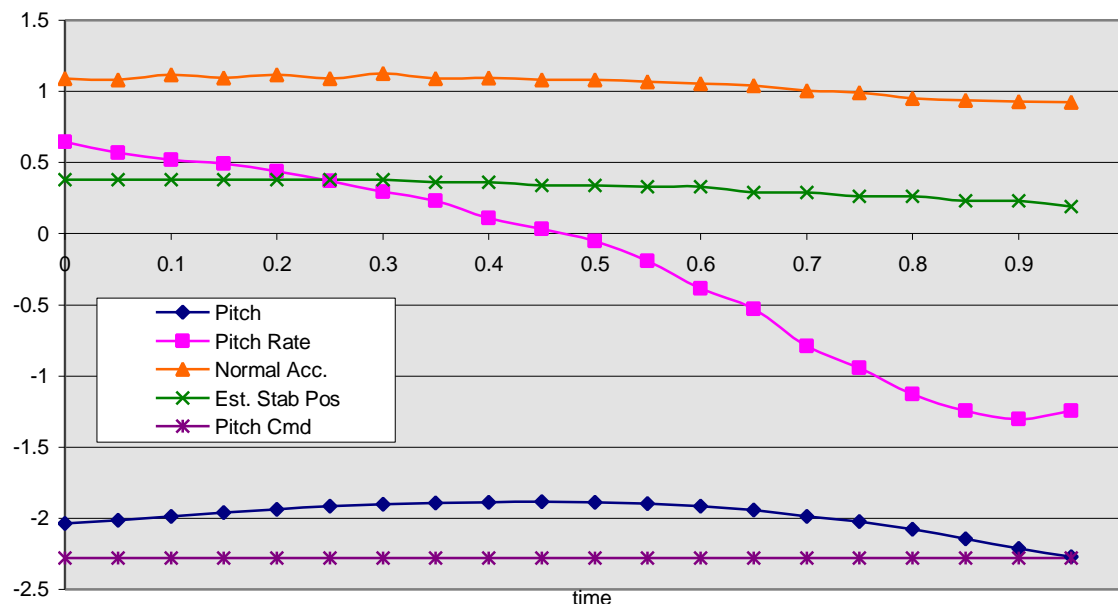
Figure 1: FGC1 Pitch Parameters

Figure 1 shows the variation in time of the pitch related parameters recorded from the A processor data in FGC1. During this period, the NVRAM data indicate that the aircraft was flying with FGC1 engaged and in pitch hold mode.

6. At the end of the 20 recorded samples (0.95seconds) FGC1 disconnects.
7. Laboratory testing and mathematical simulations indicate that the “servo motion monitor” should trip under the conditions present here. Laboratory tests also show that although the servo motion monitor does trip and cause the FGC to disconnect, this monitor trip is often not recorded in the NVRAM. Although no monitor trips are recorded in the NVRAM for this disconnect, most probably FGC1 disconnected due to a servo motion monitor trip.

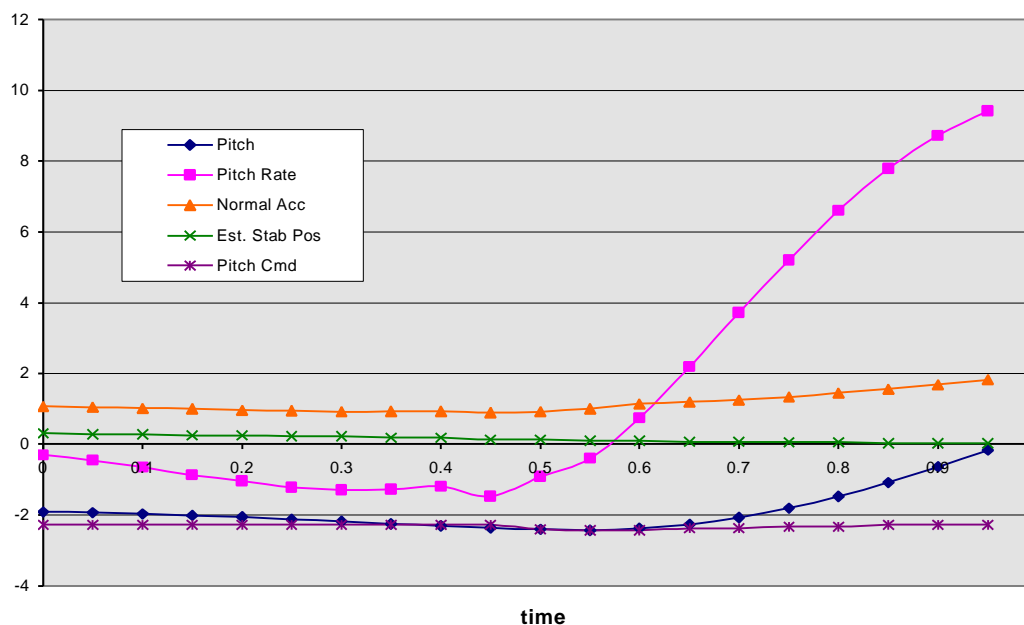
Figure 2: FGC2 Pitch Parameters

Figure 2 shows the pitch related parameters recorded from the A processor data in FGC2.

Examination of the discrete data recorded by FGC2 shows that it disengaged approximately only 0.5 seconds after FGC1. Consequently there is approximately a 0.5 seconds overlap between the data.

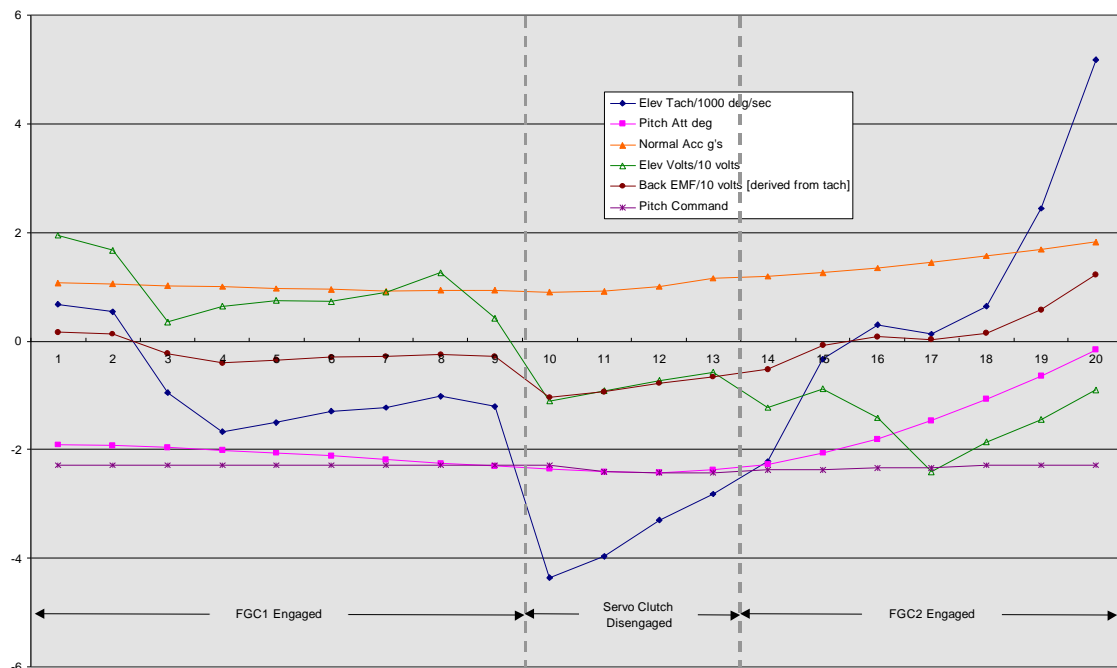
**Figure 3: Pitch Servo Parameters**

B processor data show the operation of the autopilot servo loops. B processor data were not retrieved from FGC1, but were retrieved from FGC2. The pertinent pitch parameters are shown in Figure 3. Note that, although these data were all recorded by FGC2, the servo data for the first half of the samples reflect the operation of FGC1.

In frames 4 through 8, the aircraft pitch attitude is still above the pitch command value, but is approaching it. The tach shows the elevator very rapidly moving in a nose up direction. Since elevator command voltage is opposing the rapid elevator motion. The magnitude of the tachometer signal varies from -1665 °/sec to -1018°/sec during this time period. This large tachometer rate it is much larger than the autopilot control limit for this flight condition (333°/sec). This large tach and the absence of any external stimuli to the aircraft which would have led to such a rapid motion, indicates that the pilot is overriding the autopilot servo in the nose up direction.

Sometime between frames 9 and 10, FGC1 disconnects. The exact time of disconnection cannot be determined. The disconnection appears to have most likely resulted from a trip of the Servo Motion Monitor. The FGC failed to record which monitor caused the disconnection but it is reasonable to expect the Servo Motion Monitor to disconnect if the tach signal is this much above the command limit value.

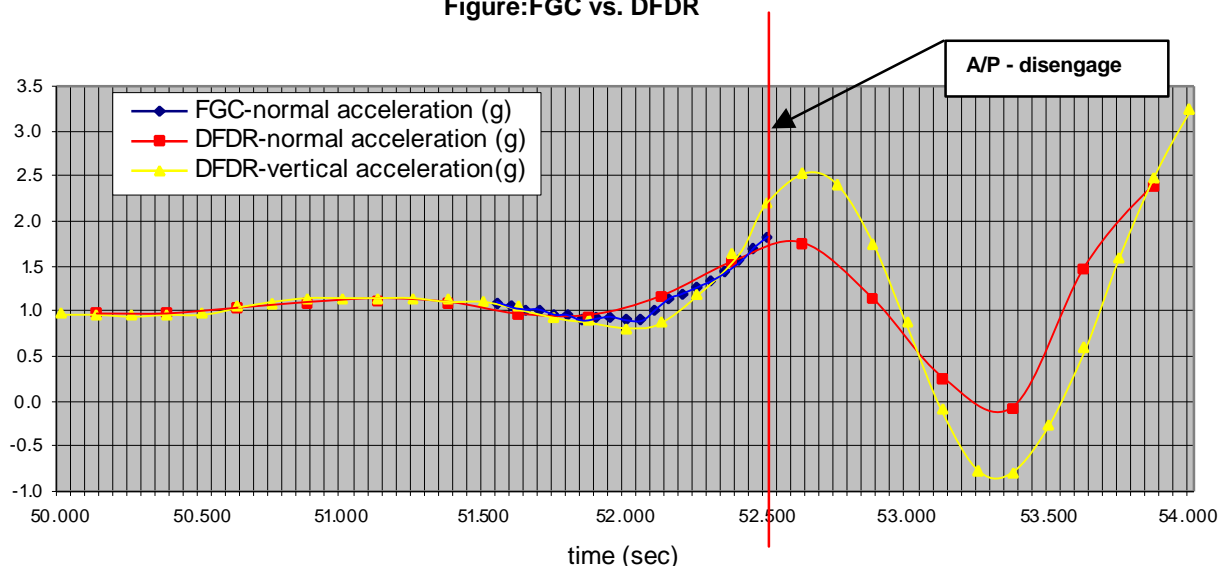
**Figure:FGC vs. DFDR**

During the A/P disconnection phase the normal acceleration data (nose up 2.5g) recorded by the DFDR and FGC, can not be explained by the recorded control column and stabilizer (nose down) data. There, some control column inputs (nose up) are missing due to DFDR recorded rate (1 record/second).

Based on the elevator tachometer data recorded by FGC which indicates how fast the elevator control moves, was computed BY INTEGRATION the control column inputs. The “computed” control column inputs confirmed the results from simulation work. The figure "Computed control column" show how should be complemented the DFDR data.

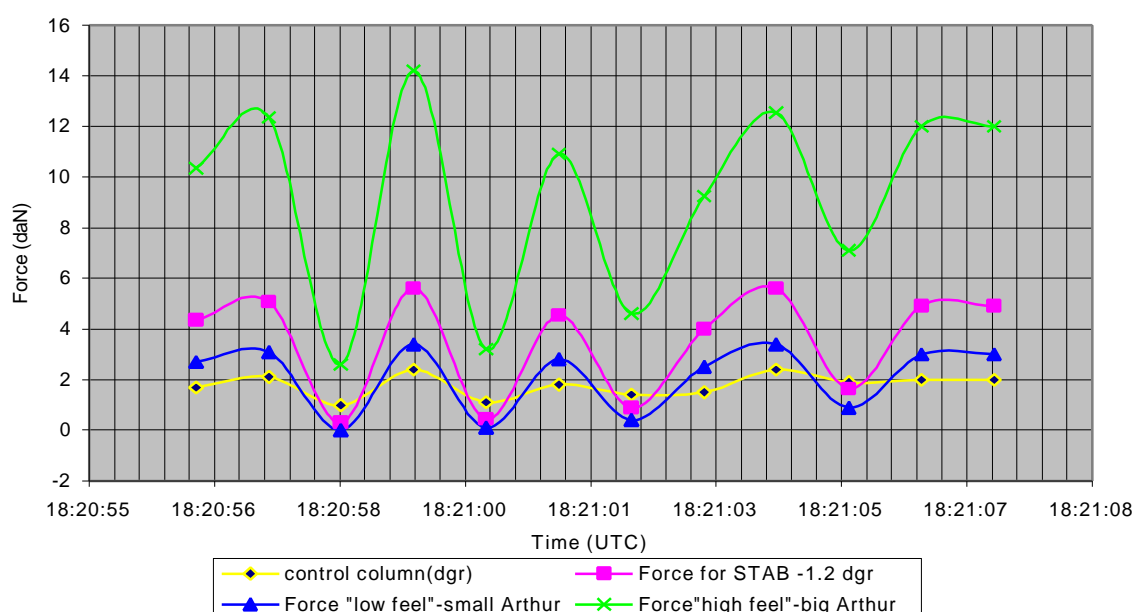
**Control Colum-Force Check**

The green line represents the theoretical forces, for highest feel, when STAB position reaches +1,25<sup>0</sup>.

On the above mentioned conditions, the PIC was not able to determine that the Arthur unit had failed in “low speed” position.

In accordance with his statement, he appreciated the forces experienced as normal. This estimate was probably influenced by the fact that this malfunction (PITCH FELL light on) also occurred few times, in the previous flights, and was classified as an INDICATION ERROR of the system.

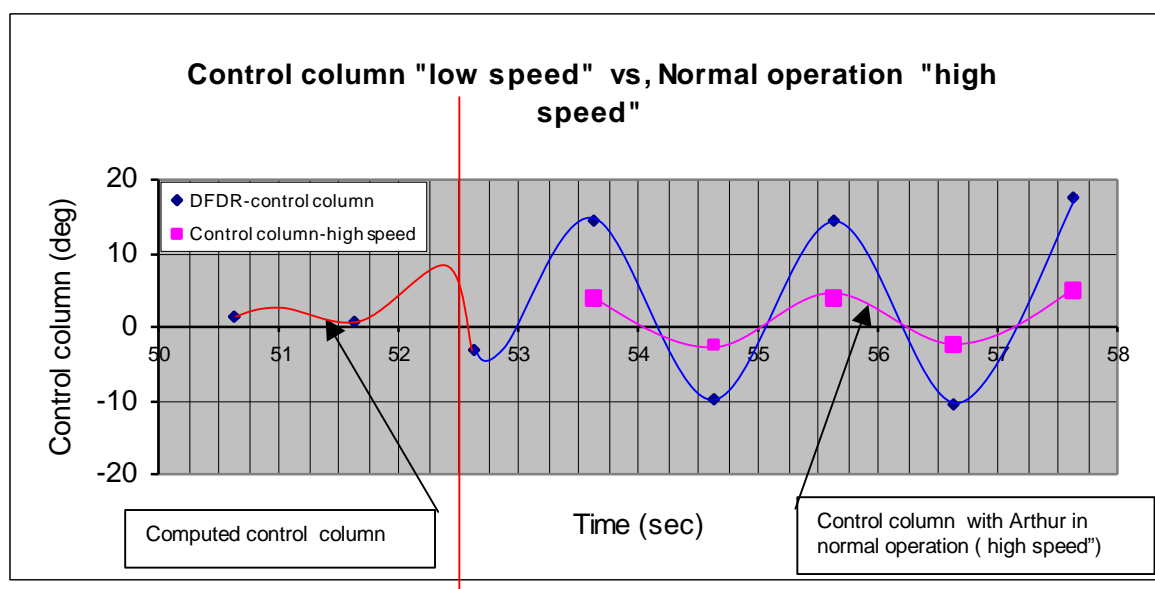
Based on the flight data, during the first oscillation, the PIC was able to move the elevator from -3° to 14 ° (max. speed movement of 17 deg./sec). For this deflection, according to Certification Report Q801 provided by Dassault Aviation, the maximum force applied by PIC on control column was 12 daN.

At the same force, in case with Arthur servo operating normally (high-speed for STAB position 0.16), the PIC should be able to deflect the elevator only to 4 deg NOSE-UP. Similarly, it can be determined the control column movement in the case of PITCH FEEL operating normally (“high speed”) and the PIC had had the same behaviour, as shown in the next figure.

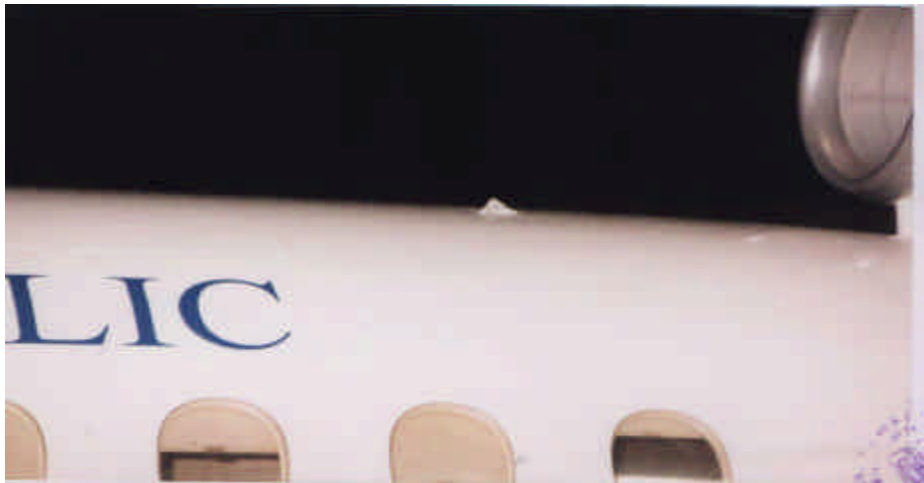
**Photo 1**

The aircraft structure was not damaged, except for a crack located on the top of the fuselage skin, caused by the penetration of a metallic catering container which is usually placed in the luggage compartment arrangement furniture (see pictures 1 & 2 in Annex 1). The hole, size of 127 mm x 25 mm, was found between frames 20 - 21 and stringers 4-5 left.
