Islamic Republic Of Iran
Civil Aviation Organization
Deputy of Flight Standard
Aircraft Accident Investigation Department

Final Report
Basic Information

Type of occurrence:	Accident
Date:	02.Jan.2008
Time of accident:	07:32 local time (04:02 UTC)
Location of accident:	Mehrabad International Airport (OIII)
Aircraft:	Airplane
Model:	Fokker 28 MK-100
Registration:	EP-IDB
Owner:	Iran Air
Operator:	Iran Air

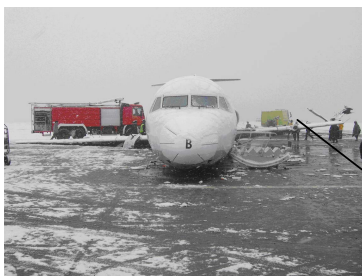
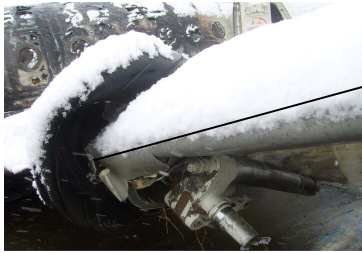
After taking off, the aircraft has reached to 30 feet altitude. The aircraft got wing stall phenomena. The aircraft lost altitude and hit the ground. The wheels of nose landing gear were separated; throw outboard and one of them hit leading edge of left wing causing fuel leakage. When the aircraft came to rest, the fire developed starting from the left wing root towards the fuselage as result of friction.

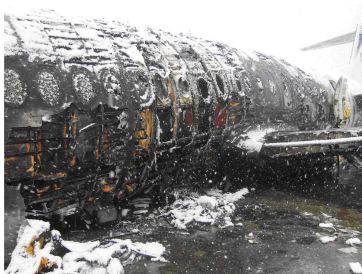
Initiation of fuel leakage
