*Final Accident Report*

*Accident involving Sudan Airways Airbus 310*

*Registration ST-ATN*

*On 10<sup>th</sup> of June 2008 at 1726 UTC*

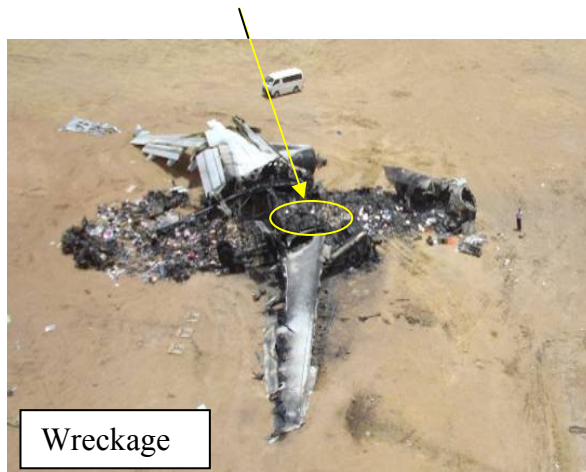
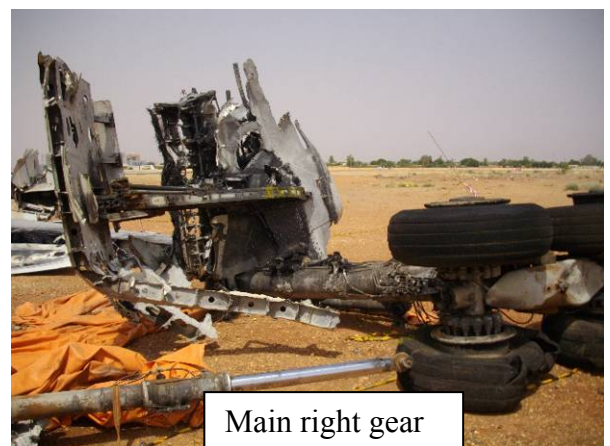
The main part of the fuselage was severely burnt. Wreckage examination showed that:

- The bottom and top skins of the wing box structure fractured at the main right gear attachment area. This assembly rotated forward and down, with the top of the assembly (top of landing gear) in contact with the ground.
- The main fire area was between the right engine and the right wing root.

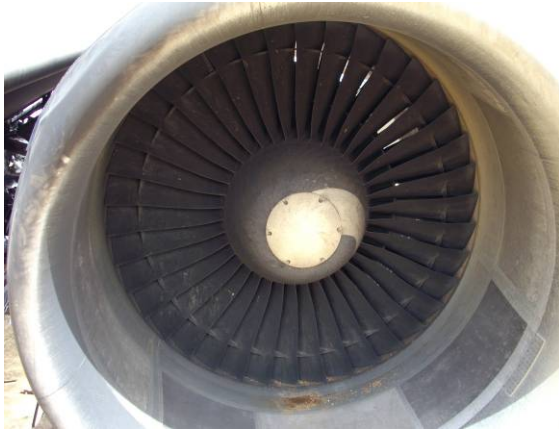
Engine 1 (LH)

Engine 1 thrust reverser was inspected to be stowed and de-activated.  
Engine 2 thrust reverser was inspected to be fully deployed.

Engine 1 did not show evidences of foreign objects ingestion.  
Engine 2 fan blades condition was consistent with foreign object ingestion.

Visible parts of both engines core did not present any trace of engine fire.

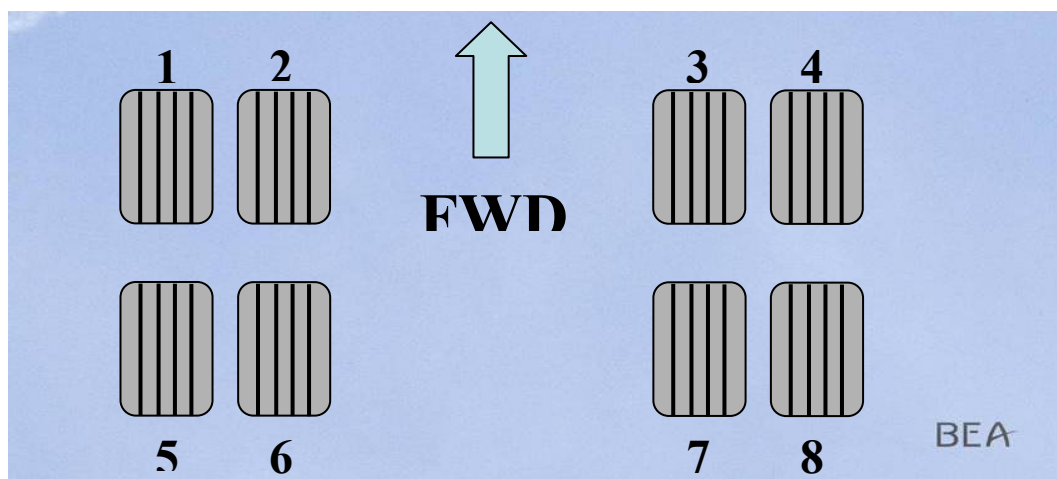
All tires including the Nose Landing gear ones were found installed on the wheels.

All tires of the two Main Landing Gears showed evidence of braking.

- “8 tires show flat spot on the tread. 7 of 8 tires have burst, only the tire #1 (LH MLG – left front tire) did not burst.
- The flat spot damages are the consequences of a locking of the wheels. So, the 8 wheels of the main landing gears were locked.
- There was no evidence of hydroplaning seen on the tires. In fact, in case of hydroplaning, the damages of the tires are typical of a tread rubber reversion. That kind of marks was not seen on the tires.
- The rim of the wheels do not show flat wear marks. That indicates the rim did not scrap on the runway.
- The LH MLG marks seen close to the runway threshold and to the end of the stabilized pavement (cp Airbus factual report) indicate that the tires of the LH MLG were not burst.”

According to the rubber marks on the end of the runway as well as the results of the tires examination conducted by the CEAT, locking of wheels was evidenced on each tire. No hydroplaning traces were observed on the tires tread.

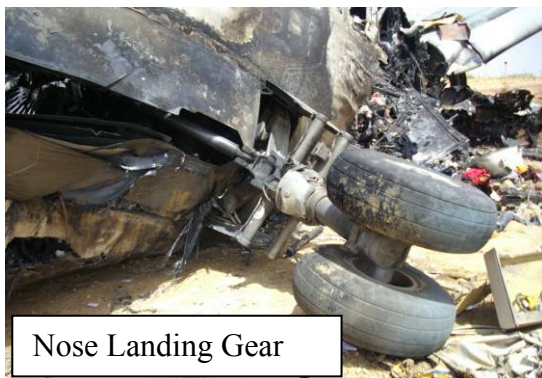
#### ***Nose Landing Gear***

Nose Landing Gear did not collapse and was found few degrees turned to the right. Nose landing Gear down-locking indicator was found in down-locked position.

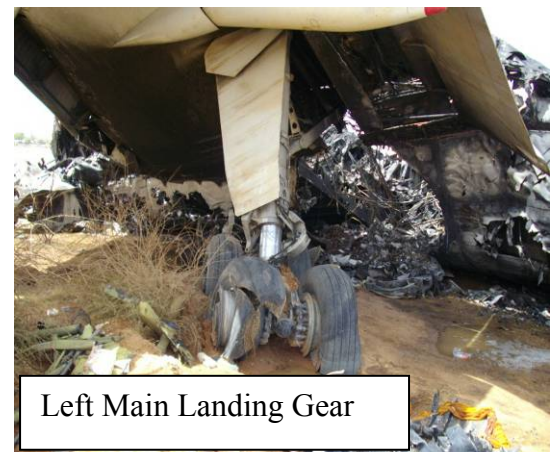
#### **Left main landing gear**

The front of the bogie was stuck on the ground. The bogie axle was aligned with the runway direction but not with the aircraft direction.

The torque link was broken. This indicated that aircraft pivoted around the left main landing gear when it stopped.

Shock absorber extension was measured (380 mm), indicating that it was not deflated.

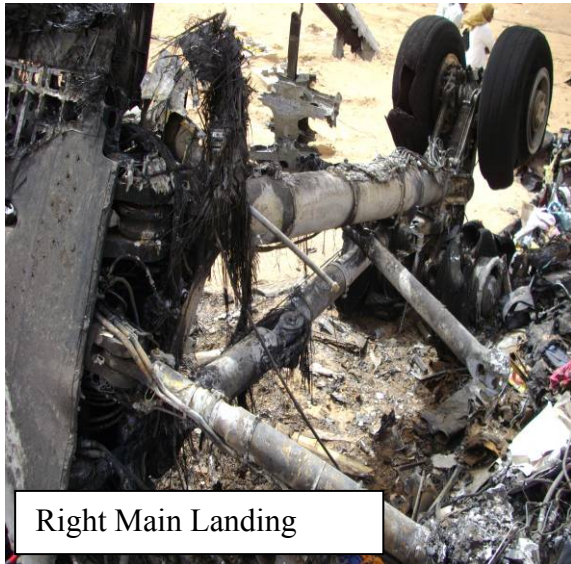
Right Main Landing

Main right undercarriage was attached to the wing box structure pieces.

The right brace strut and the brace strut actuating cylinder were found partially melt.

The cross brace was still attached to the Rib 5 but found separated from the structure area on the other side (brace strut side). The retraction actuator was found attached on both sides.

Investigations were done to determine the cause of the right landing gear collapse with a part of the wing still attached. The results were the following:

- The maximum loads recorded by the DFDR during the rollout were the following (refer to annex II) :
  - Vertical g: +2.36
  - Longitudinal g: +0.78
  - Lateral g: -0.67
- According to certification requirements, structure is designed to resist to combined accelerations values up to 9 g.
- The structure analysis allowed confirming that the rupture was not caused by fatigue.
- On site investigation and Captain interview confirm that during the overrun, the aircraft destroyed some lights and antennae. Some parts were ingested by engine 2. Since the thrust reverser was deployed, these parts may have been thrown to the right wing.
- According to the Captain, the aircraft was on its three gears when he left the aircraft. Consequently the right landing gear did not collapse when the aircraft stopped, but later on.

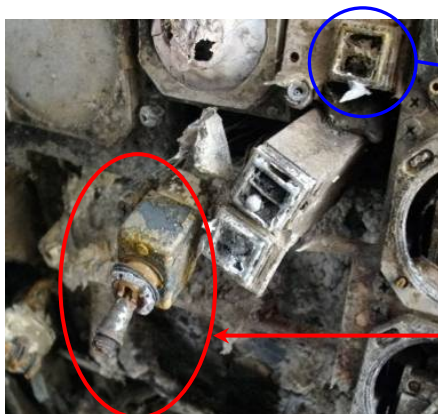
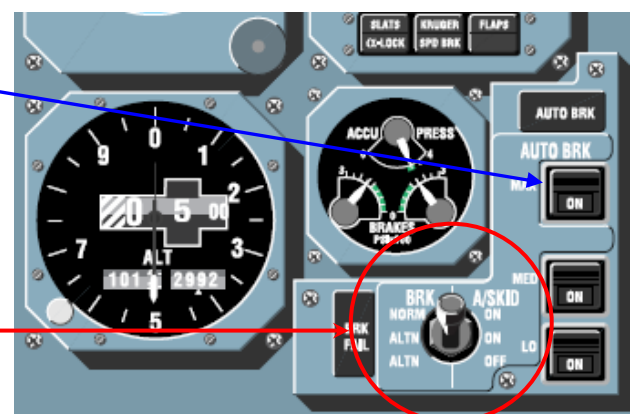
The “BRK A/SKID” lever (FIN 96GG) was found hanging from the 401VU panel, in the position indicated on the below picture. This position was consistent with the switch being set to “ALTN OFF” (Alternate braking / Anti skid off)

The 3 push buttons of AUTO BRK selection were severely damaged by fire.

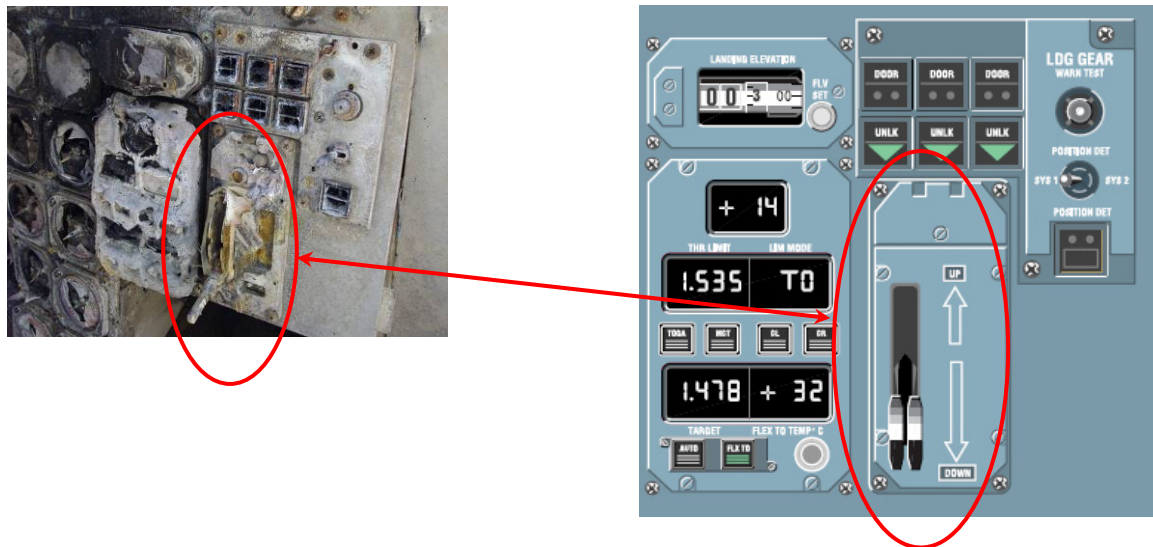
The Landing gear control handle was found in DOWN position:

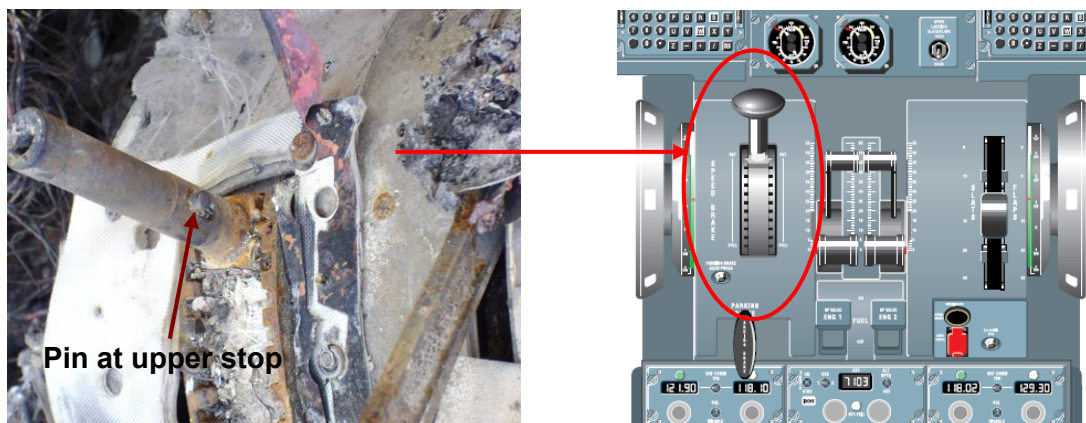
The speed brake/ground spoilers control lever, located at central pedestal, was damaged by fire, but the position of the pin at upper stop of its groove indicated that lever was in ARMED position.

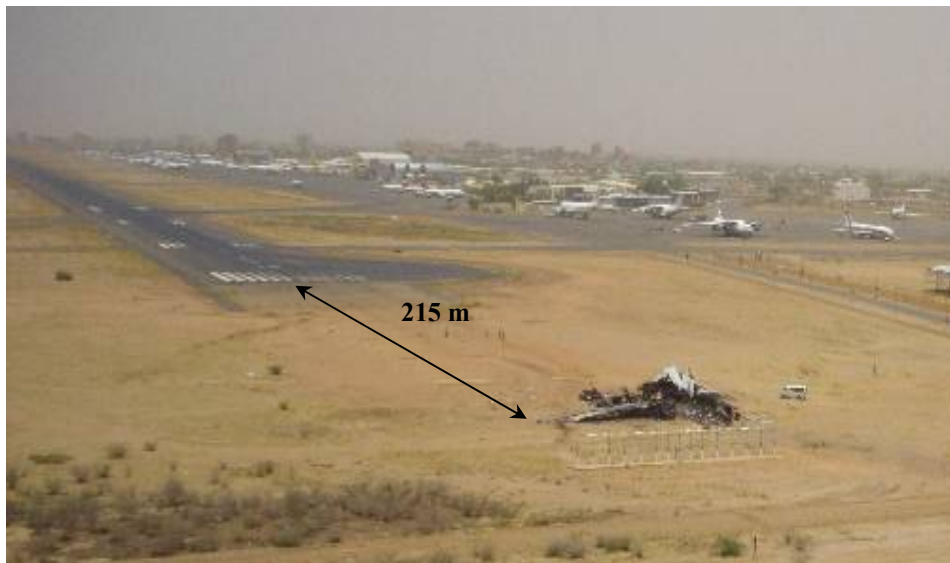
- Middle and forward aircraft sections, that included wings, engines, and cockpit, were located at about 215 meters from the end of runway 36, on hard ground.

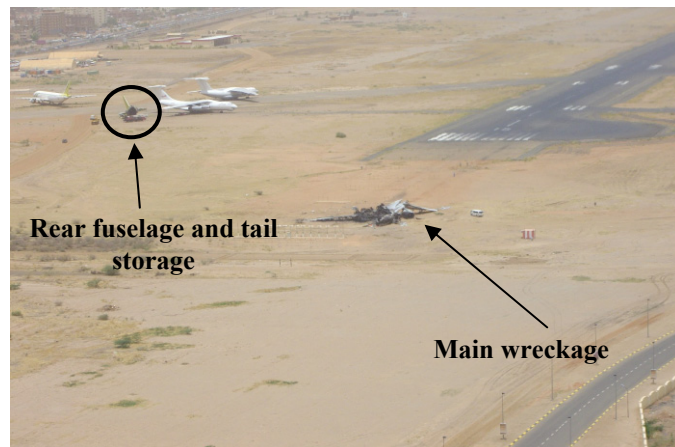
- Rear section of the aircraft structure was transported to an aircraft parking area aside of the runway. This rear section included the rear fuselage, fin and rudder, horizontal stabilizer and elevators, Auxiliary Power Unit (APU).

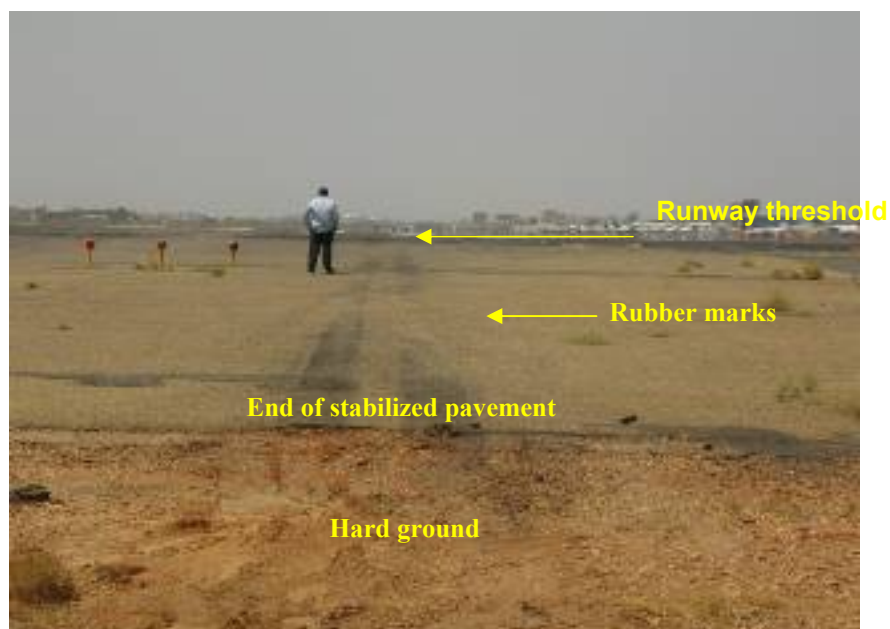
- Runway 36 ended into a stabilized pavement before changing to hard ground. In the continuation of runway 36 there were 6 series of lights, used for landing on runway 18, and a row of antennae. Rubber marks were observed on the end of the runway and the stabilized pavement.

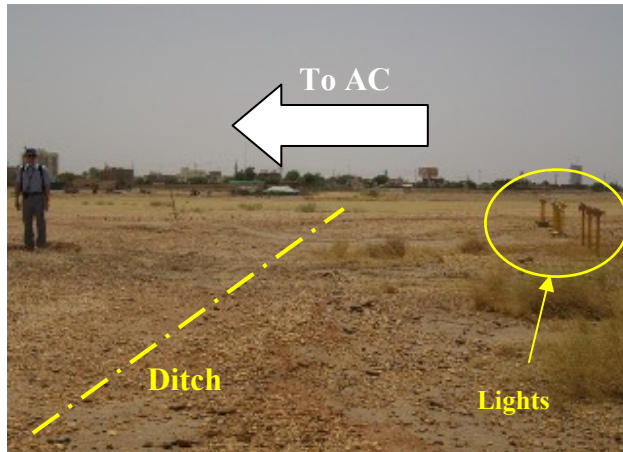
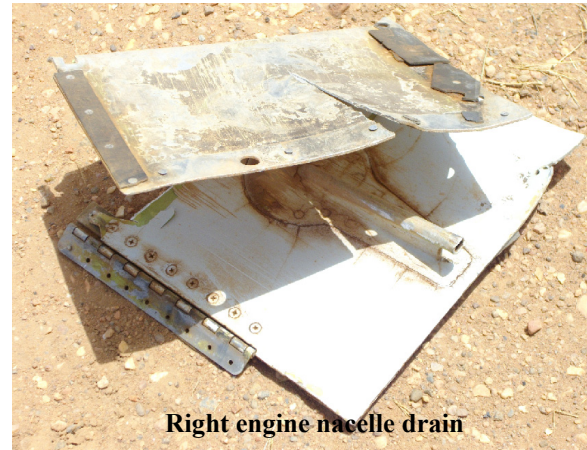
- There was a ditch (between the 3<sup>rd</sup> and 4<sup>th</sup> series of lights) which dimension was about 0.9 meters width and 0.5 meter deep. There were no traces of aircraft impact with the ground in the overrun area. However,

the drain of the right engine nacelle showing scrapping marks was found after the ditch at about 110 meters from the runway threshold, possibly suggesting a contact of the nacelle with the ground.

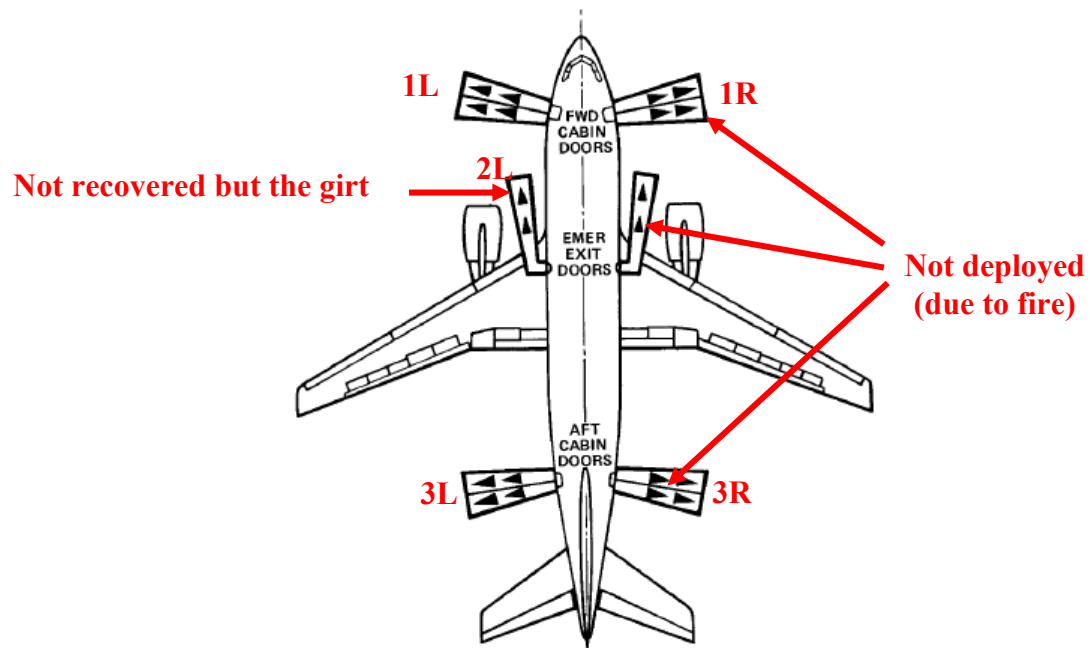
- The three left doors (1L, 2L, 3L) were opened, slides 1L and 3L were deployed and deflated, girt of slide 2L was attached to the door.
- According to the Captain interview, doors 1R, 2R and 3R were not used due to fire on right side.
  - Door 1R: it was not possible to extract it from the wreckage or to determine the condition of its mechanism. Its slide was found not deployed.

- Door 2R: neither the door nor the slide was recovered.
- Door 3R: it was found opened, with its slide in place not deployed.
