**AIRCRAFT ACCIDENT REPORT 3/2003**

**Air Accidents Investigation Branch**

**Report on the accident to  
Boeing 747-2B5F, HL-7451  
near London Stansted Airport  
on 22 December 1999**

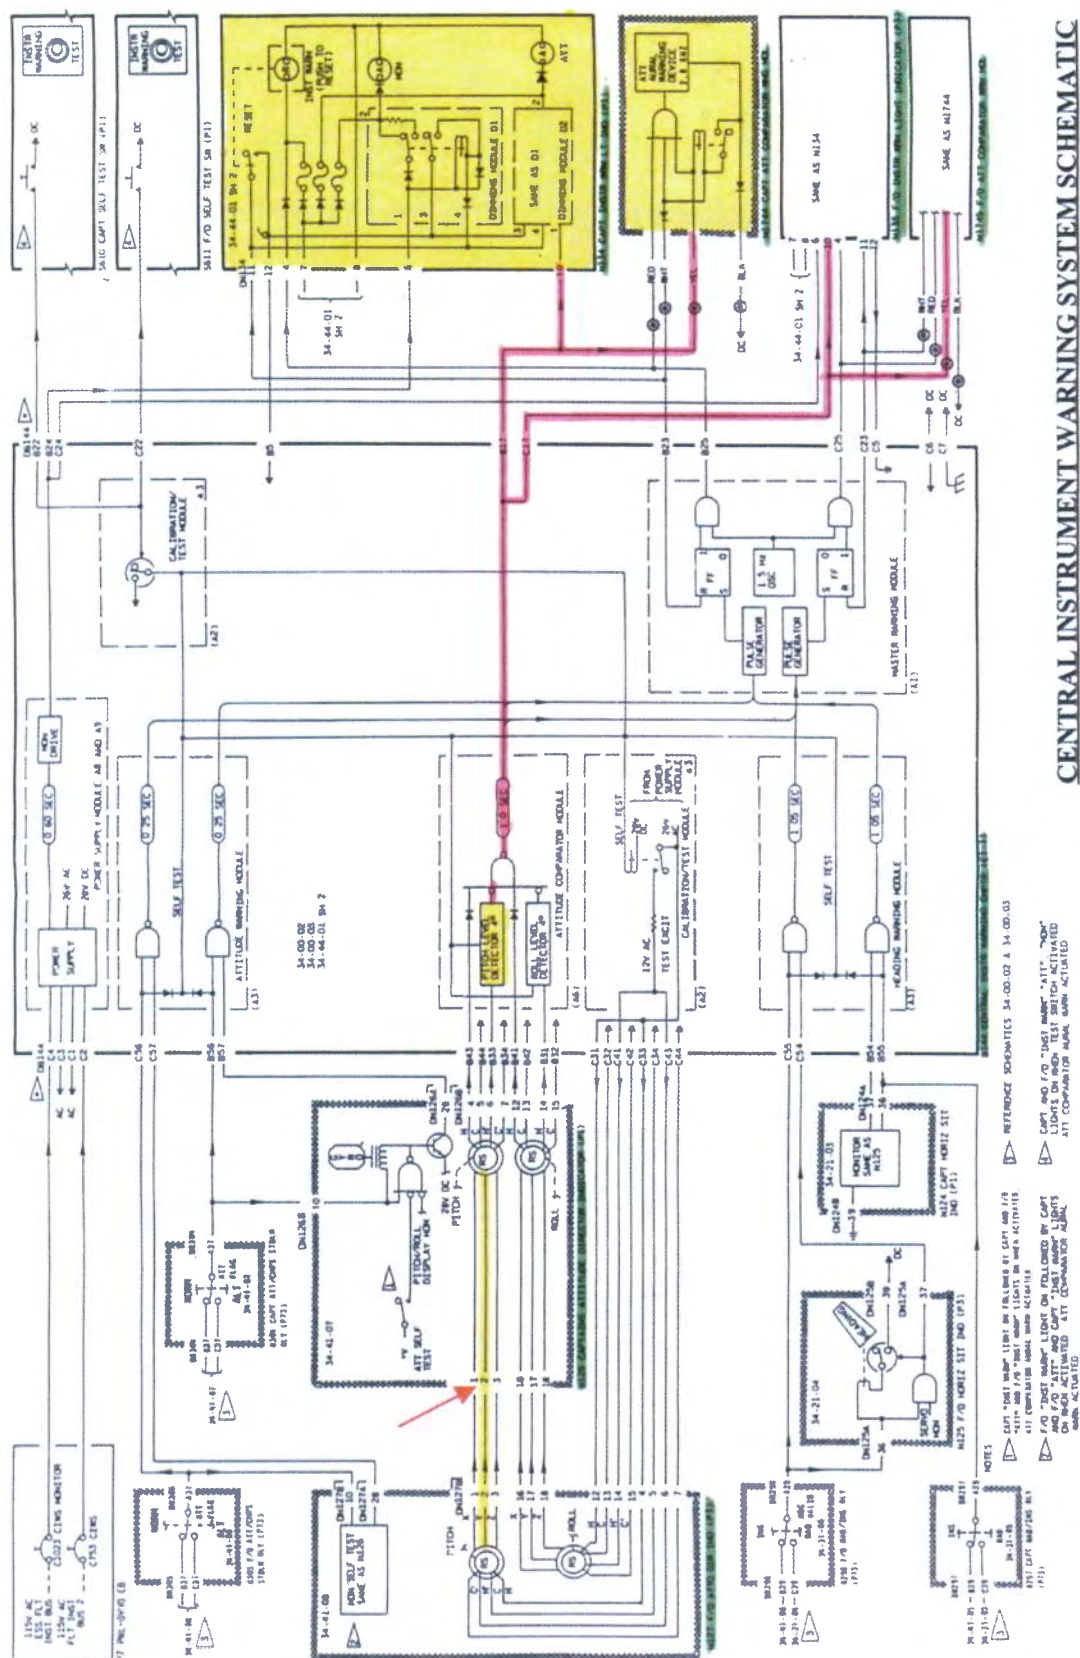
**CENTRAL INSTRUMENT WARNING SYSTEM SCHEMATIC**  
(taken from KoreanAir Boeing 747 wiring manual)

Location of 'displaced' pin No 2, plug J1, arrowed

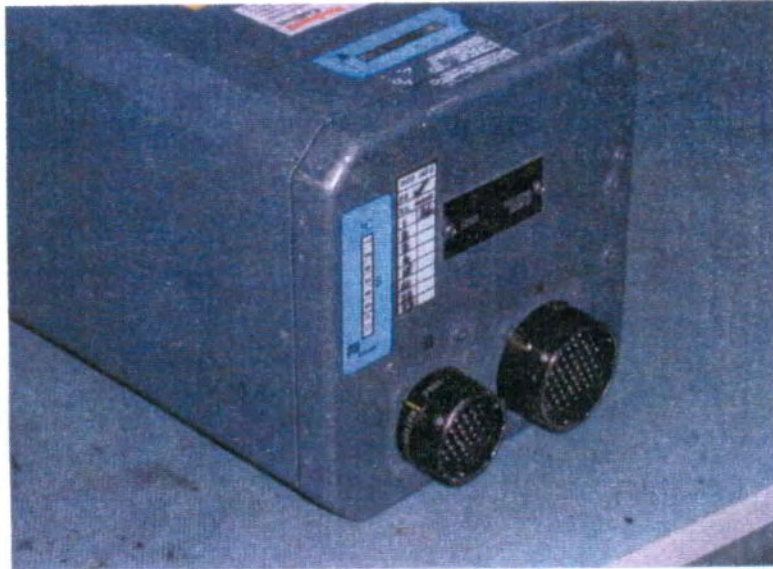
**Rear view of 329B-8J Flight Director Indicator**

Illustrating location of multi-pin connectors J1 and J2

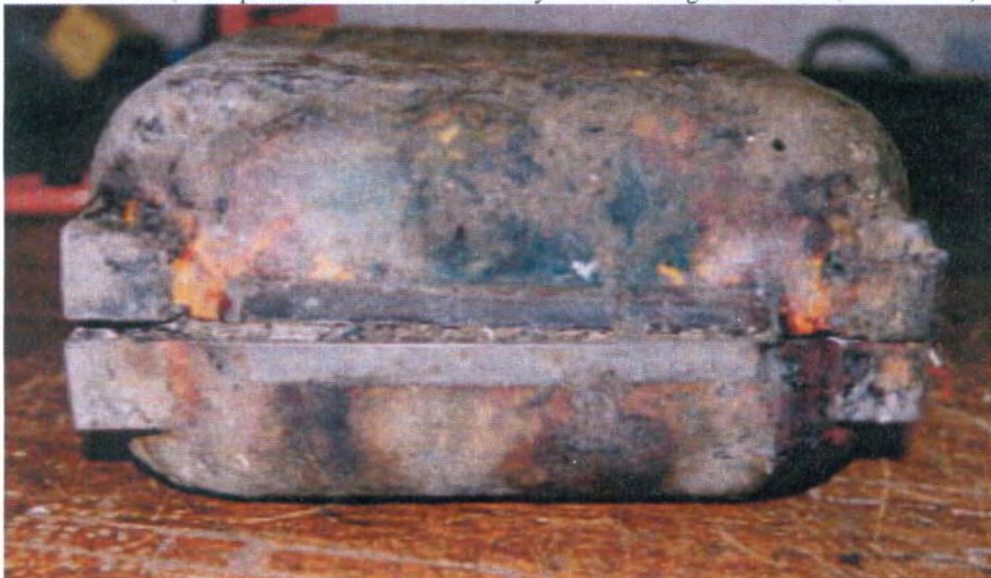
The crash protected thermal enclosure containing the tape was found in the impact crater one week after the accident. It had become separated from the rest of the unit that was also found within the crater. The ULB was found completely detached approximately 10 metres from the edge of the crater. The front panel was never found. Appendix G, Figure 1 shows the damage. The enclosure itself had suffered an impact severe enough to break two of the bolts that secure the two halves of the enclosure together, allowing partial separation (see Appendix G, Figure 2). This could have allowed heat to penetrate the enclosure, but on examination the tape itself was essentially undamaged (Appendix G, Figure 3).

Crash Protected enclosure (showing separation of the two halves)

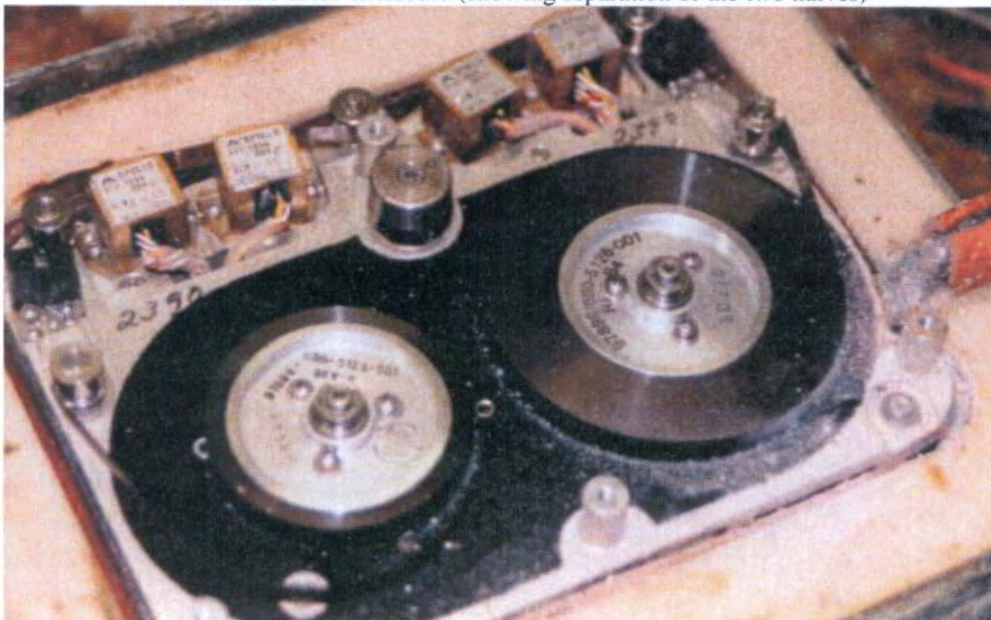
Magnetic tape inside crash protection

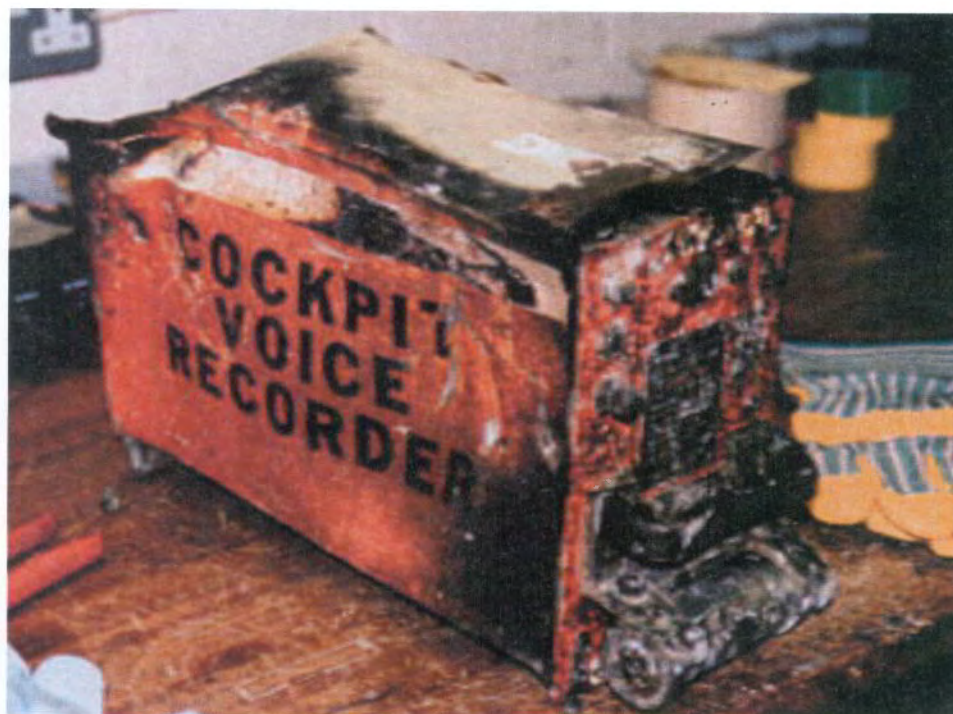
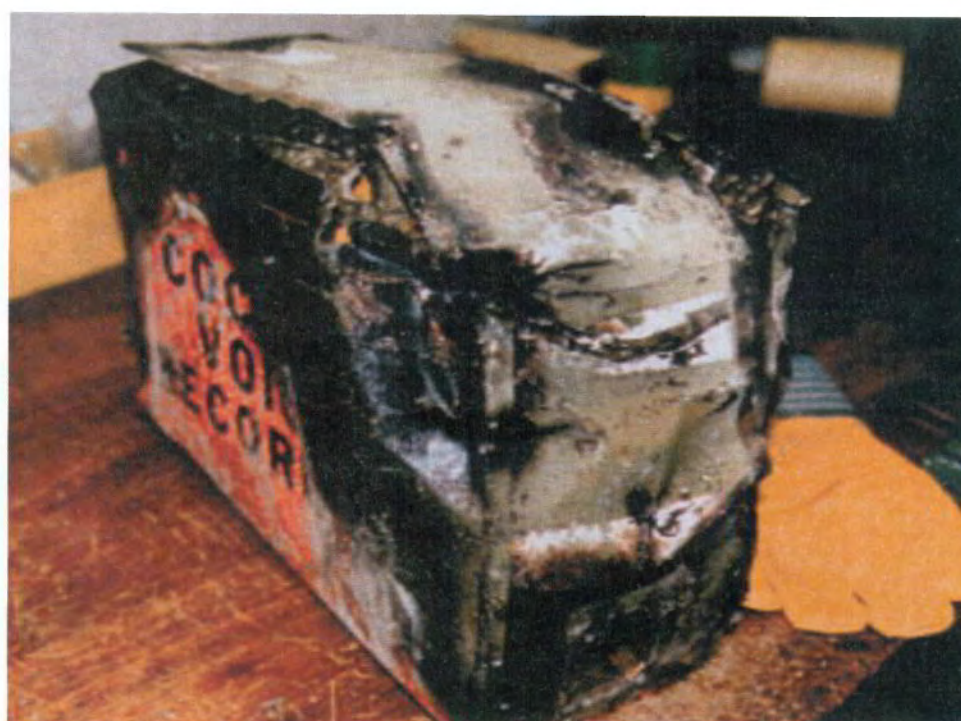
The aircraft was equipped with a Fairchild model A100 re-cycling CVR that records the latest 30 minutes of audio information on four tracks. The CVR, which had suffered much less damage than the FDR, was recovered from beside the impact crater on the night of the accident. Appendix G, Figure 4 shows the CVR unit as found.

CVR unit

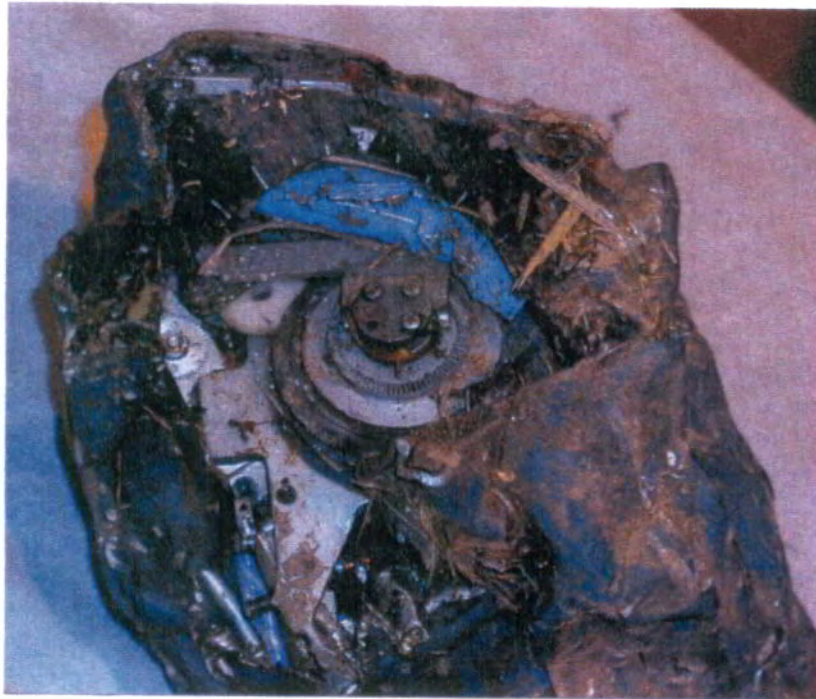
Figure 1

Despite an exhaustive search of the accident site only one relatively complete, but severely damaged, ADI was recovered and a view of its front face is shown in Appendix M, Figure 1. The backplate of another unit, complete with data plate, was also recovered attached by wires to some internal components. The serial number, 5D2193, identified this backplate as belonging to the spare ADI from the 'fly away kit' carried on board the aircraft, thus indicating the more complete unit recovered as one of the two fitted to the instrument panels in the cockpit.

Initial visual examination of the ADI revealed deformation to the rear of the unit consistent with an aircraft impact attitude of some 40° nose down and a roll angle of some 80° to 90° to the left. Although severely crushed, the body of this unit was largely complete and contained within the casing almost all of the mechanical and electronic components. However, most of the delicate warning flags and indicators, together with the lower section of the attitude tape and its support frame, were missing from the front of the instrument. The backplate, containing both electrical connectors, was also missing. From this initial examination the 'as found' position of the attitude tape frame suggested that this ADI had been displaying a low angle of bank at the time of impact with the ground.

## FRONT VIEW OF INDICATOR AS FOUND

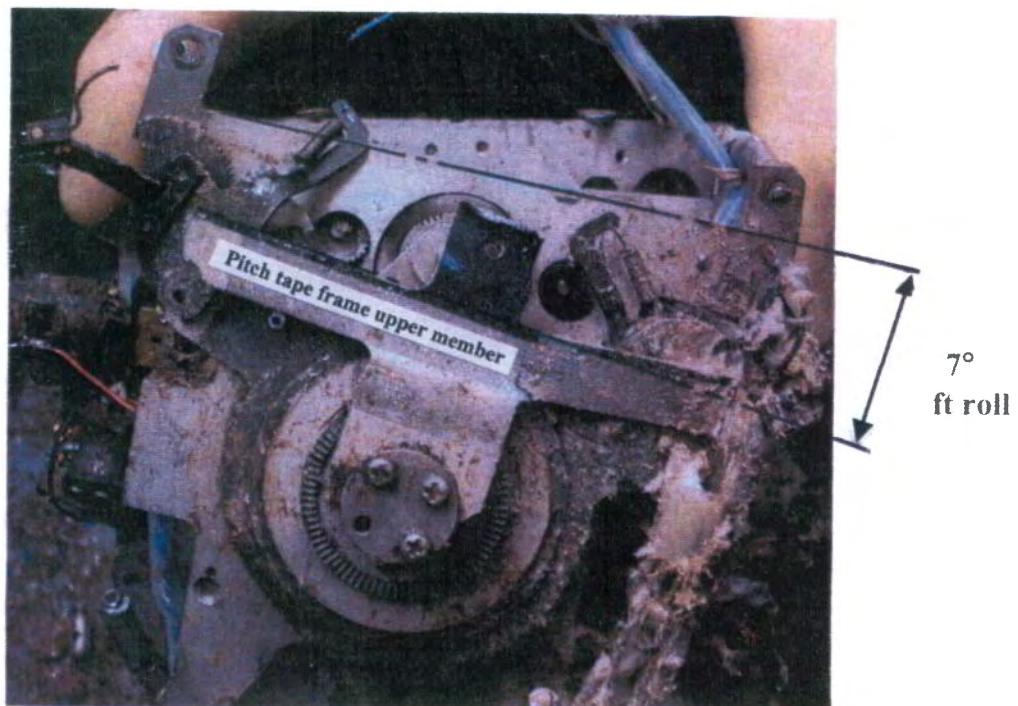
Figure 2

## ASSESSMENT OF INDICATED ROLL ANGLE ALLOWING FOR DISTORTION

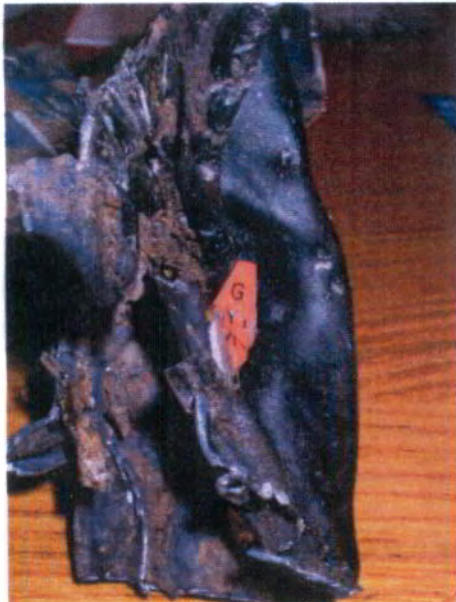
Figure 5

GYRO flag as-found, seen from the front, crimped between the folds of the FDI case sidewall. Angle of flag, in relation to front and top edge of the casing, is similar to the flag out of view position

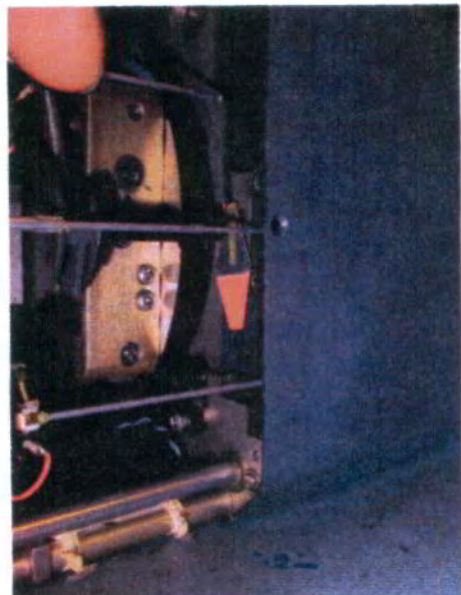
Figure 6

ASSESSMENT OF GYRO FLAG POSITION PRIOR TO IMPACT

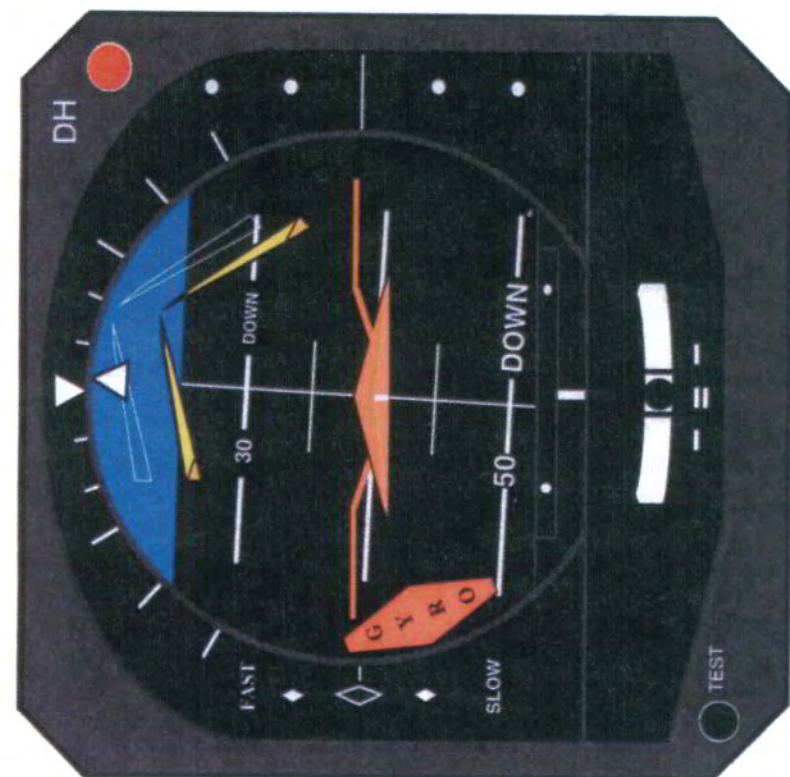
Figure 1

### DIAGRAM OF ESTIMATED FDI PRESENTATION AT MOMENT OF IMPACT

Yellow command bars drawn at maximum normal fly UP (15°) and RIGHT (20°) position, roll attitude indicating approx. 2.5° LEFT roll  
(White command bars represent as-found position, derived from FDI strip examination)

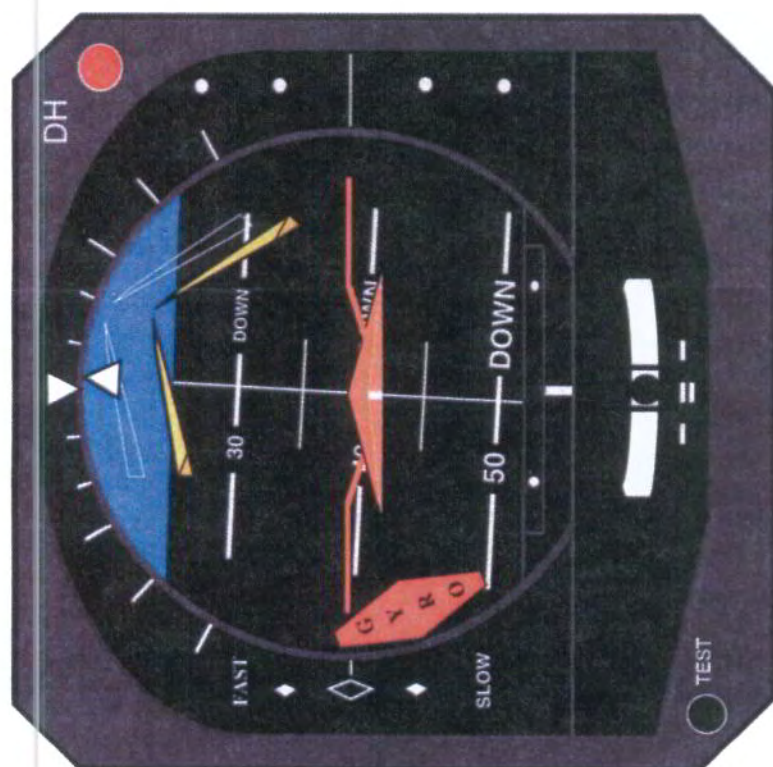
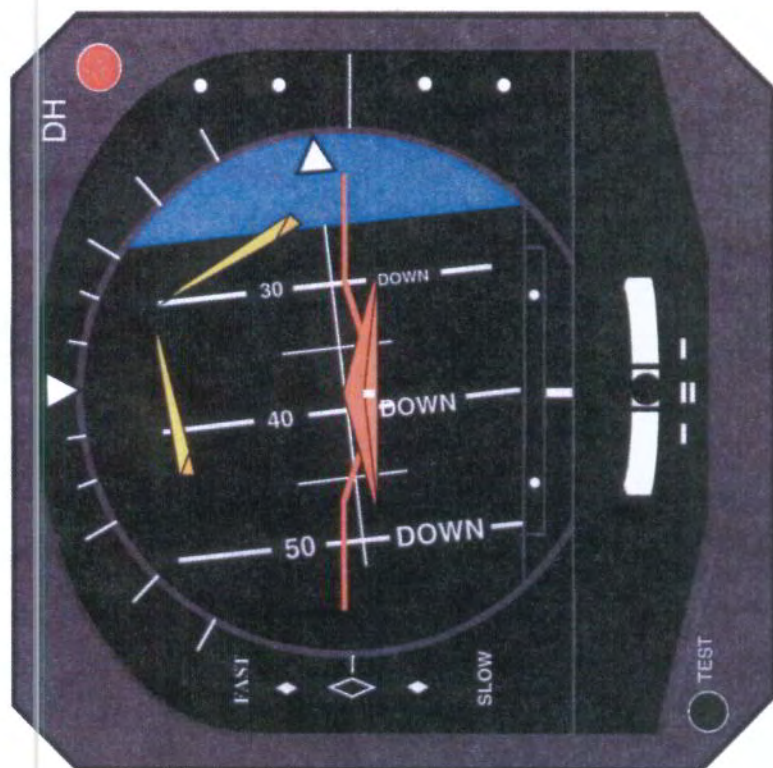
# DIAGRAM OF ESTIMATED FDI PRESENTATIONS AT MOMENT OF IMPACT

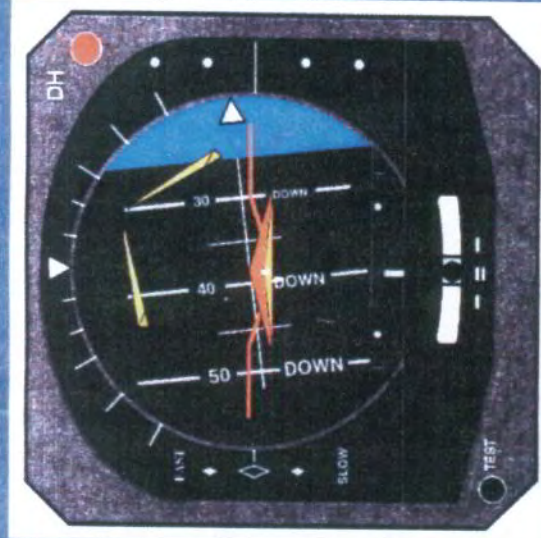
*CO-PILOT's ADI - indications assumed  
from FDR data*

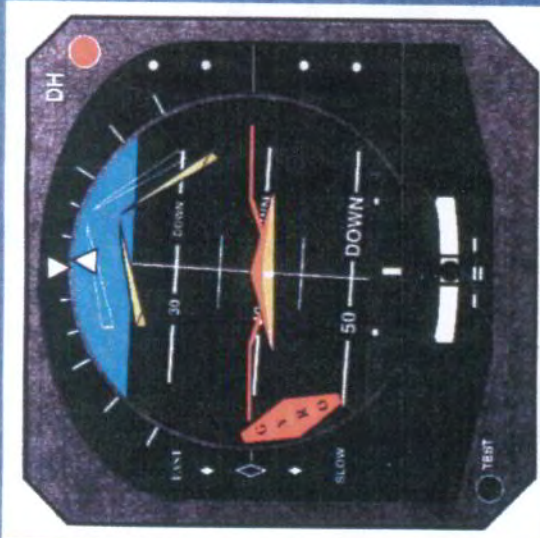
*CAPTAIN's ADI - indications derived from  
strip examination and FDR data*
