*Accident
on 2 May 2000
at Lyon-Satolas (69)
to the Learjet 35A
registered G-MURI
operated by
Northern Executive Aviation Ltd*

REPORT
g-ri000502a

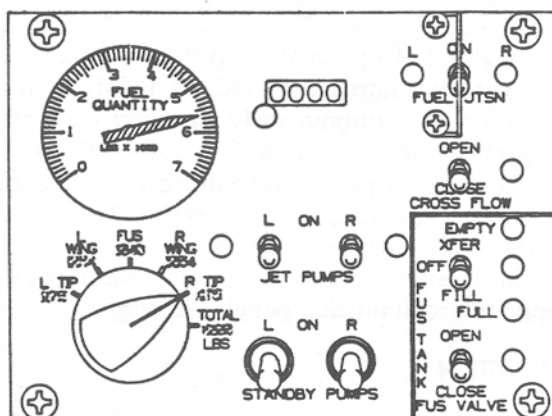
Illustration of the fuel management panel

The Learjet 35A's fuel system includes two wingtip tanks with a capacity of 1,150 lb each and a fuselage tank of 1,340 lb. Fuel consumption occurs through transfer from the wingtip tanks to the wing tanks. Transfer from the fuselage tank to the wing tanks normally takes place by positioning the TANK XFER-FILL switch on the XFER position. The wing tank crossfeed valve opens and the transfer pump begins to operate. During this activity, temporary illumination of an amber light on the fuel control panel indicates transit to the appropriate operating position. Permanent illumination indicates that the valve is not in the selected position.

The positions noted on the valves, fuselage transfer open and cross-feed closed, allows two hypotheses to be considered to determine the fuel balance. Either these positions resulted from a malfunction leading to incorrect positioning of the cross-feed valve during the transfer procedure, or the incorrect positioning of this valve resulted from the impact.
