# NATIONAL TRANSPORTATION SAFETY BOARD

## AIRCRAFT ACCIDENT REPORT

CONTROLLED FLIGHT INTO TERRAIN  
KOREAN AIR FLIGHT 801  
BOEING 747-300, HL7468  
NIMITZ HILL, GUAM  
AUGUST 6, 1997

NTSB/AAR-00/01  
PB00-910401  
Notation 6952B  
Adopted January 13, 2000

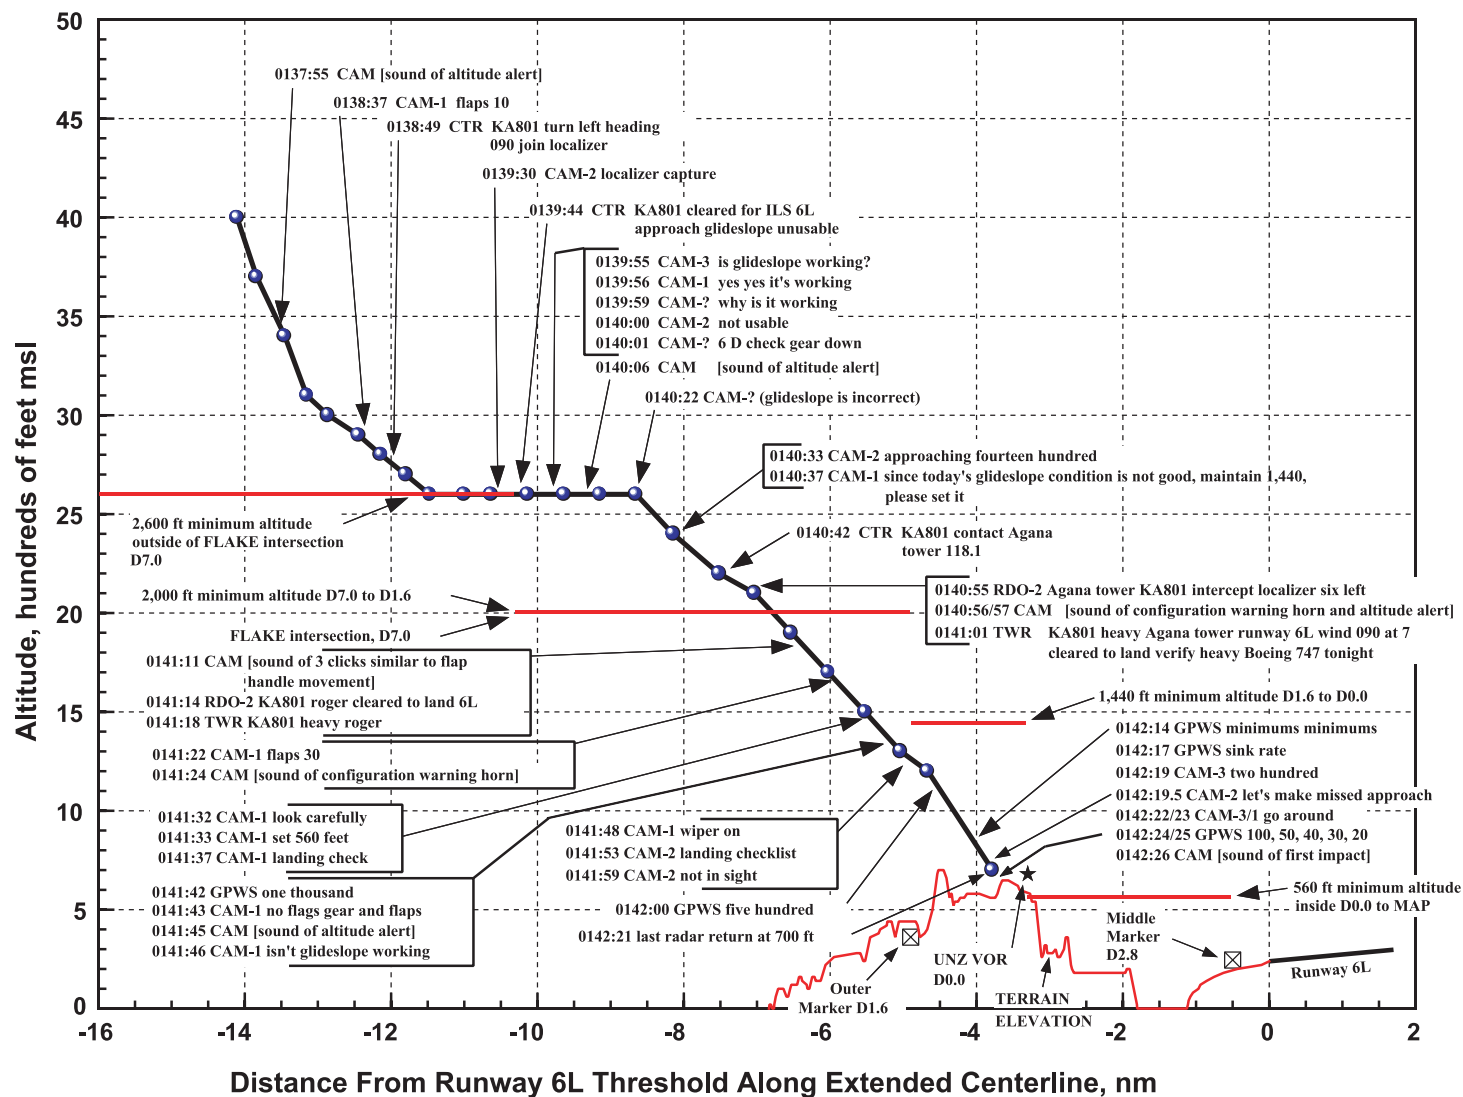
**Figure 2.** Side view of FAA radar data with selected ATC and CVR communication excerpts.

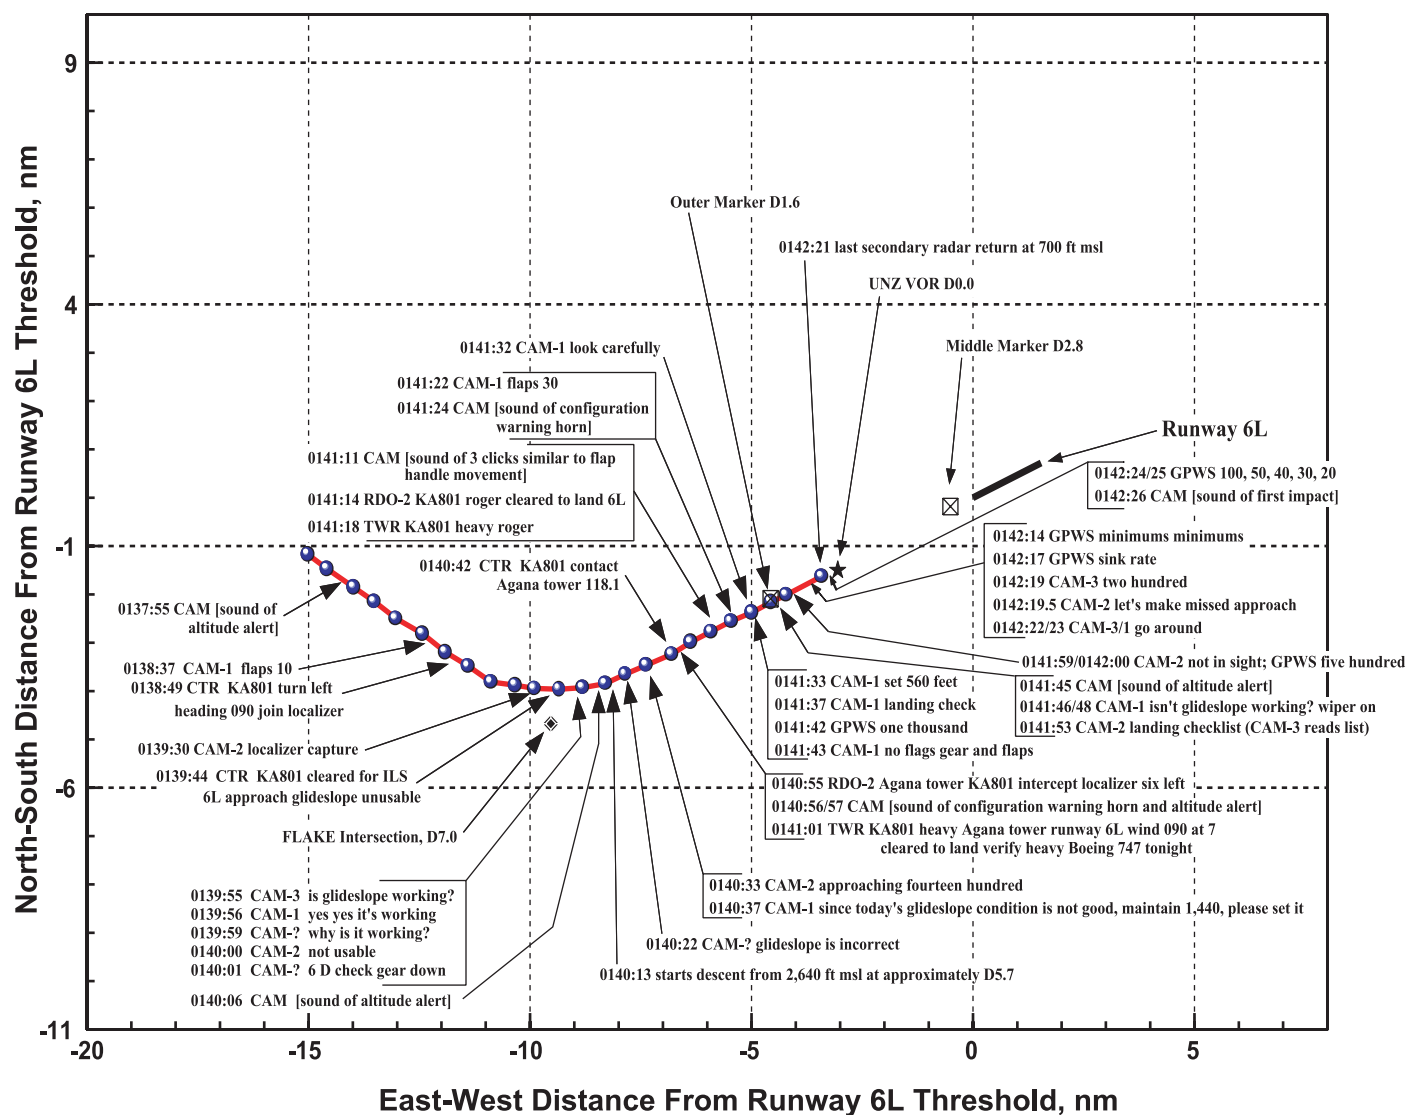
**Figure 3.** Overhead view of FAA radar data with selected ATC and CVR communication excerpts.

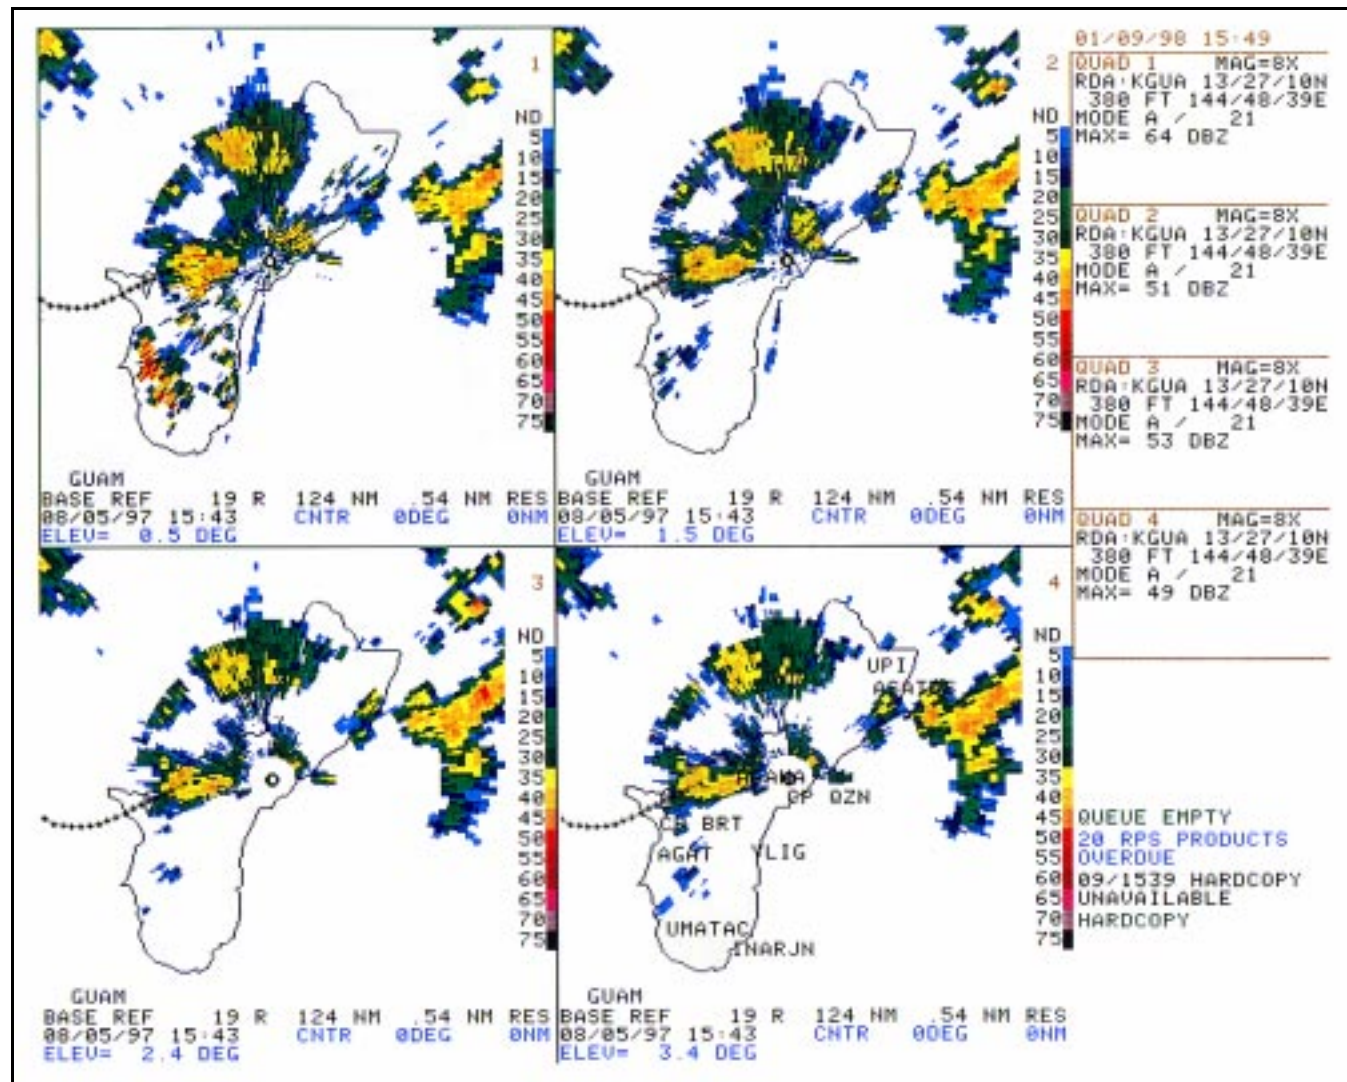
The CERAP radar controller stated that, although areas of weather were in the vicinity of the VOR and airport, he had not received any pilot reports from midnight to the time of the accident. The controller stated that a “relatively small cell,”<sup>38</sup> which he believed to be of light to moderate intensity, was depicted on the Airport Surveillance Radar (ASR)-8 display. Further, the controller said that the “relatively small cell” observed on radar extended about 3 to 5 miles on the final approach course and was about 2 to 3 miles across in the largest area. The controller said that he had no means of determining the intensity of this or any other weather cell because, unlike other weather radar displays, the ASR-8 radar display is monochromatic, and it is difficult to differentiate precipitation intensity without color. However, the controller also said that he

Figure 6. WSR-88D four-panel base reflectivity product for Guam.

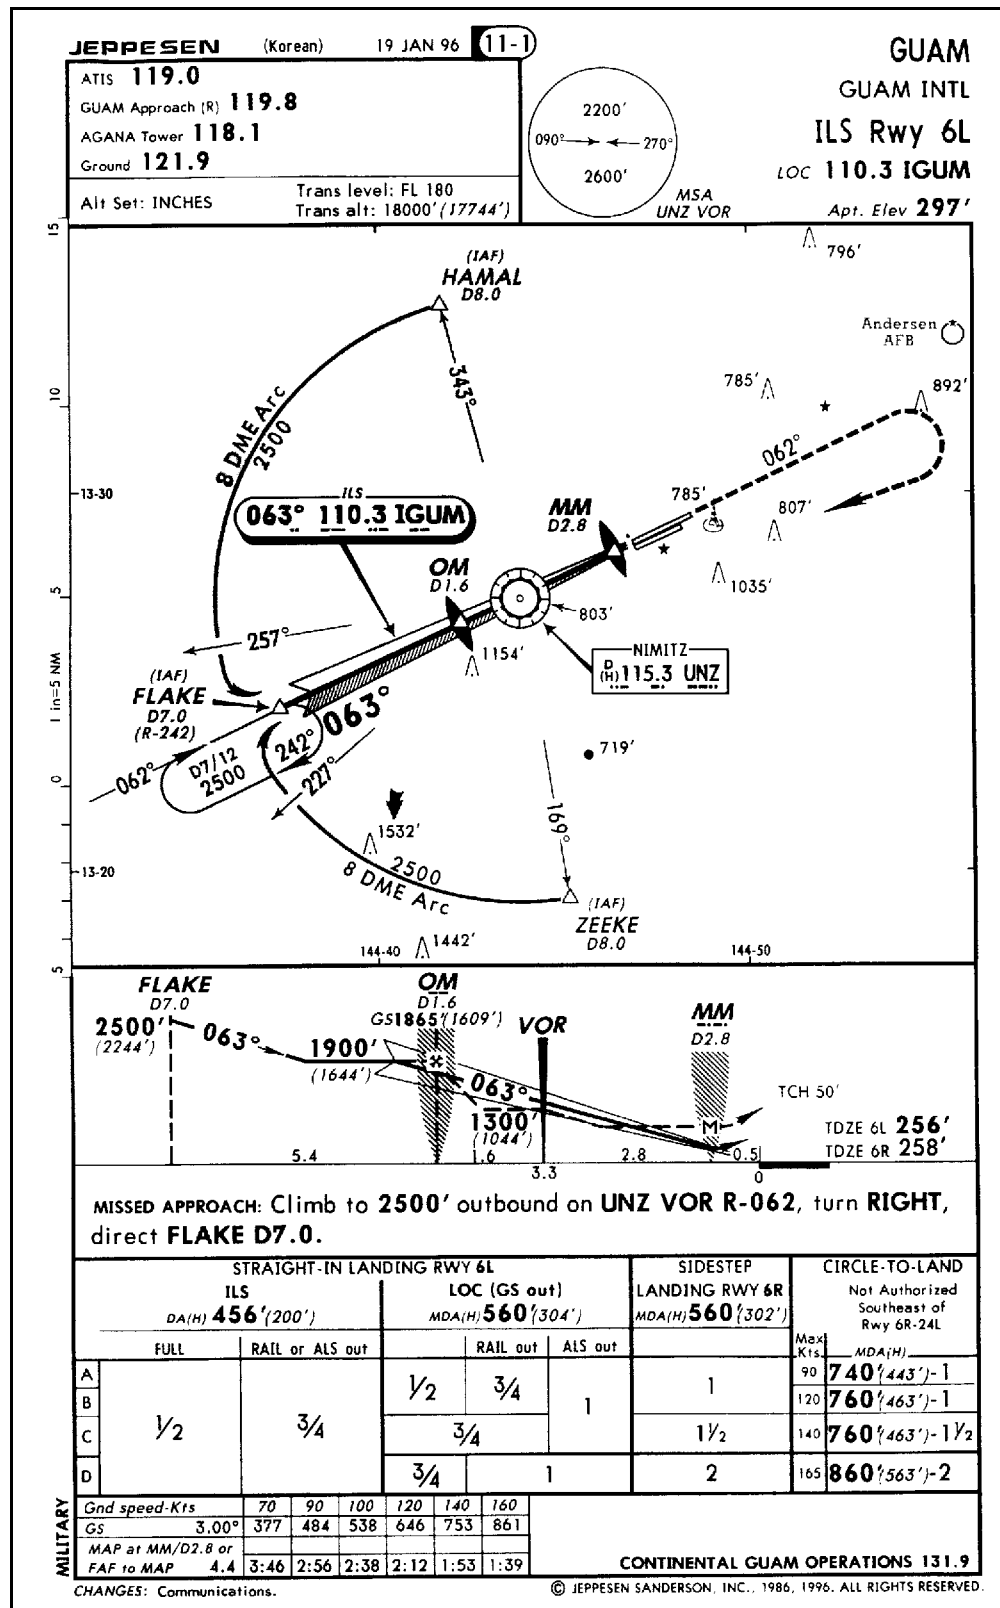
Charts 11-1 and 13-2 were found side by side and were visible through one face of the plastic sleeve. Chart 16-1 and the blank side of an approach plate were visible through the opposite face of the plastic sleeve. Chart 11-1, which is shown in figure 7, had the following items highlighted with a green fluorescent tint:<sup>62</sup>

Figure 7. The January 19, 1996, 11-1 ILS runway 6L instrument approach chart.
