**FINAL INVESTIGATION REPORT ON SERIOUS INCIDENT TO
AIRINDIA CHARTERS LTD AIRCRAFT , B737-800NG, VT-AXJ NEAR
POSITION PARAR IN VABF 26.05.2010.**

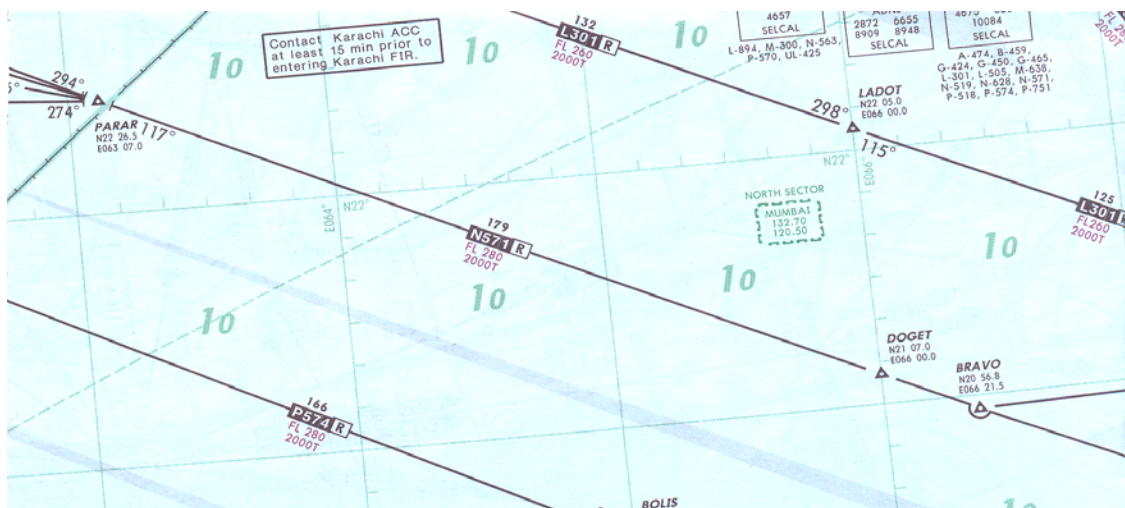
The incident happened immediately after crossing PARAR at 17:53Z.
