FINAL REPORT

**ACCIDENT
INVOLVING ATR 72 AIRCRAFT
REGISTRATION MARKS TS-LBB
ditching off the coast of Capo Gallo (Palermo - Sicily)
August 6th, 2005**

AGENZIA NAZIONALE
PER LA SICUREZZA DEL VOLO

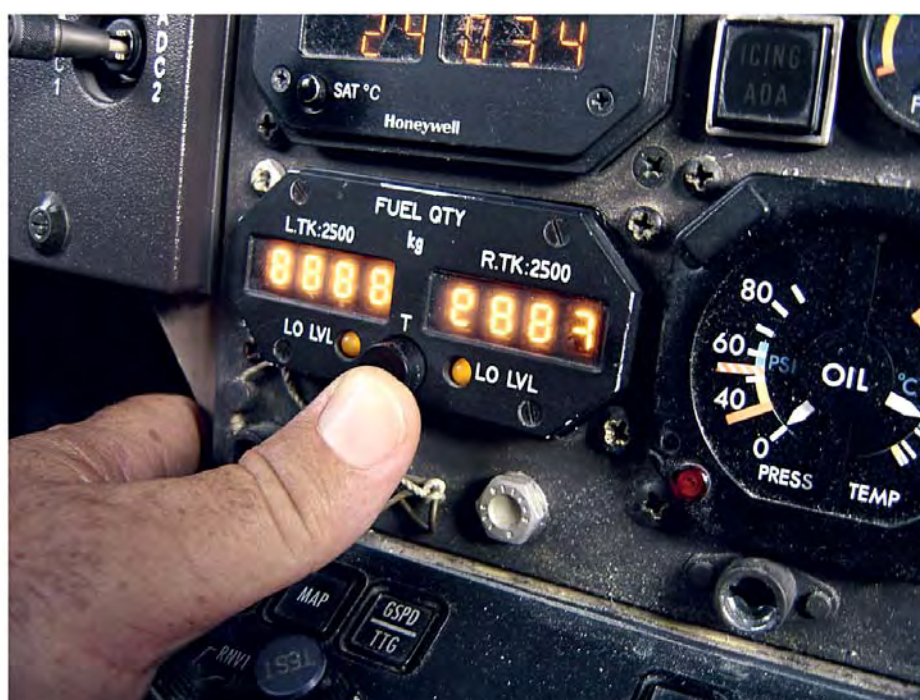
During the first route, Tunis-Catania, the flight captain had become aware of the inefficiency of the fuel quantity indicator (FQI); in particular, the value shown by the FQI for the right-hand tank was not normal: some LEDS of the display were not working, which meant that the fuel quantity was not correctly displayed. In photo 1 it's in fact possible to see the lights of the right display that were not working correctly: the one for the thousands, and the one for the units. The FQI provides the crew with the value of the fuel quantity, in kg or in pounds, depending on the aircraft model, inside the wing fuel tanks. Further details on how this instrument works are outlined in the following paragraph 1.6.5.2.

Photo 1: The FQI installed on TS-LBB before replacement.

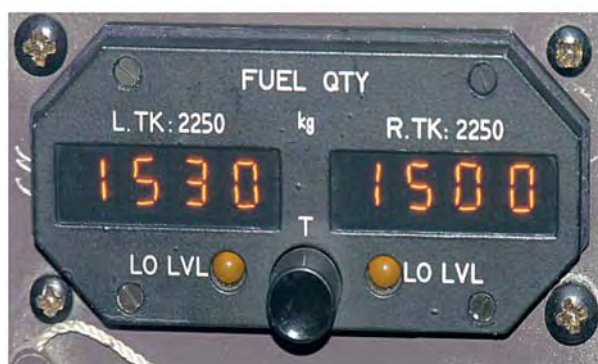
The ATR 42 and ATR 72 type FQIs are identical in their dimension and installation procedure. Therefore an ATR 42 type FQI could be installed by mistake on an ATR 72 aircraft and vice versa. The only difference between the two FQIs, when installed on the aircraft, is white lettering indicating the maximum fuel quantity for each wing fuel tank. This can be found on the front of the instrument and is “2500” for the ATR 72 type FQI and “2250” for the ATR 42 type.

Photo 7: FQI ATR 42.

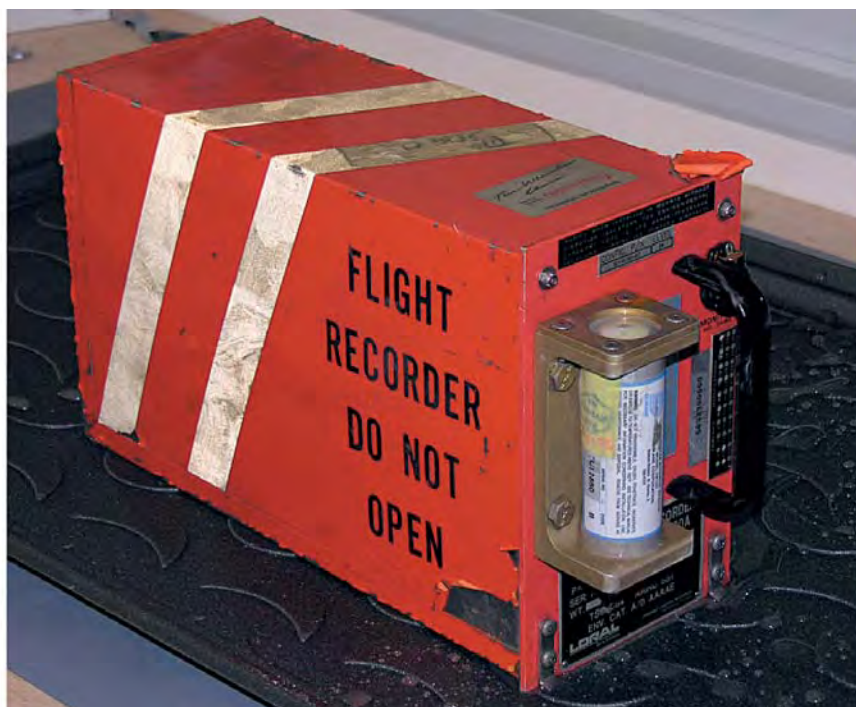
Both units were in reasonable general condition, without evidence of impact or fire damage.

Photo 18: CVR, external condition. ULB in foreground.

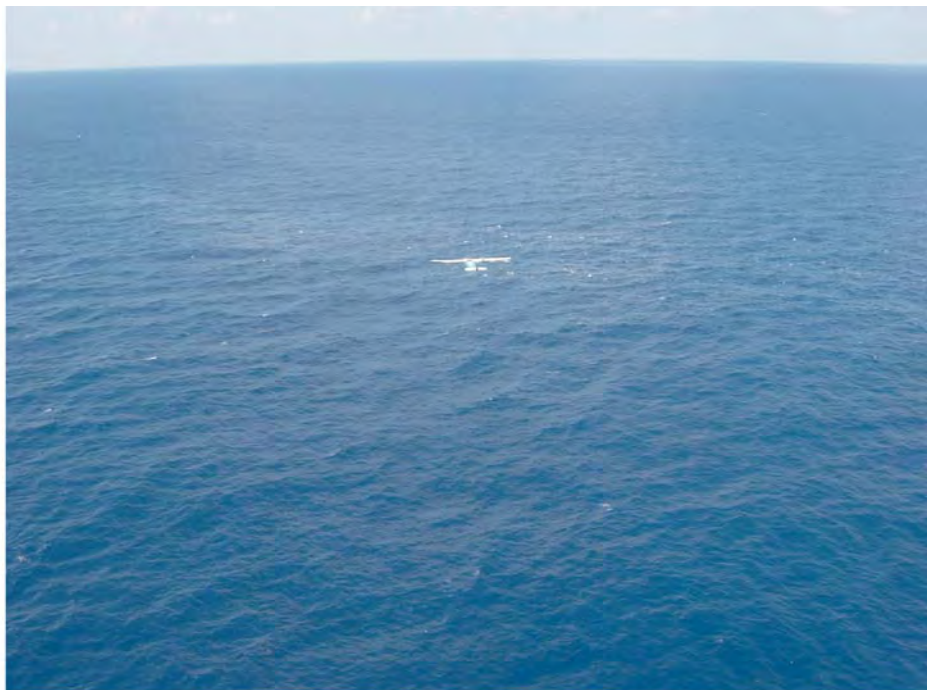
Photo 19: View of the wreckage upon arrival of the first rescue helicopter.

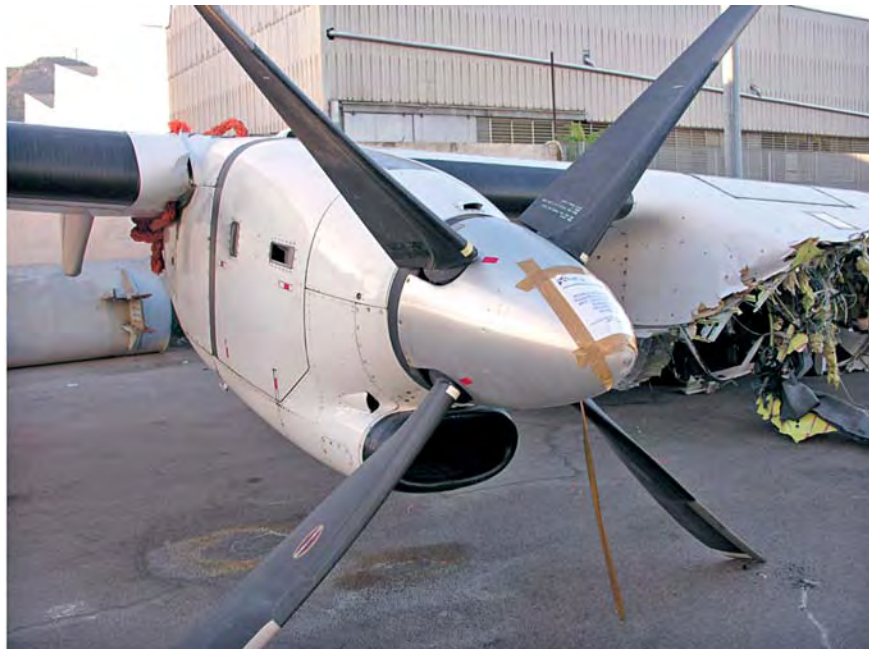
- Considerable presence of corrosion on various components, caused by the action of the seawater they came into contact with. The engines were immediately treated with fresh water to limit any further corrosion to the components.
- Some of the propeller blades, resting on the ground, were clearly bent.
- MFCU Fuel Control in the shut-off position.
- No visible loss of fluids from components and accessories.
- No clear breaks in the fuel feed line.
- Low pressure filter removed to check its condition. No external contamination was detected.

Photo 21: Right engine – note the propellers in the fully feathered position (red line).

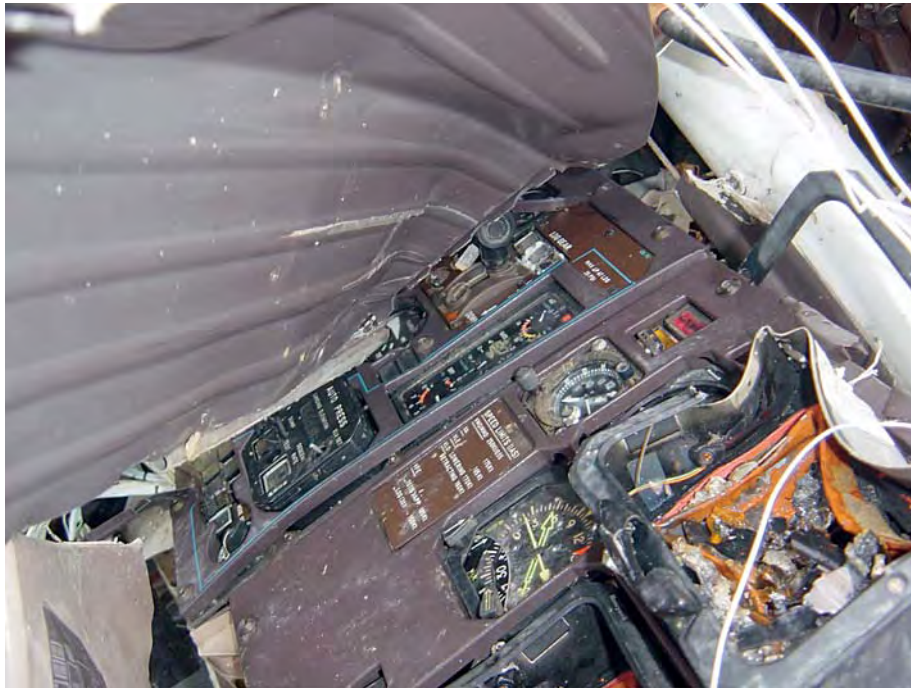
Photo 28, taken immediately after positioning the wreckage on the deck of the ship, shows in fact that the lever of the landing gear was in the UP position. It was also found after removal that the flaps position analogue indicator was showing 30°.

Photo 28: part of the TS-LBB instrument panel after recovery
(note the landing gear lever in the “UP” position at the centre of the photo).

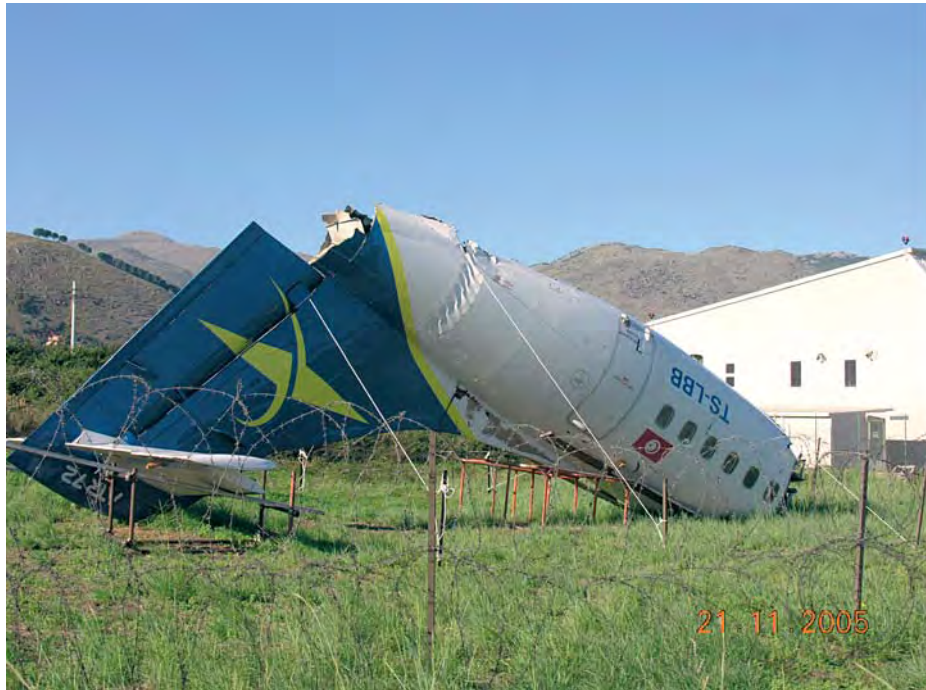
Photo 32: Rear section of the wreckage at Bocca di Falco airport – left-hand view.

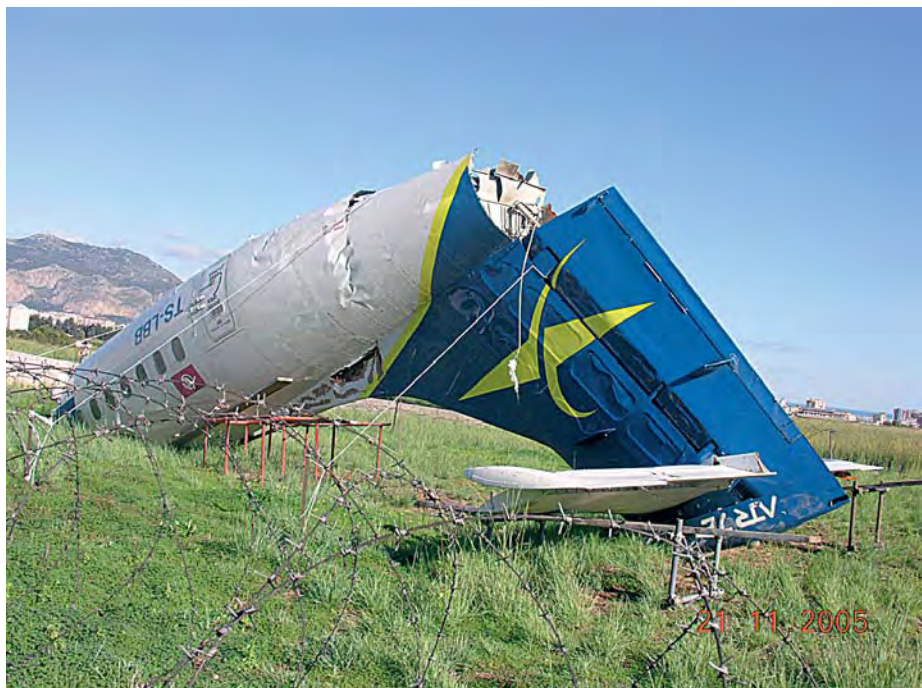
The rear of this section showed a great amount of damage and deformation, resulting in the breaking of the pressure bulkhead between the pressurised and the non pressurised zone. This indicates that the impact of the aircraft against the sea surface was very strong. The rear had in fact completely collapsed, while the seating area was virtually intact.

Photo 33: Rear of the wreckage at Bocca di Falco airport, right-hand view.

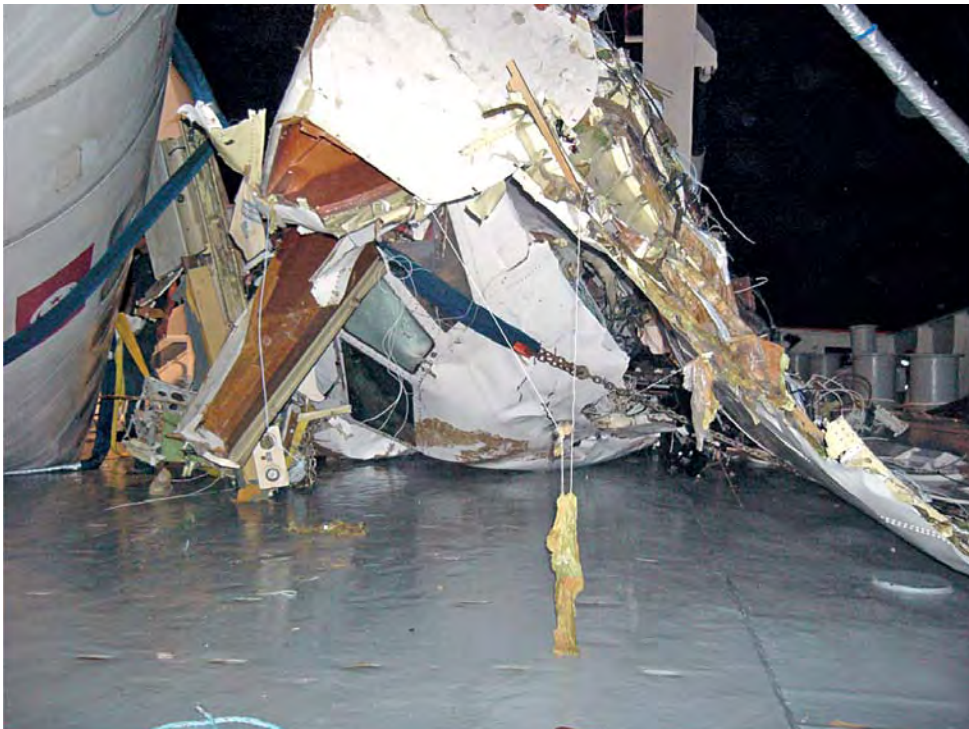
This section was divided into two parts. One part included the cockpit and the left-hand structure, while the other included the right-hand structure and the top part of the cabin. Also in this section no evidence of breaks due to fatigue and/or corrosion were found. All breakage points showed in fact a morphology typical of breaks caused by overload. No signs of fire were detected either. The section of the cockpit showed serious and extensive damage. It is very likely such damage was caused not only by the impact with the sea surface, but also by the subsequent impact with the seabed.

Photo 37: Part of the cockpit immediately after recovery.

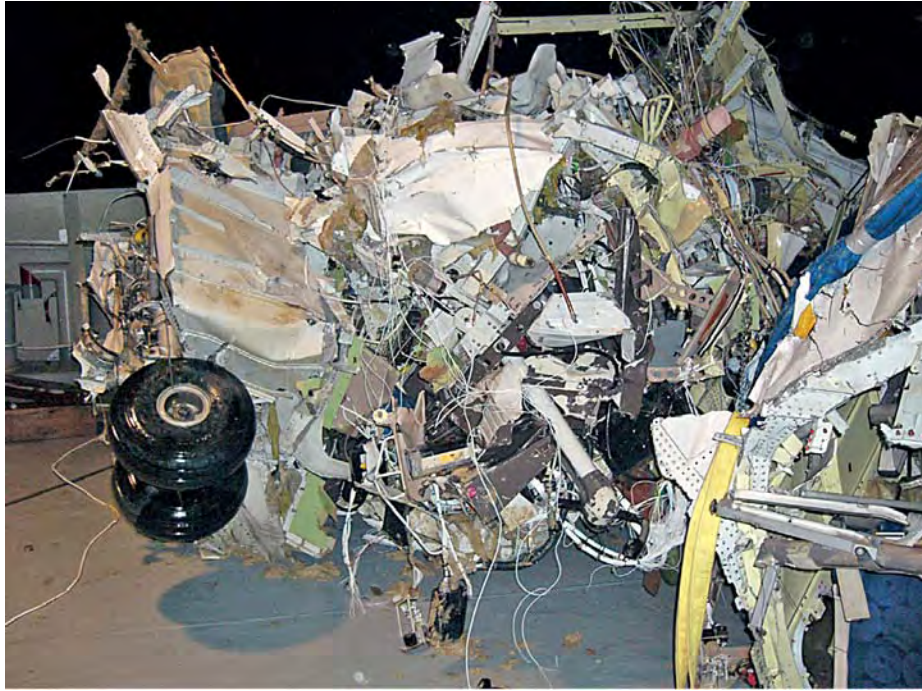
The internal structure of the right-hand of the aircraft showed an extensive amount of damage. The seats and the floor were no longer attached.

Photo 38: Part of the front section of the fuselage immediately after recovery.

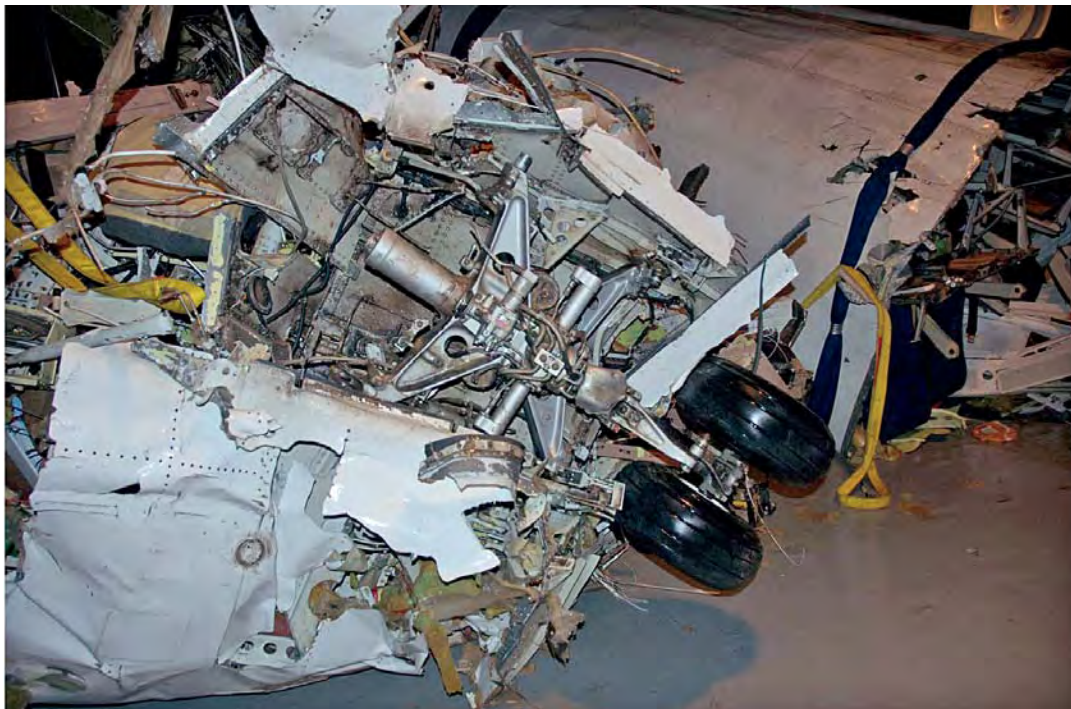
Photo 59: Front of the fuselage, nose landing gear.

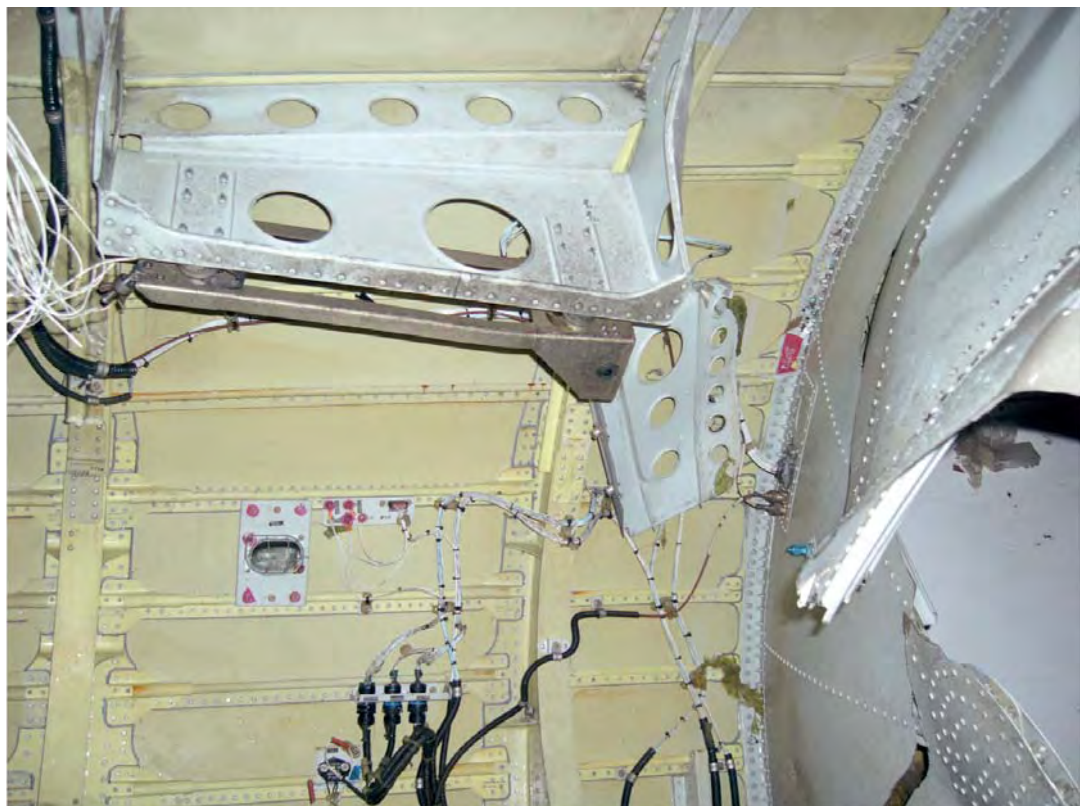
Considerable structural damage was found on the inside. The pressure bulkhead between the cabin pressurized zone and the tail had a large diagonal gash (see photo 34 and 61). The tail assemblies did not show any significant deformation. The CVR was removed from its housing. It was removed, immediately washed with fresh water and then placed in a container full of distilled water. The supports of the FDR housing appeared damaged and the device itself was missing (photo 61).

Photo 61: The damaged FDR housing (note the deformation of the pressure bulkhead, demonstrating the strong impact sustained by the rear section of the aircraft).

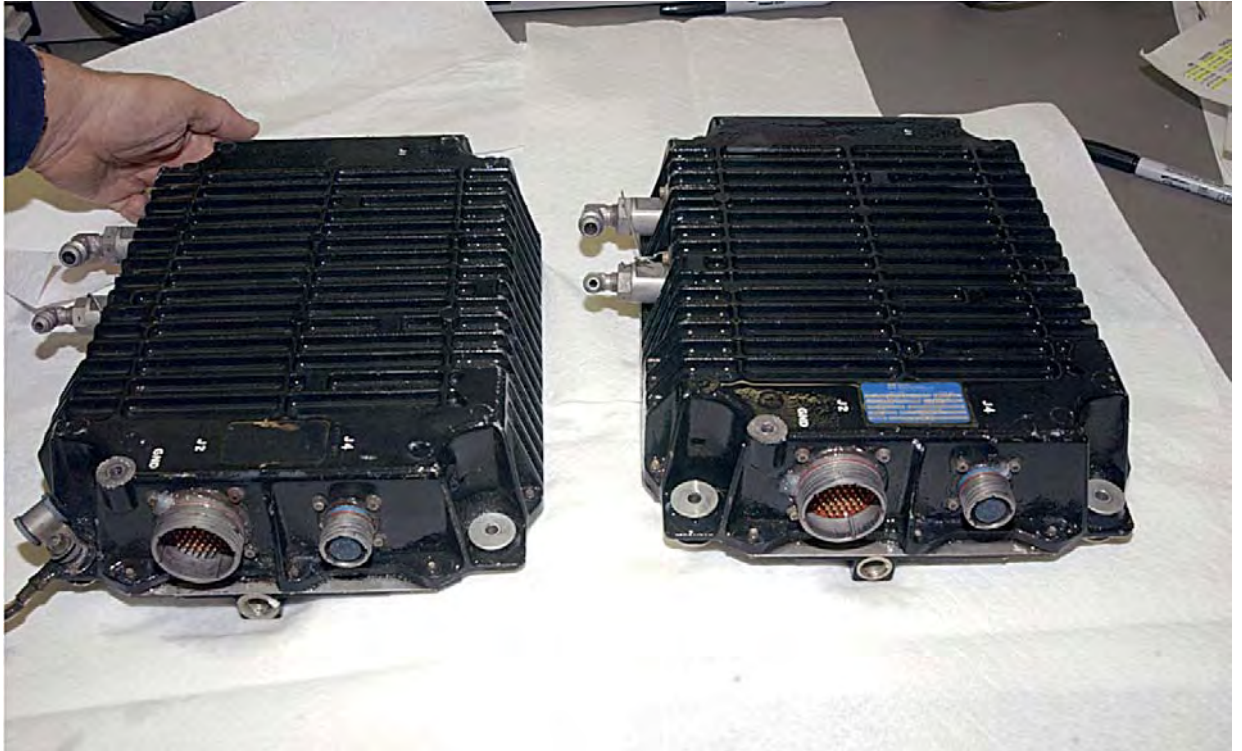
Photo 74: Engine EECs. Note the one on the left, for the right engine, without identification plate.

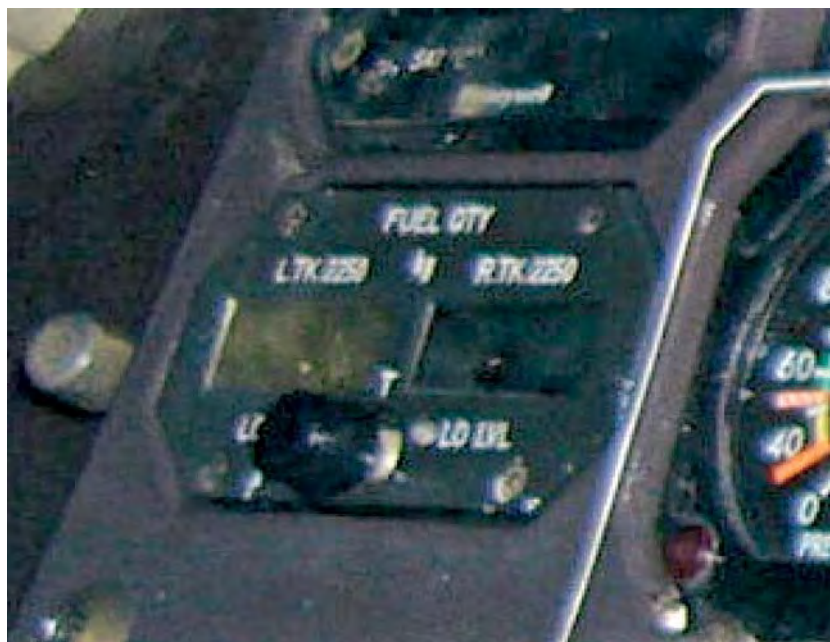
Photo 87: FQI installed onboard TS-LBB, taken immediately after wreckage recovery.
