## AIRCRAFT ACCIDENT REPORT

IN-FLIGHT LOSS OF PROPELLER BLADE  
FORCED LANDING, AND COLLISION WITH TERRAIN  
ATLANTIC SOUTHEAST AIRLINES, INC., FLIGHT 529  
EMBRAER EMB-120RT, N256AS  
CARROLLTON, GEORGIA  
AUGUST 21, 1995

**Adopted: November 26, 1996  
Notation 6609B**

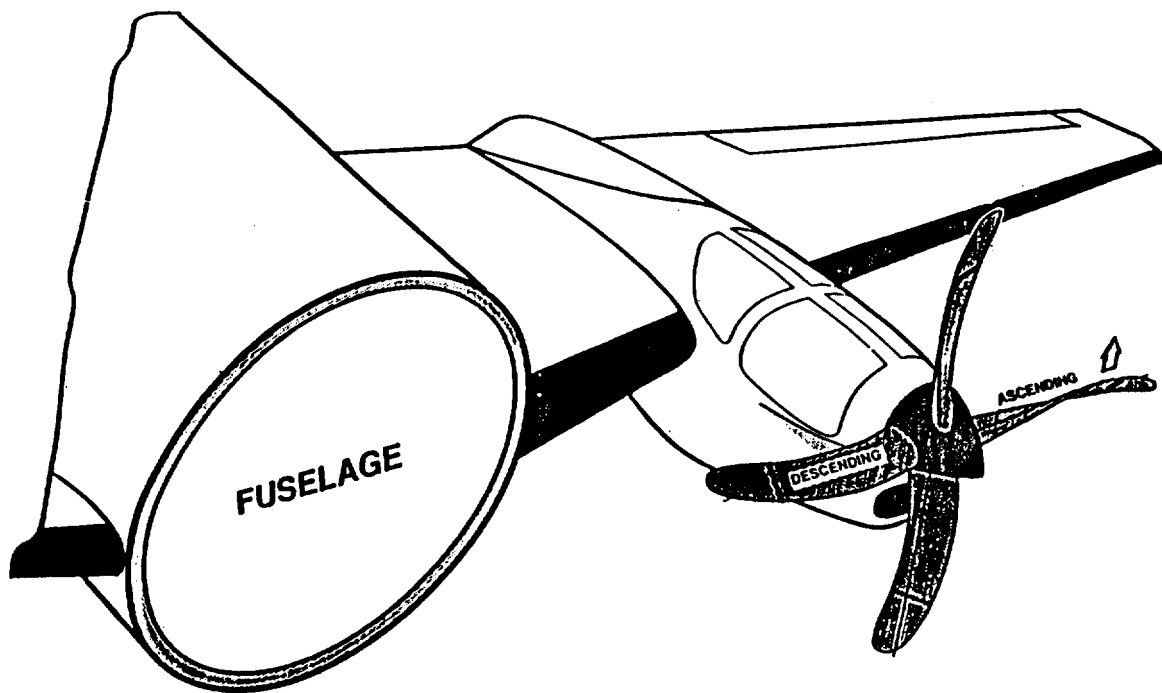
Figure 1.--Propeller installation - left wing.
