AIRCRAFT ACCIDENT REPORT

COLLISION WITH TREES ON FINAL APPROACH
AMERICAN AIRLINES FLIGHT 1572
McDONNELL DOUGLAS MD-83, N566AA
EAST GRANBY, CONNECTICUT
NOVEMBER 12, 1995

**Adopted: November 13, 1996
Notation 6638B**

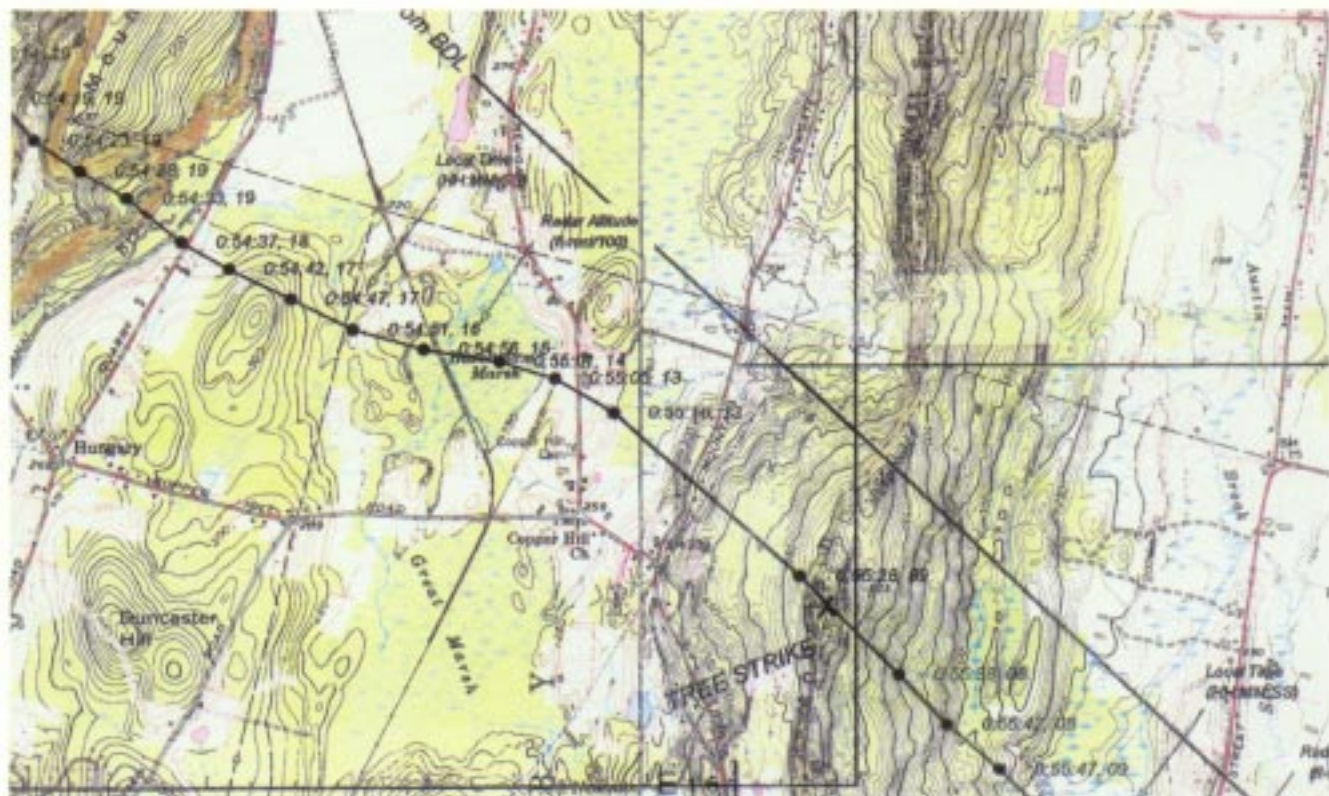
Figure 2b.--Plan view of the approach with terrain features.

¹¹Investigators determined that the first impact point was with trees on the top of a ridge line approximately 2.54 nautical miles northwest of the approach end of runway 15.

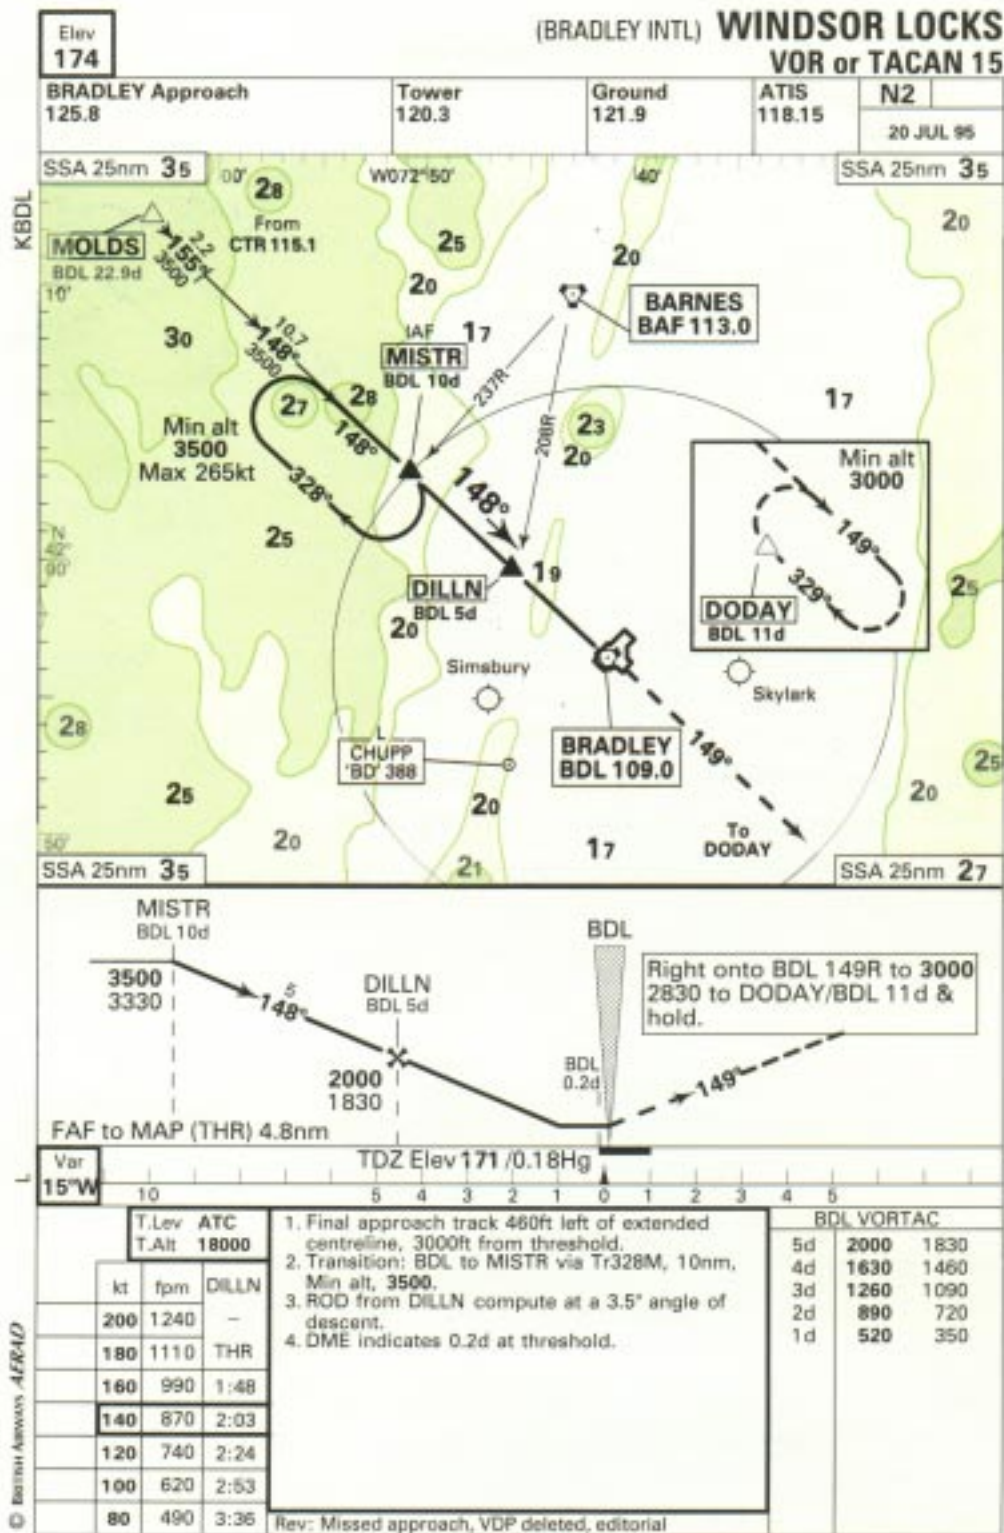
Figure 4.--BDL approach plate used by British Airways.

The single 819-foot obstacle depicted on the final approach course of most BDL runway 15 VOR approach plates could lead flightcrews to believe that there was one discrete obstacle, and that it was the only dangerous point on the final approach (see Figure 1). However, the Safety Board concludes that the entire ridge line is an obstacle, and that it and similar terrain close to other airports should be fully depicted on the appropriate approach charts. As an example, see Figure 4, the BDL approach plate used by British Airways. The Safety Board continues to believe, as reflected in Safety Recommendation A-96-102, following the accident near Buga, Colombia, that the FAA should require that all approach and navigation charts graphically present terrain information.

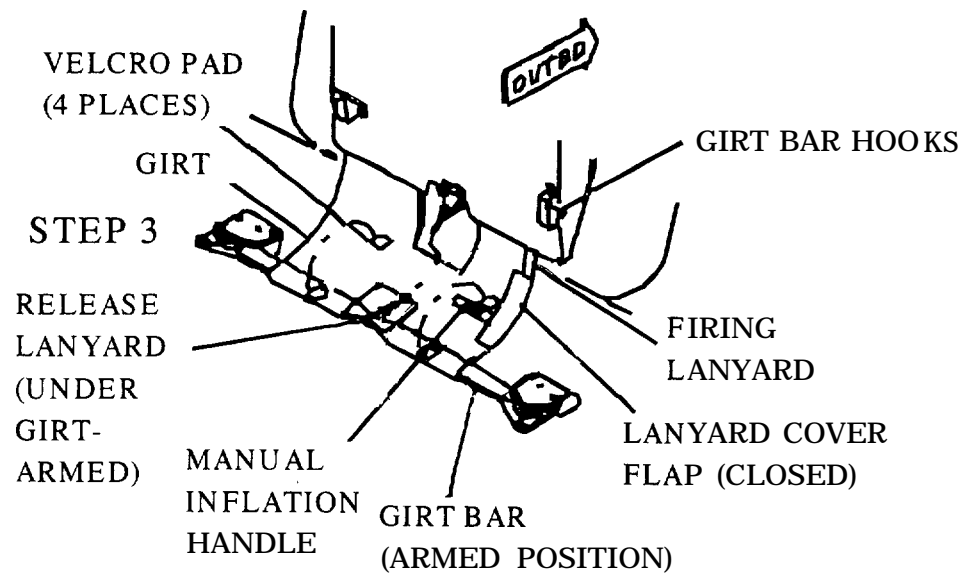
Figure 5.--Instruction diagram for rigging the firing lanyard (inflation cable).

Because the evacuation slide failed to inflate automatically, it was examined by investigators from the Safety Board, American Airlines, and the FAA at the facilities of the manufacturer, Air Cruisers Company.
