**AIRCRAFT ACCIDENT REPORT 5/2009**

**Report on the serious incident to  
BAe 146-200, registration EI-CZO  
at London City Airport  
on 20 February 2007**

**Air Accidents Investigation Branch****Aircraft Accident Report No: 5/2009 (EW/C2007/02/06)**

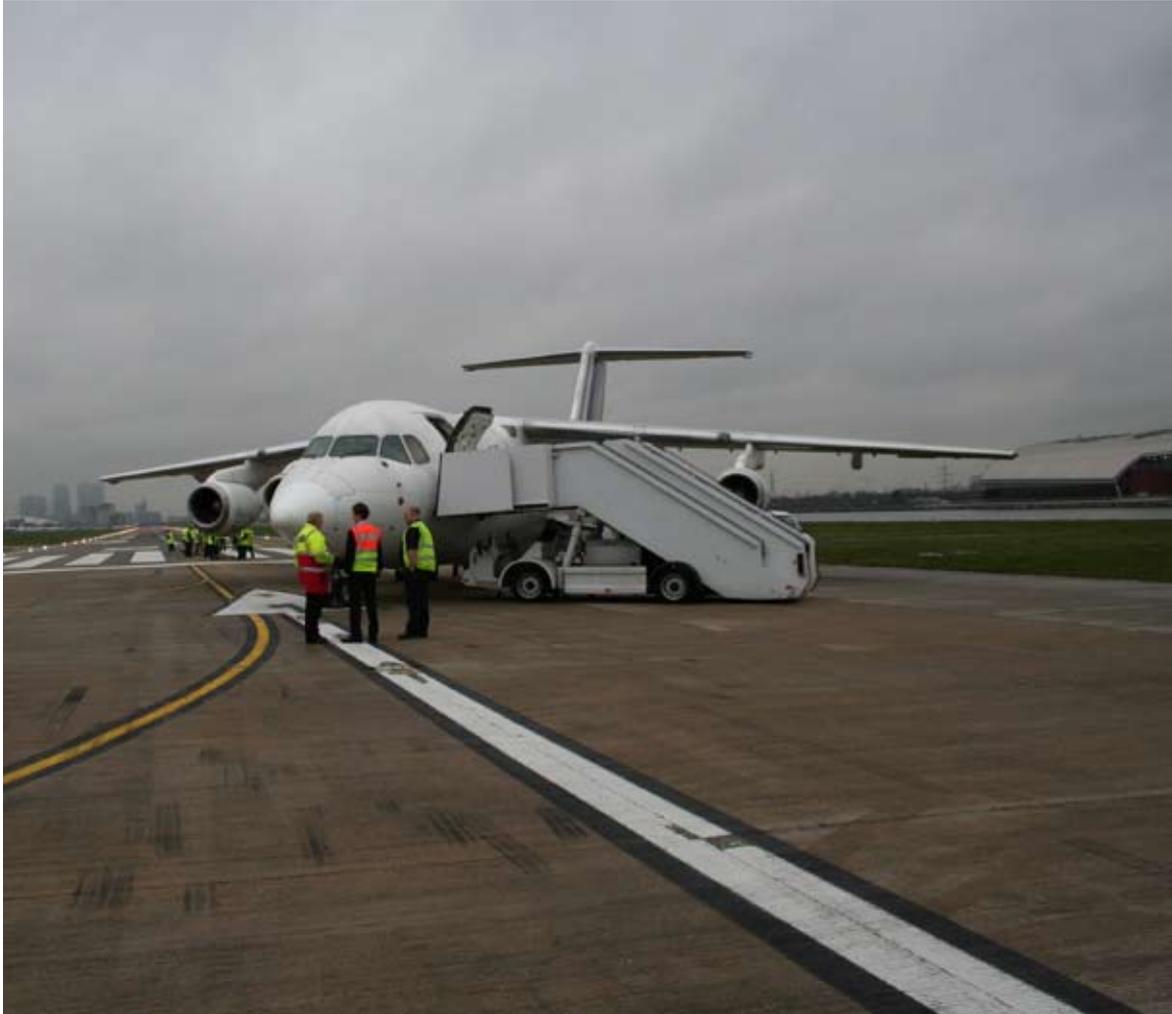
**Stopped position of EI-CZO**

The aircraft came to rest on the paved surface but with its nose some 50 m beyond the end of the LDA, and approximately 160 m from the dock edge. It had turned through approximately 30° over the last part of the ground roll, onto a heading of 130°. During the final part of the roll, all four main landing gear wheels locked and the tyres were worn down by friction with the surface until they burst. The flight crew were not aware of the tyre failures.

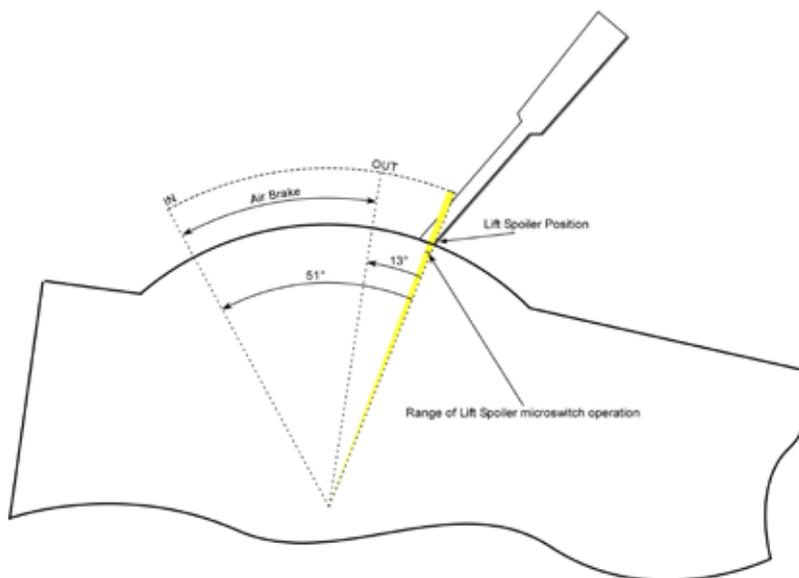
**Figure 5**

The aircraft examination revealed no defects that could explain the reason for the lift spoilers not deploying on landing. However, tests on the airbrake/lift spoiler lever did show that it was very easy to move the lever forward from 'lift-spoiler' to the full 'airbrake' position, due to the lack of friction in the mechanism. Indeed, during the aircraft tests it was noted that just nudging the lever whilst in the lift spoiler detent, caused the deployed lift spoilers to retract. With this lack of resistive force, it is possible that a lever that has already been placed in the lift-spoiler position by the pilot in the left seat, could be nudged or vibrated out of the selection, thereby stowing the deployed spoilers.

It is recommended that the European Aviation Safety Agency should mandate BAe Systems Service Bulletin 27-73-00889 for the BAe 146 series of aircraft, which increases the operating force in the forward direction from zero to 12 lb, of the lift spoiler/airbrake selector lever, to prevent the lever moving forward under the influence of vibration or being inadvertently nudged forward during the landing roll. (**Safety Recommendation 2008-062**)

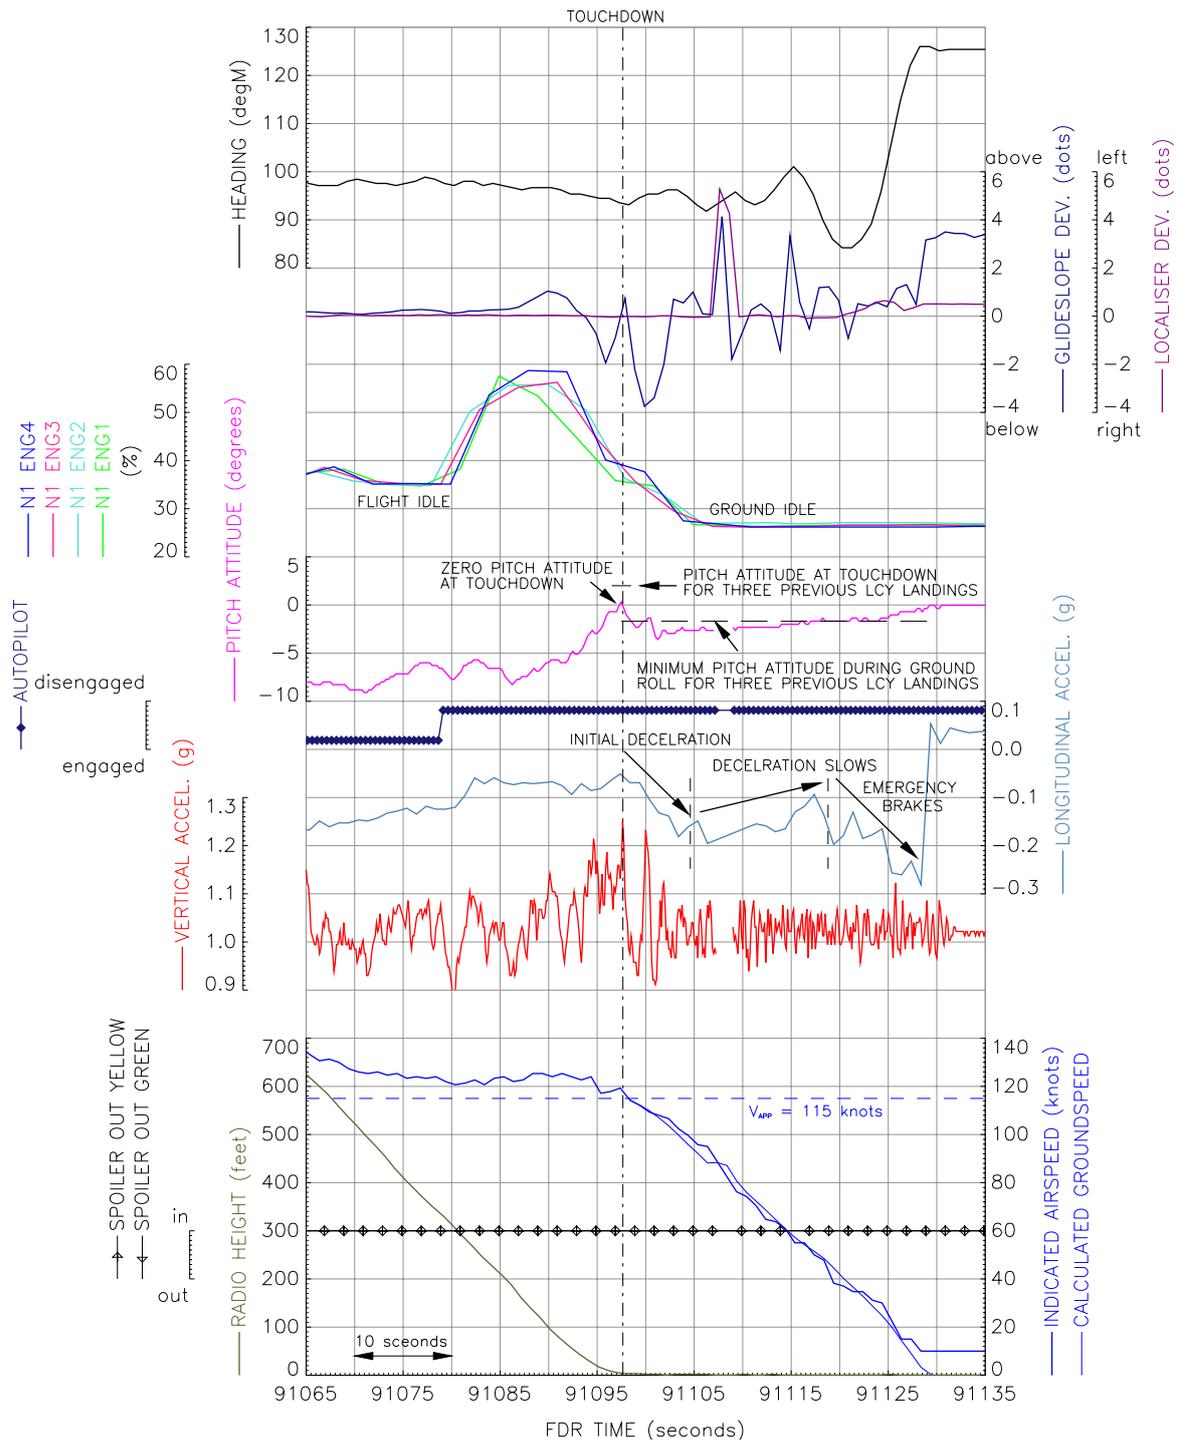
**Figure 7**  
Salient FDR Parameters

At 380 ft agl, with the airspeed at 124 kt (ie,  $V_{APP} +9$ ), the autopilot disengaged while the engine thrust increased. The thrust reached between 55% and 59%  $N_1$  eight seconds later, as EI-CZO passed through 200 ft agl, before reducing back to about fight idle just before touchdown<sup>5</sup>. As the thrust decreased, the pitch attitude increased (at a rate of no more than 1°/second) until touchdown.

From initial touchdown, the aircraft slowed to a halt over a period of 31 seconds during which it veered to the left and right with increasing amplitude, until finally veering off to the right on a heading of 126°M. Three distinct phases of deceleration were noted:

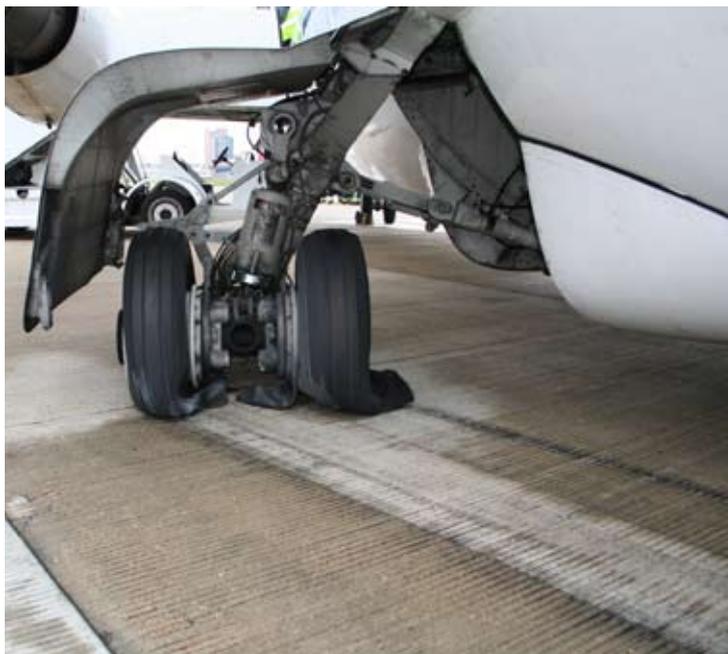
**Figure 8**

The four main wheel tyres had been worn through by surface friction until they deflated. The main wheel hubs were also damaged.

Damage to left Main Landing Gear tyres; right similar

17. Skid marks on the runway surface indicated that all four main wheels had locked up over the last 473 m of the ground roll.
18. The locked main wheels caused all four tyres to be worn through by friction with the surface and to deflate.
