PB95-910406
NTSB/AAR-95/06
DCA95MA020

AIRCRAFT ACCIDENT REPORT

UNCONTROLLED COLLISION WITH TERRAIN
AIR TRANSPORT INTERNATIONAL
DOUGLAS DC-8-63, N782AL
KANSAS CITY INTERNATIONAL AIRPORT
KANSAS CITY, MISSOURI
FEBRUARY 16, 1995

**Adopted: August 30, 1995
Notation 6538A**

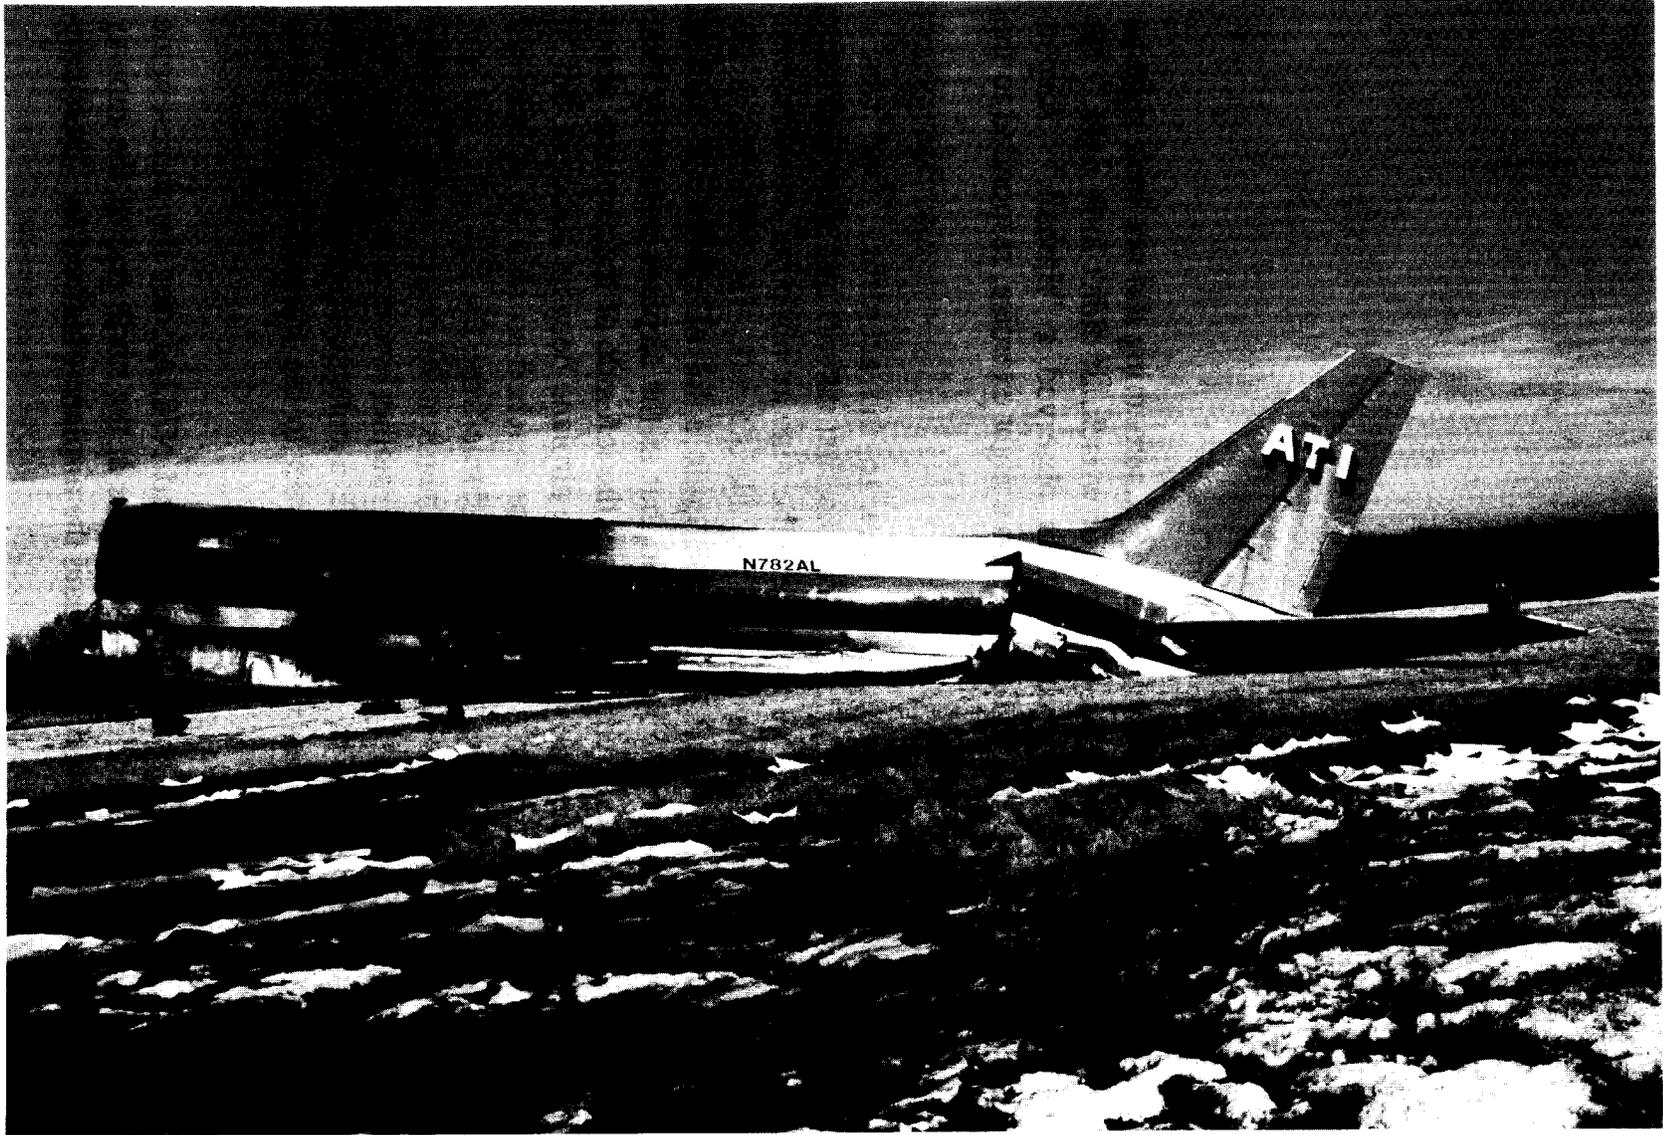
Figure 1.--Ground view of wreckage.

nose high attitude during rotation,” and he observed a “bright yellowish-orange ball of fire from the exhaust of the No. 2 engine.” He then saw the airplane enter a “slowly increasing left bank” just before impacting the ground. See figures 1 and 2.

The cockpit and forward fuselage suffered severe impact damage. The upper cockpit structure remained recognizable, but the lower cockpit structure, radome, and fuselage were mostly broken into smaller pieces. The upper, forward section of the cockpit was found upside down, and the front windows were shattered.

The forward fuselage remained intact and attached to the wing structure. The left and right sides were sooted, more so on the left side and near the wings, but no soot and only minor deformation were observed on the interior of the fuselage. The forward fuselage section came to rest on a magnetic heading of 125 degrees.

The **aft** fuselage section remained intact, and with the empennage attached. Some postcrash sooting was observed. The cabin structure remained intact, with no fire penetration. The fuselage belly sustained considerable crushing damage. The section came to rest on a magnetic heading of 240 degrees.

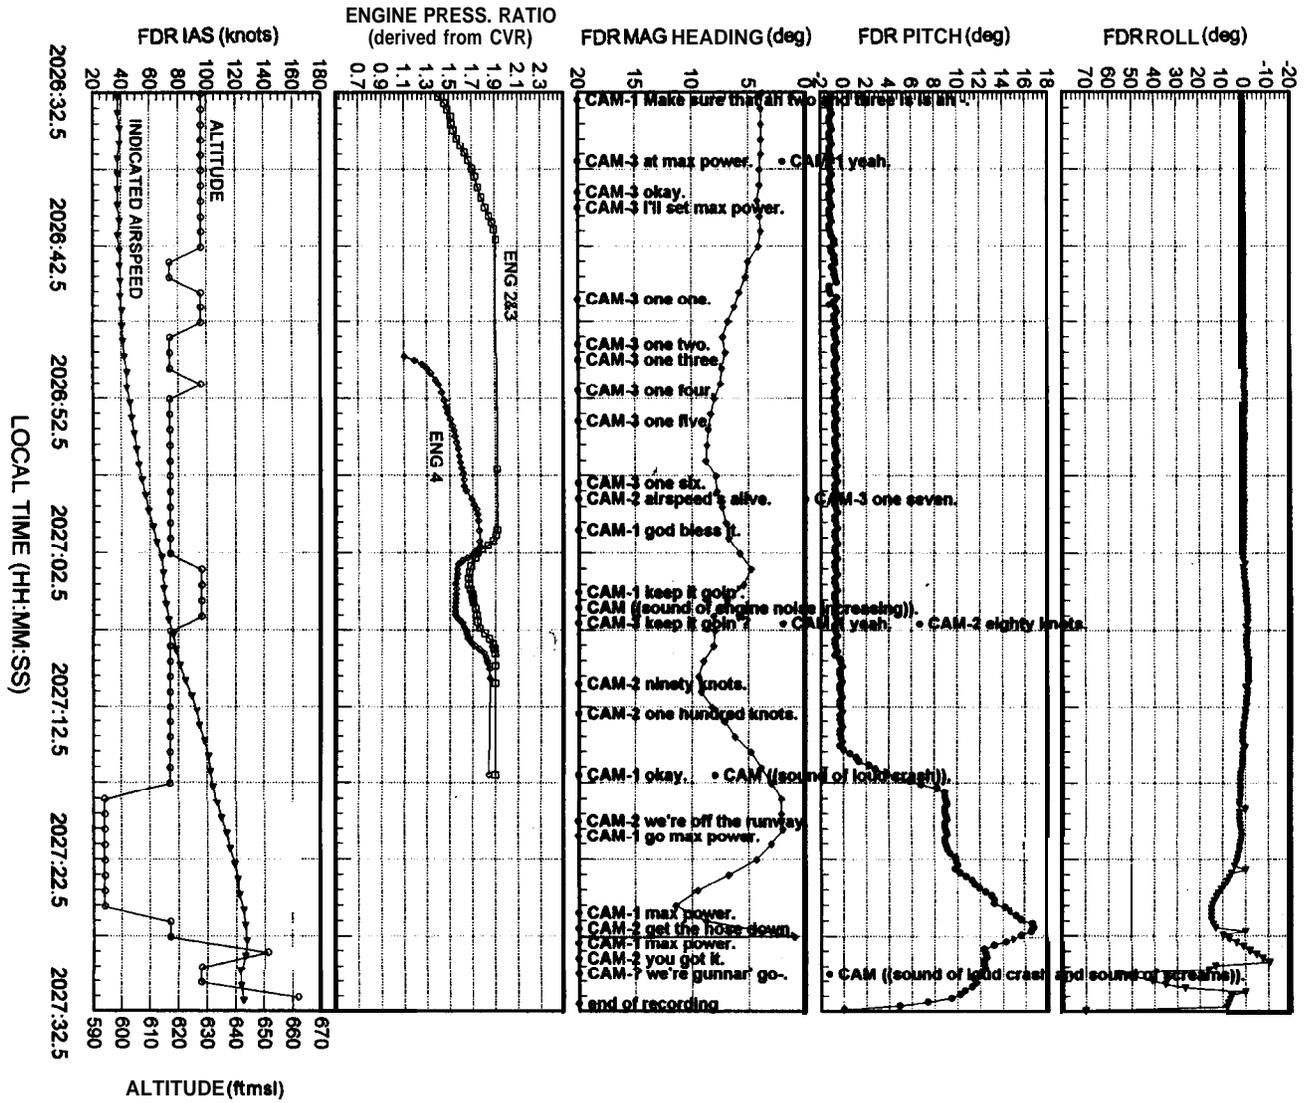
Figure 3.--FDR/CVR presentation.

The airplane was equipped with a Fairchild Model A100 cockpit voice recorder (CVR), S/N 2325, and a Sundstrand digital flight data recorder (**DFDR**), P/N **980-4100-60US**, S/N 7768. Both units were mounted in a compartment in the aft fuselage below the cargo bay floor. Both units were found separated from their mounts. Only minor dents in the outer cases were seen. There was no evidence of fire damage. DFDR information is included in figure 3, and a transcript of the CVR recording is included in Appendix B.

microphone keying. The DFDR was upgraded from five parameters to eleven parameters by Aircraft Systems and Manufacturing, Inc. Documentation of this upgrade was found to be incomplete and difficult to interpret. Documentation for elevator position was not sufficient to convert the raw values to engineering units. Engine rpm data was spurious and unusable. All engine data for this accident was derived from the CVR sound spectrum.

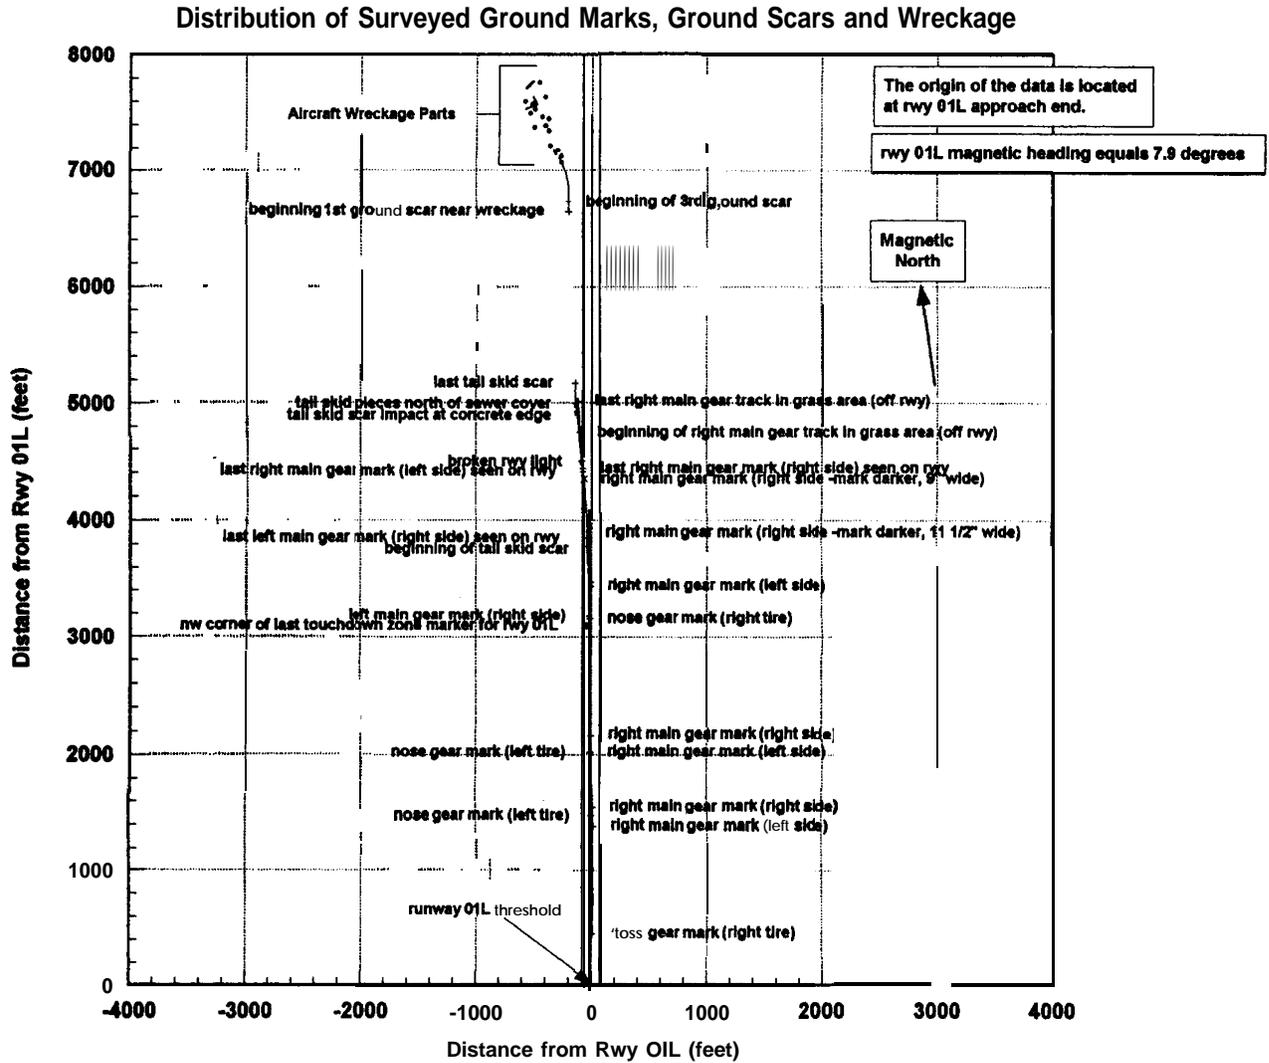
Figure 4.--Ground scars, ground marks, and wreckage.

The runway marks attributed to the airplane's second takeoff attempt were consistent with skid marks from the NLG and main landing gear (MLG) tires. Marks in the grass from the right MLG tires were also documented, as were marks on the runway and in the ground adjacent to the runway from the tail skid. The first surveyed tire mark was from the right NLG tire and was located 9 feet right of centerline and 451 feet from the threshold. The tail skid mark began 29 feet left of centerline and 3,779 feet from the threshold. Several pieces of the tail skid casting and fairing were found along the tail skid ground scar. The ground scar ended 144 feet left of centerline and 5,174 feet from the threshold. This was determined to be the takeoff point of the airplane. No additional ground scars or airplane parts were documented until the beginning of the ground scars at the main wreckage site.

Several ground impact scars, containing pieces of left wing, were observed near the main wreckage site. The first of these ground scars began 1,470 feet from the end of the tail skid scar. Fuel was spilled throughout the area of the initial ground scars, and most of the grass in this area was burned. A large trench began approximately 300 feet from the initial ground scar. The trench was generally oriented along a magnetic heading of 350 degrees, although it curved to the west slightly.

A large crater was located beyond the trench. Pieces of cockpit side window, a nose landing gear door, forward fuselage, a main cargo door latch assembly, and pieces of the No. 2 engine were found in and around the crater. A 10-foot section of the left wing tip was located near the crater. This piece had been heavily damaged by fire, and the outboard tip structure was mangled and bent. Also found just beyond the crater were a 19-foot-long piece of outboard left lower skin and most of the main cargo door. Examination of the door revealed that it was latched and locked. Pieces of red lens were found between the initial left wing

ground scars and the left wing tip.

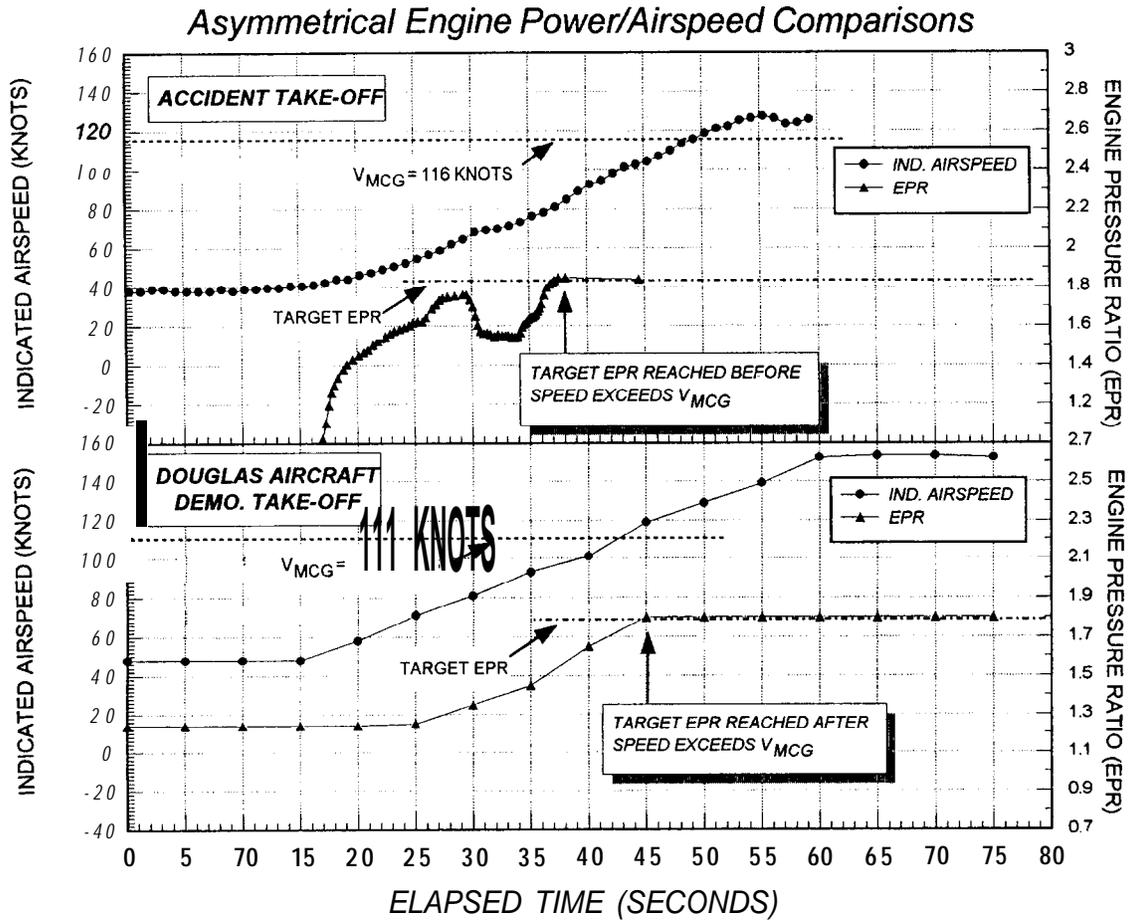
Figure 7.--No. 4 engine EPR/IAS comparison.

The high rate of asymmetric throttle application by crewmembers in both the attempted takeoffs precluded successful completion of the maneuver. However, the Safety Board believes that even with the proper application of asymmetric throttle during a three-engine takeoff, the margin of safety is quite small. The procedure now calls for arriving at full takeoff power on the asymmetric engine at the computed V_{mcg} to provide for the minimum possible takeoff roll. A properly executed three-engine takeoff also entails full rudder application at the computed V_{mcg} . Any adverse crosswind condition, for instance, would place the flightcrew in a position in which they could not have full control of the airplane due to a loss of rudder authority. In addition, it is very difficult to time the throttle application to arrive at full power at exactly the computed V_{mcg} given the spool-up lag inherent in turbine engine operation.

A flightcrew, therefore, invariably reaches full asymmetric power early, and accepts a certain loss of directional control, or reaches full asymmetric power late, and accepts a longer takeoff roll. The Safety Board considers the latter to be the safer course of action, and believes that manufacturers should revise one-engine inoperative takeoff procedures to provide adequate rudder availability for correcting directional deviations during the takeoff roll compatible with the achievement of maximum asymmetric thrust at an appropriate speed greater than ground minimum control speed. Performance figures and runway requirements considering these factors should also be determined.
