Cabin Fire during Cruise

Aircraft	Boeing 777-228ER registered F-GSPK
Date and time	8 December 2010 at 6 h 10 ⁽¹⁾
Operator	Air France
Place	In cruise above the Atlantic Ocean, at FL 380
Type of flight	Scheduled international public transport of passengers
Persons on board	Captain (PF); Copilot (PNF); 219 passengers
Consequences and damage	Passenger seat damaged

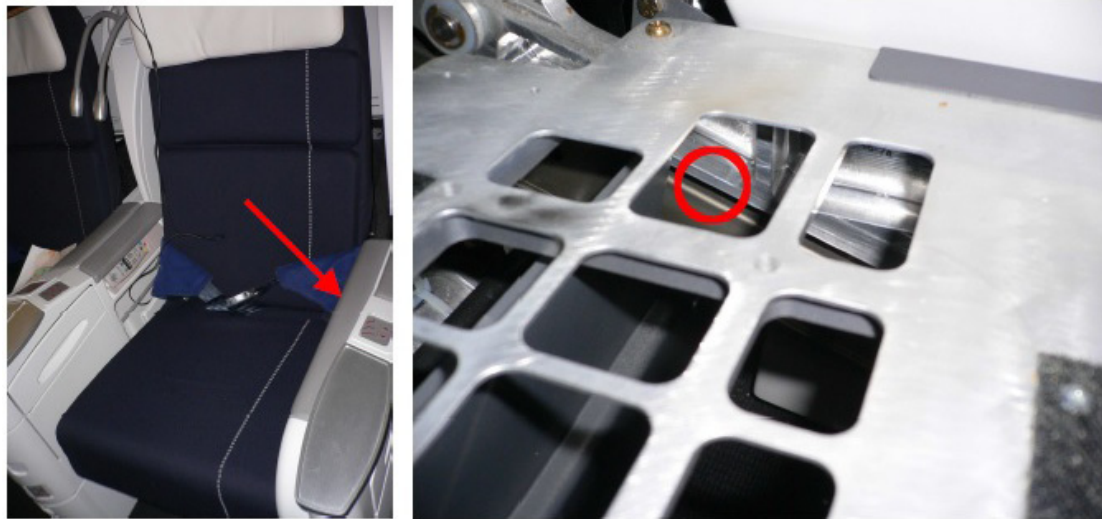
On the ground, during dismantling of the seat, a spare external battery from a passenger's electronic device was found severely damaged in the structure of the seat. It showed traces of fire. This Lithium-Polymer-type (Li-Po) battery has a capacity of 1 Ah and delivers 5 V and 500 mA. It is intended to extend the capacity of electronic equipment such as mobile phones, tablets, audio equipment etc.

The battery was crushed in the slide identified on the photo below. It is possible that it slipped under the seat covering, behind the armrest or down the side of the seat.

Seat identical to that in the incident

An X-ray examination showed that the active elements in the battery had disappeared and the electronic control circuits had been destroyed. The crushing of the battery in the seat mechanism likely caused a short-circuit, leading to an increase in the internal temperature. The exposure of the lithium electrodes to the air caused a fire, and oxygen contributed to the combustion.
