Bureau Enquêtes-Accidents

R E P O R T

*on the accident on 12 November 1999
North of Pristina (Kosovo)
to the ATR 42-300 registered F-OHFV
operated by SI FLY*

F-FV99112A

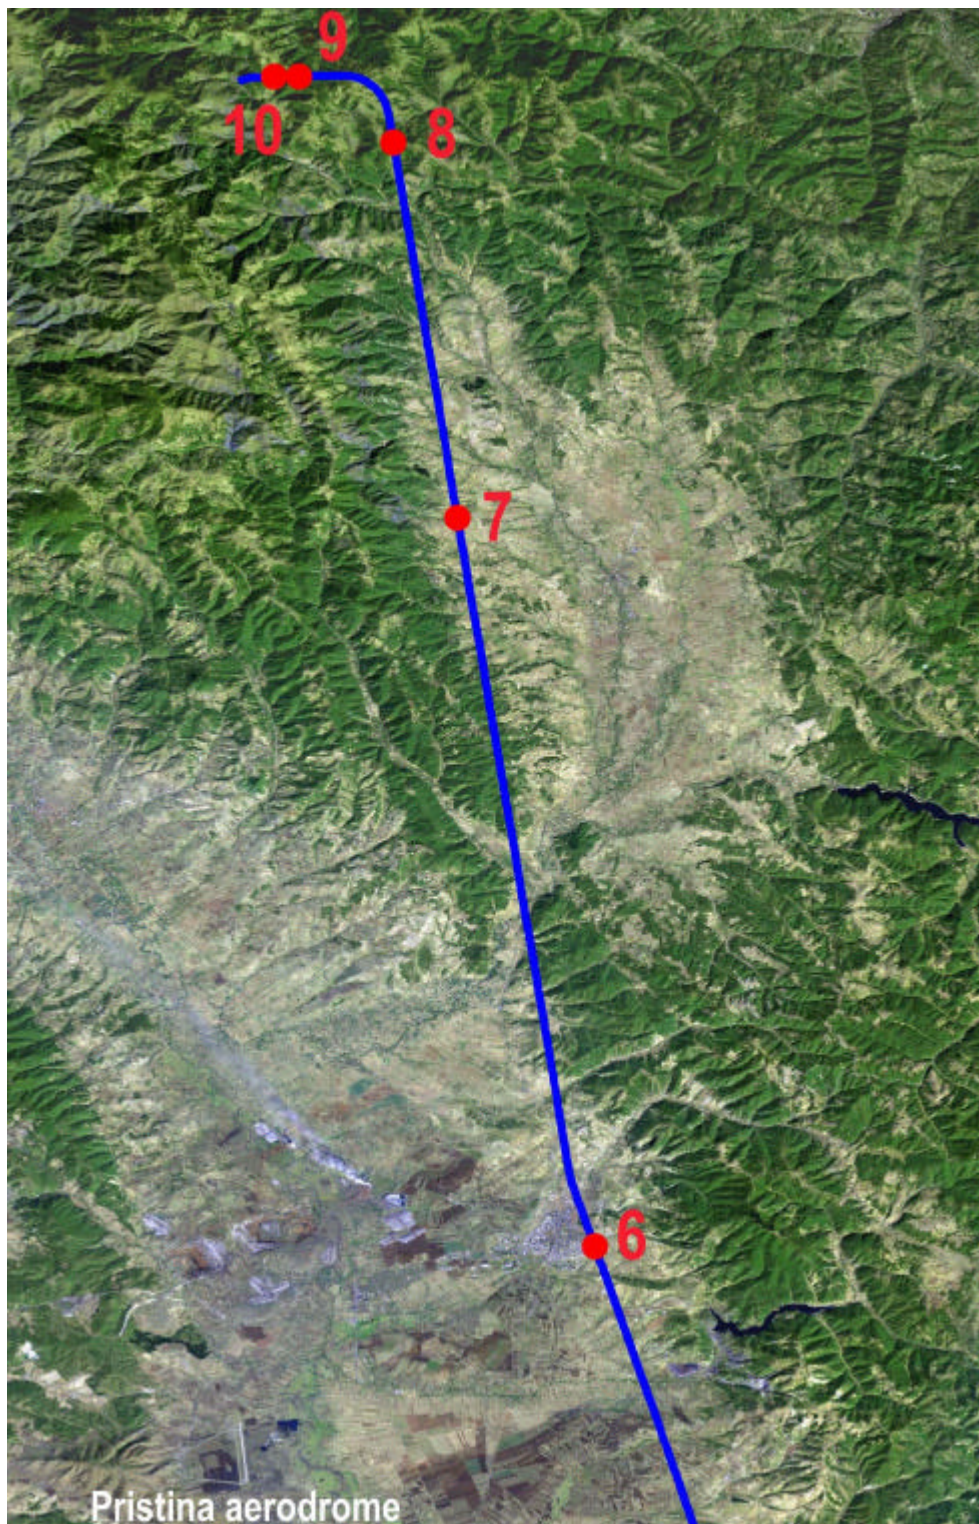
Figure 10 : Track of KSV 3275

At the time of the accident, a French Air Force AWACS was on a mission in the region. Information relevant to the tracks of KSV 3275 and HCN 993 was provided to the investigators. It showed an approximate speed of 250 kt for KSV 3275 and of 400 kt for HCN 993. It allowed them to validate the track calculated from the parameters recorded on the aircraft's Flight Data Recorder (see 1.11.3) and to determine the relative position of the two aircraft at the moment when HCV 993 became number one for landing (see § 2.2).

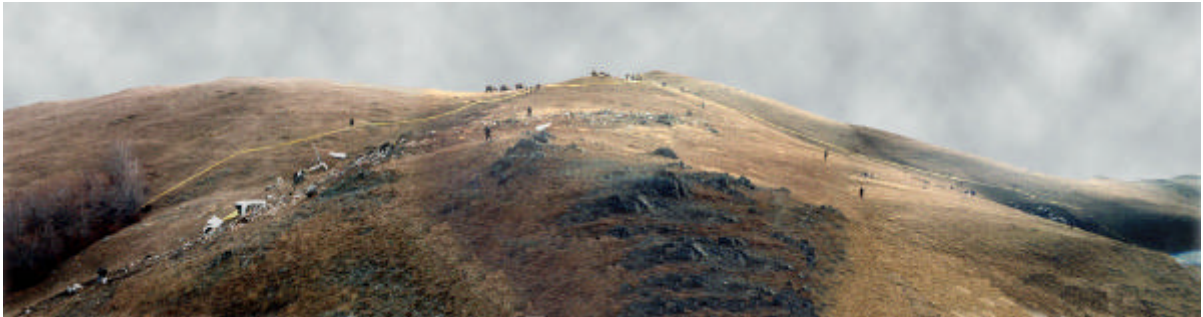
Figure 11 : View of accident site

The accident site is situated 25 NM north of Pristina Aerodrome (10 NM NE of Mitrovica) at an altitude of 4,600 feet. The first impact occurred 15 metres from the top of a ridge, in a rocky mid-mountain area. The peaks in this area vary between 3,380 and 5,800 feet.

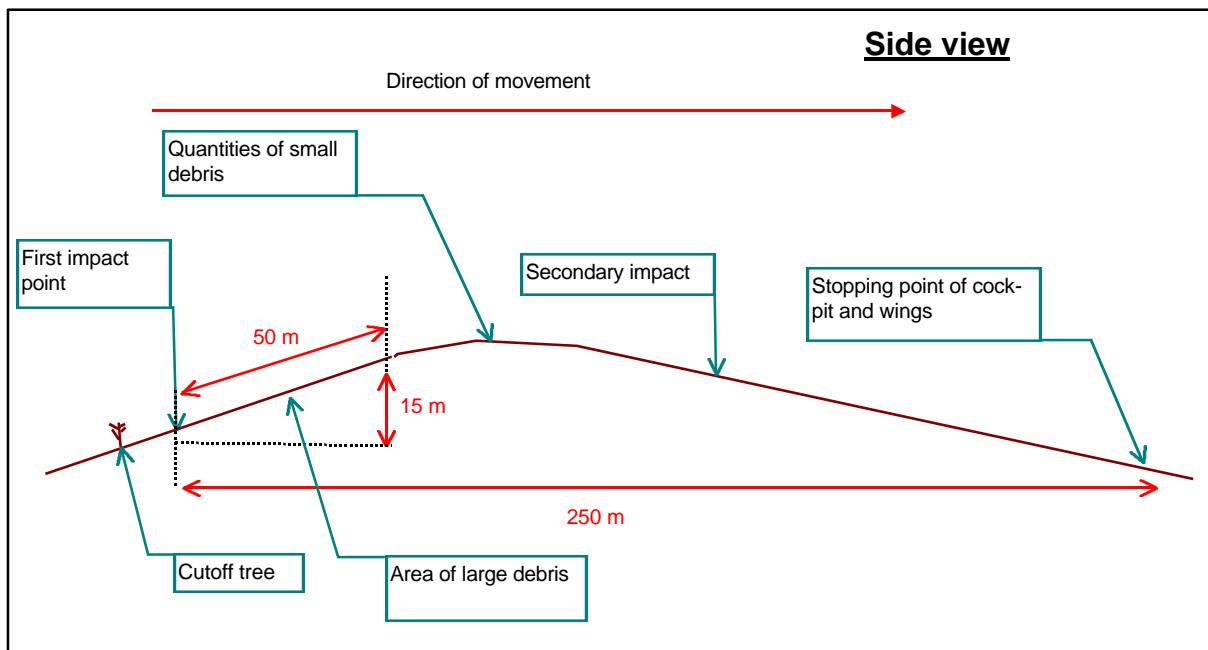
Figure 12 : Side view of site

Twenty-five metres before the impact point, the top of a seven-metre-tall tree had been chopped off on the right side of the track. Then the point of impact of the engine and left propeller slashes were found.

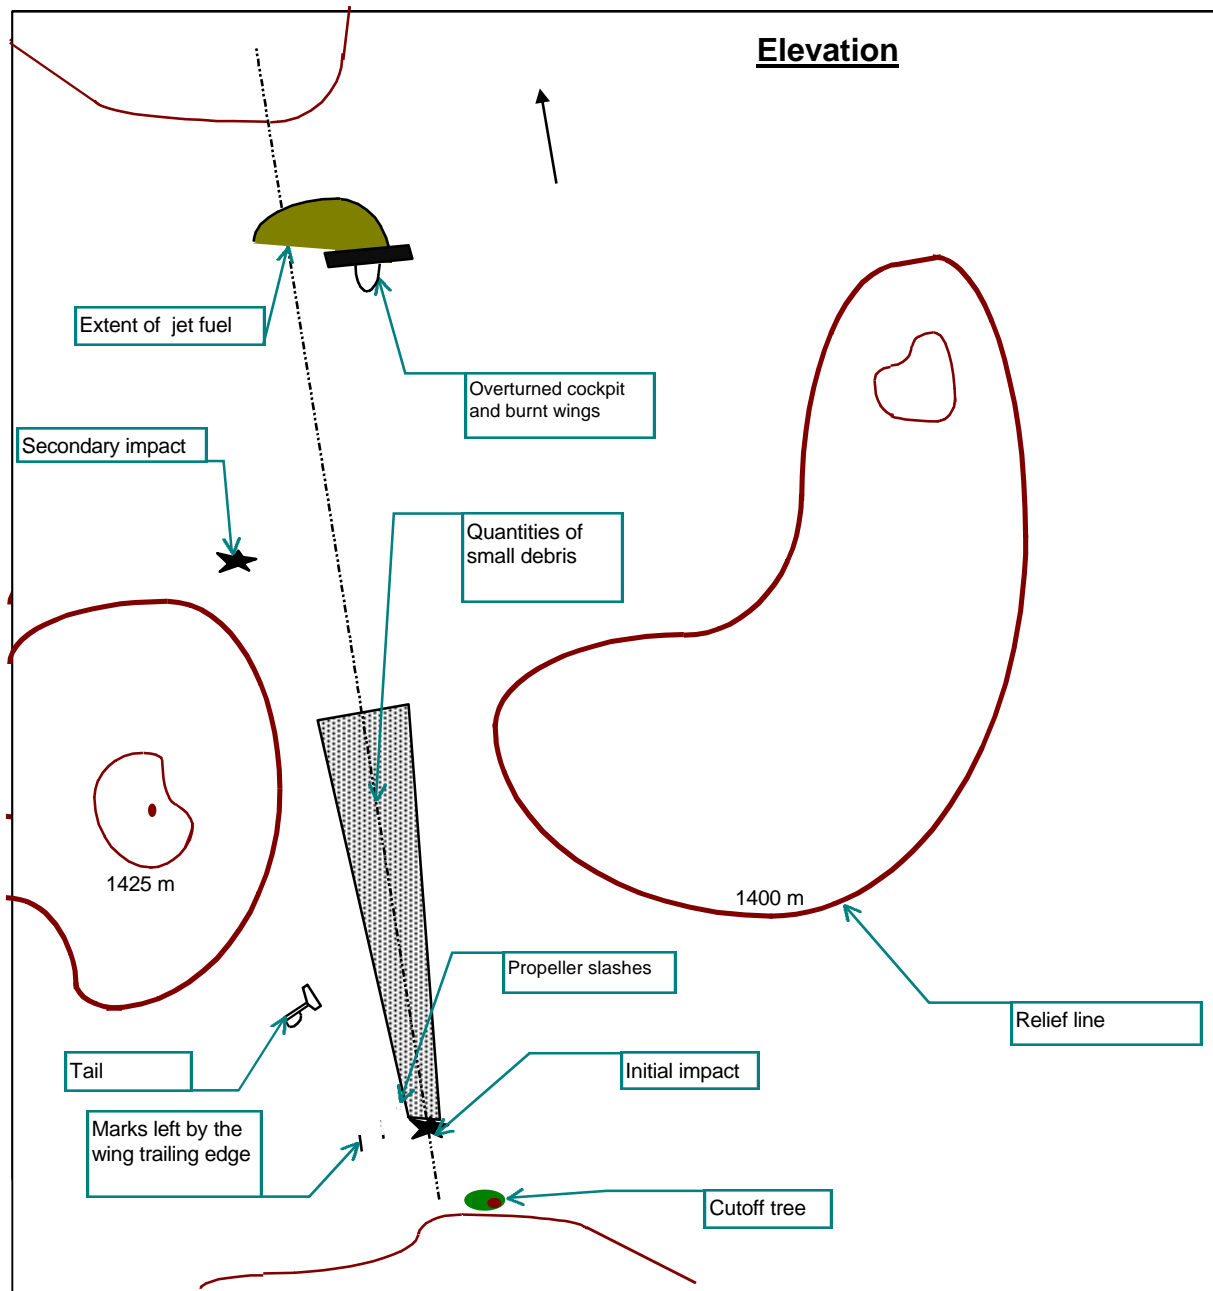
Figure 13 : Accident site seen from above

The fuselage impact point was a little further, about fifty metres from the top of the ridge. The tail, from which half of the left stabiliser was detached, was found on the left.

The debris was then spread about over a length of about 250 m on a line at 250°, on either side of a pass. The lower part of the fuselage had disintegrated on the rocks on a slope rising at 30 %. On the other side of the ridge, the two main landing gears were found in relatively good condition, along with two items of electrical equipment (the GPS and an ADC) and the right engine.
