AIFN/0008/2014

Smoke Emission from Passenger Entertainment System Video Display Unit

Operator: Flydubai
Type: Boeing 737-800
Registration: A6-FEK
Location: Enroute Dubai to Kiev
Date of Occurrence: 19 April 2014

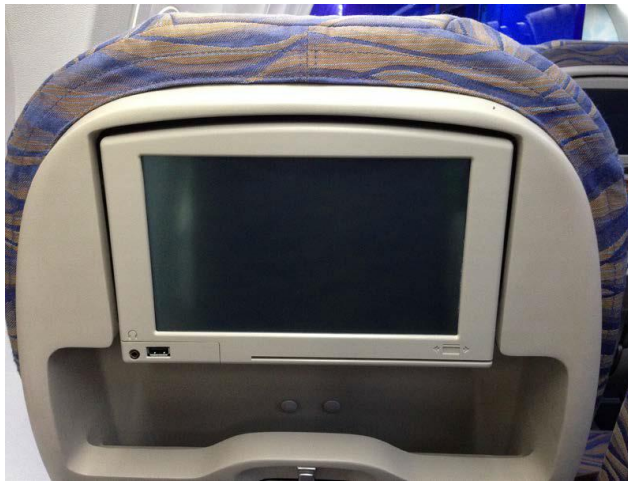
Figure 4. Seat 9A VDU prior to removal

The affected VDU was shipped to the manufacturer for forensic laboratory examination. According to the examination report, there were no external visible signs of smoke, fire, or other noticeable damage to the VDU. Internal damage was limited to the power transformer circuit board components and the area of the fuse that had overheated and emitted smoke and odors momentarily until power to the IFE system was shut off.

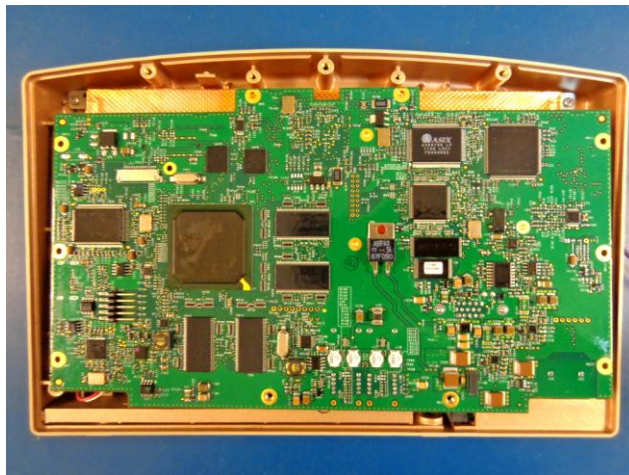
Figure 6. VDU Main CCA – bottom side

The teardown examination found that the component that had failed was the backlight inverter circuit card assembly (CCA) which provides operating power to the cold-cathode fluorescent (CCFL) backlight of the LCD display. The inverter card assembly is mounted on the main circuit card assembly as a daughter card. Its purpose is to output an alternating current (AC) high-voltage signal to power the CCFL backlight tube.

Stage 1: failure of the secondary winding of the power supply transformer, which developed a break leading to increased current demand and failure of the primary side transistor components causing a low impedance path to circuit ground through the input fuse.

Stage 2: the resultant increased input current was not enough to blow the fuse open quickly, but caused the fuse itself to heat up and smolder in that area of the printed circuit board (PCB) until it eventually opened fully.

Where feasible, and whenever the VDU is removed from the aircraft for any reason; the VDU to be shipped to the manufacturer for replacement of the fiberglass substrate material fuse by a ceramic body, suspended-in-air filament fuse.
