**FINAL REPORT ON
MA-60, XY-AIQ, RUNWAY EXCURSION
ACCIDENT MONGHSAT AIRPORT (VYMS)
ON 16 MAY 2013**

Executive Summary

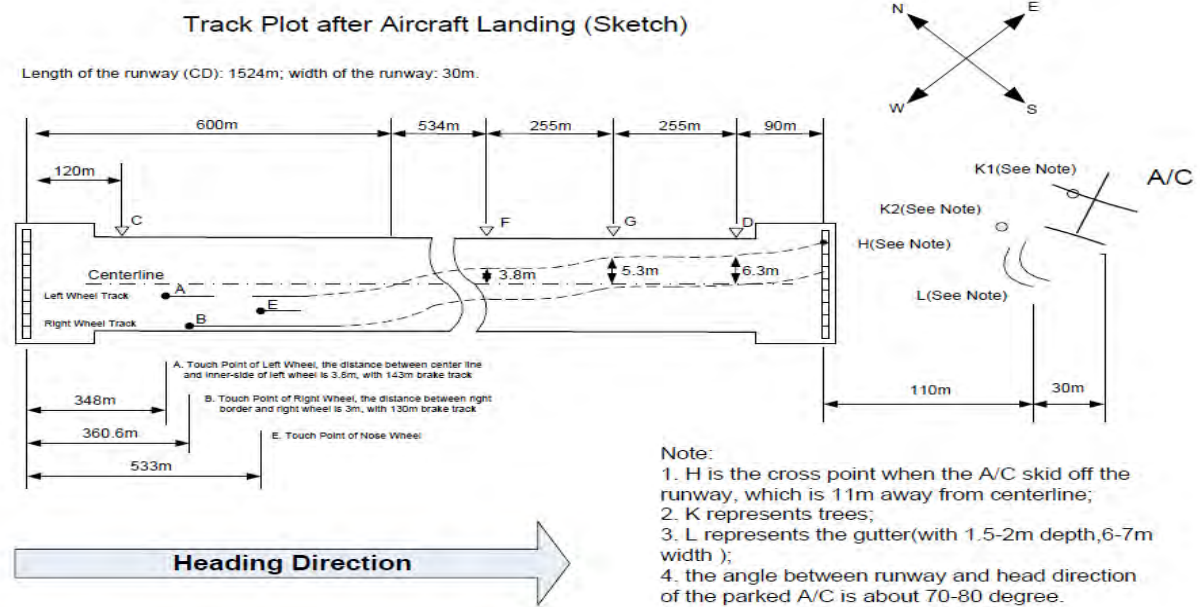
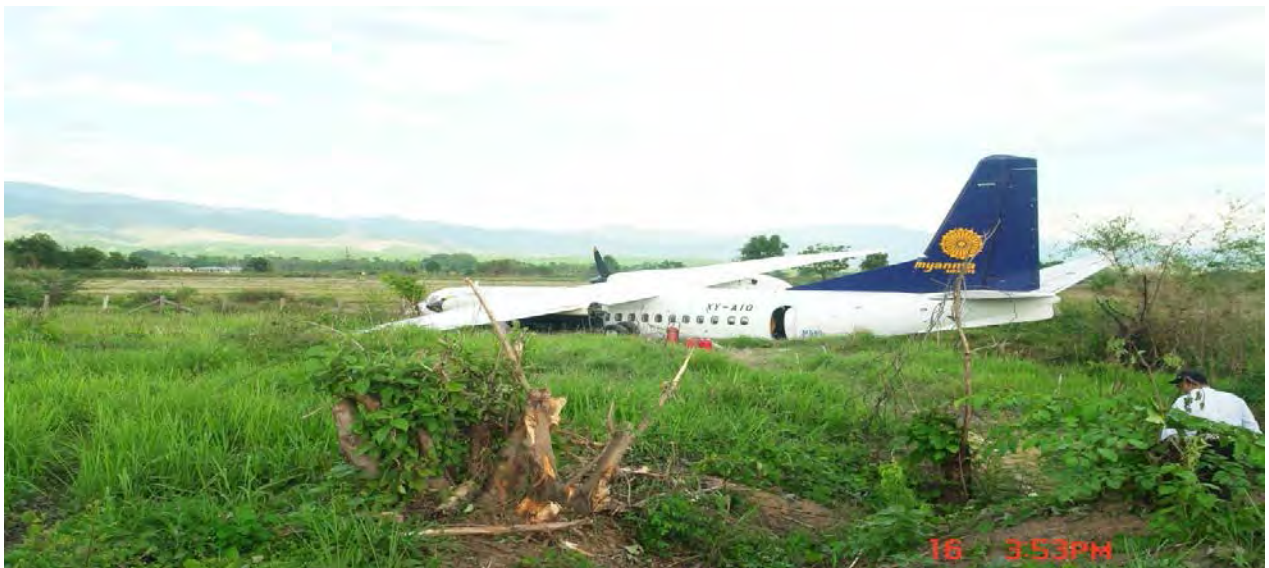
Figure (3). Accident site,

At about 11:47:59 local time, aircraft first touchdown to runway 12 with IAS 114 knots, vertical speed -288, flap 30 degree. During landing roll, aircraft over run to runway 30. At about (11:48:33) local time, aircraft struck to tree stump with IAS 40 knots and passing across to water drainage (gutter) located 110 meters from runway 30. After striking, aircraft turned to left 80 degree and came to rest. Cabin crews performed emergency evacuation, one passenger suffered serious injury, other one suffered minor injury and 53 of the occupants were survived.

The accident site was located in a over run area about 140 meters from the threshold of runway 30 at an elevation of 1895 ft. The initial strike with trees stump with left propellers, left landing gear and nose gear; then aircraft passing a water drainage (gutter). After aircraft struck the trees stump, left main landing gear and nose gear folding struts broken and then aircraft turning left and came to rest. Left wing tip was broken, lower fuselage was dent.

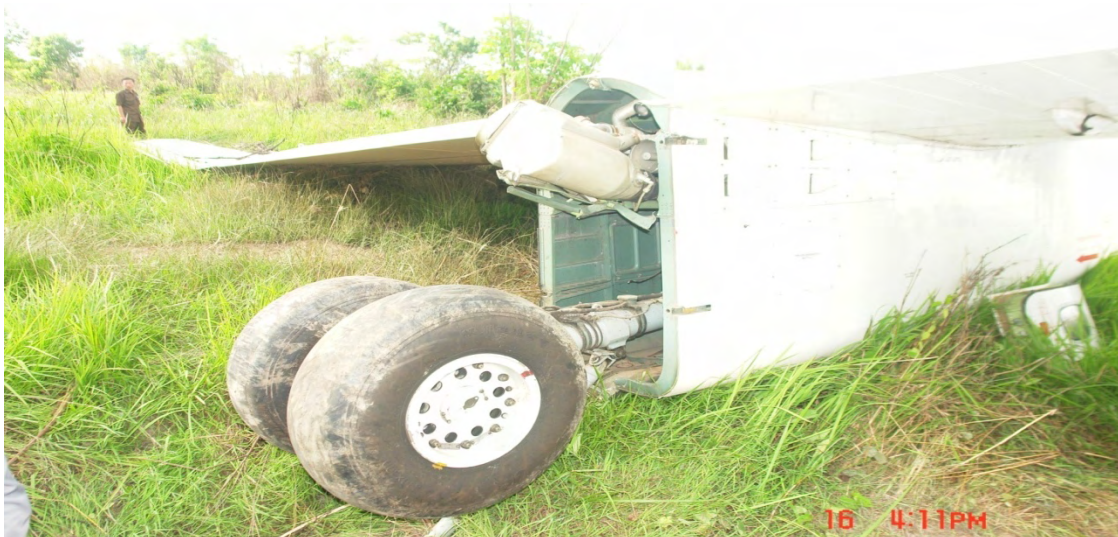
Figure (4). Damage to Aircraft

The left main leading gear and nose landing gear strut broken, left engine propeller blades broken, left wing tip broken and lower fuselage frame dents. Aircraft was substantial damage.

- Left wing tip was broken.
- Left landing gear collapsed backward and nose gear forward. .
- Flap position was fully up and selector S/W retract position.
- Left emergency door and passenger door were opened. The cargo door and right emergency exit were not deployed due to right engine propellers rotating.
- Lower fuselage skin was dent and antennas were broken.
- Left propeller blades were broken.

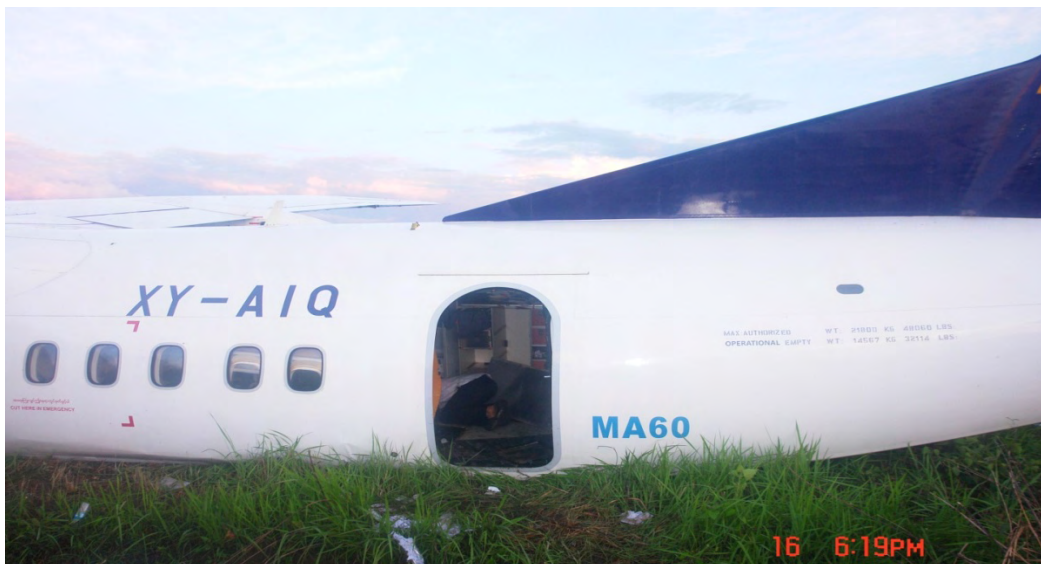
Figure (10). Survival aspect

The cabin crew initiated an emergency evacuation as soon as the aircraft came to rest. The MA-60 aircraft has 5 exits and 1 front cargo door. Passenger entry door left and right passenger cabin emergency exits, cockpit emergency exit hatch, rear cargo compartment door and front cargo compartment door and passenger entry door. The entry door and left passenger cabin emergency exit opened. The right side passenger emergency exit and front cargo exits remained closed due to the damage of right propeller rotating. One passenger serious injury, one passenger minor injury and other were survived.
