**AVIATION INVESTIGATION REPORT
A13W0120**

**ENGINE FAILURE AFTER TAKEOFF AND
COLLISION WITH TERRAIN**

**BUFFALO AIRWAYS LTD.
DOUGLAS DC-3C, C-GWIR
YELLOWKNIFE AIRPORT, NORTHWEST TERRITORIES
19 AUGUST 2013**

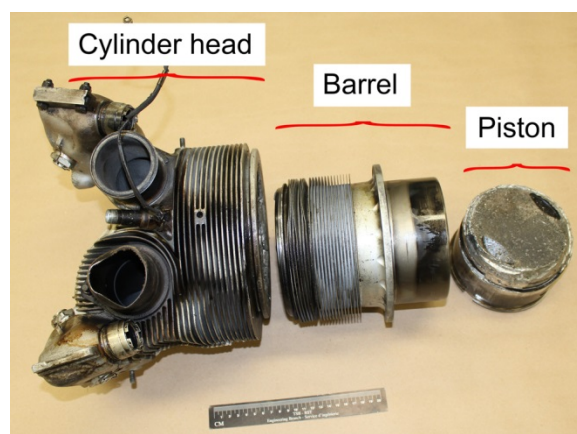
Photo 1. Failed cylinder assembly from C-GWIR

C-GWIR right engine cylinder number 1 head and barrel were found separated due to a fracture of the barrel at the threaded joint with the head assembly (Photo 1). The cylinder head, barrel and piston were forwarded to the TSB laboratory for examination. A pre-existing fatigue crack was discovered in a thread groove on the outer mating surface of the barrel assembly. The cause of the fatigue crack could not be determined due to post-separation damage in the area of the point of origin.

The right engine number 1 cylinder failed as a result of a pre-existing fatigue crack located in a thread groove on the outer mating surface of the barrel assembly. The resulting separation of the head assembly and induction pipe would have allowed supercharged air/fuel mixture and engine oil to be discharged into the engine compartment where spark ignition of the failed cylinder or hot exhaust pipes in the immediate area caused the engine fire.

The location of the fatigue crack point of origin on the failed cylinder was not readily accessible for any direct inspection prior to the occurrence. The fatigue crack had not progressed through the barrel wall, and disassembly of the cylinder would have been required to inspect the inner surface. Cylinder differential pressure checks would also not have detected this crack as the surrounding cylinder head would have prevented the crack from opening. Fatigue is the mode of failure not the reason for failure. Due to post-separation surface damage of the fatigue crack point of origin, the cause could not be determined.

2. The right engine number 1 cylinder failed during the take-off sequence due to a pre-existing fatigue crack, resulting in an engine fire.
3. After the right propeller's feathering mechanism was activated, the propeller never achieved a fully feathered condition likely due to a seized bearing in the feathering pump.

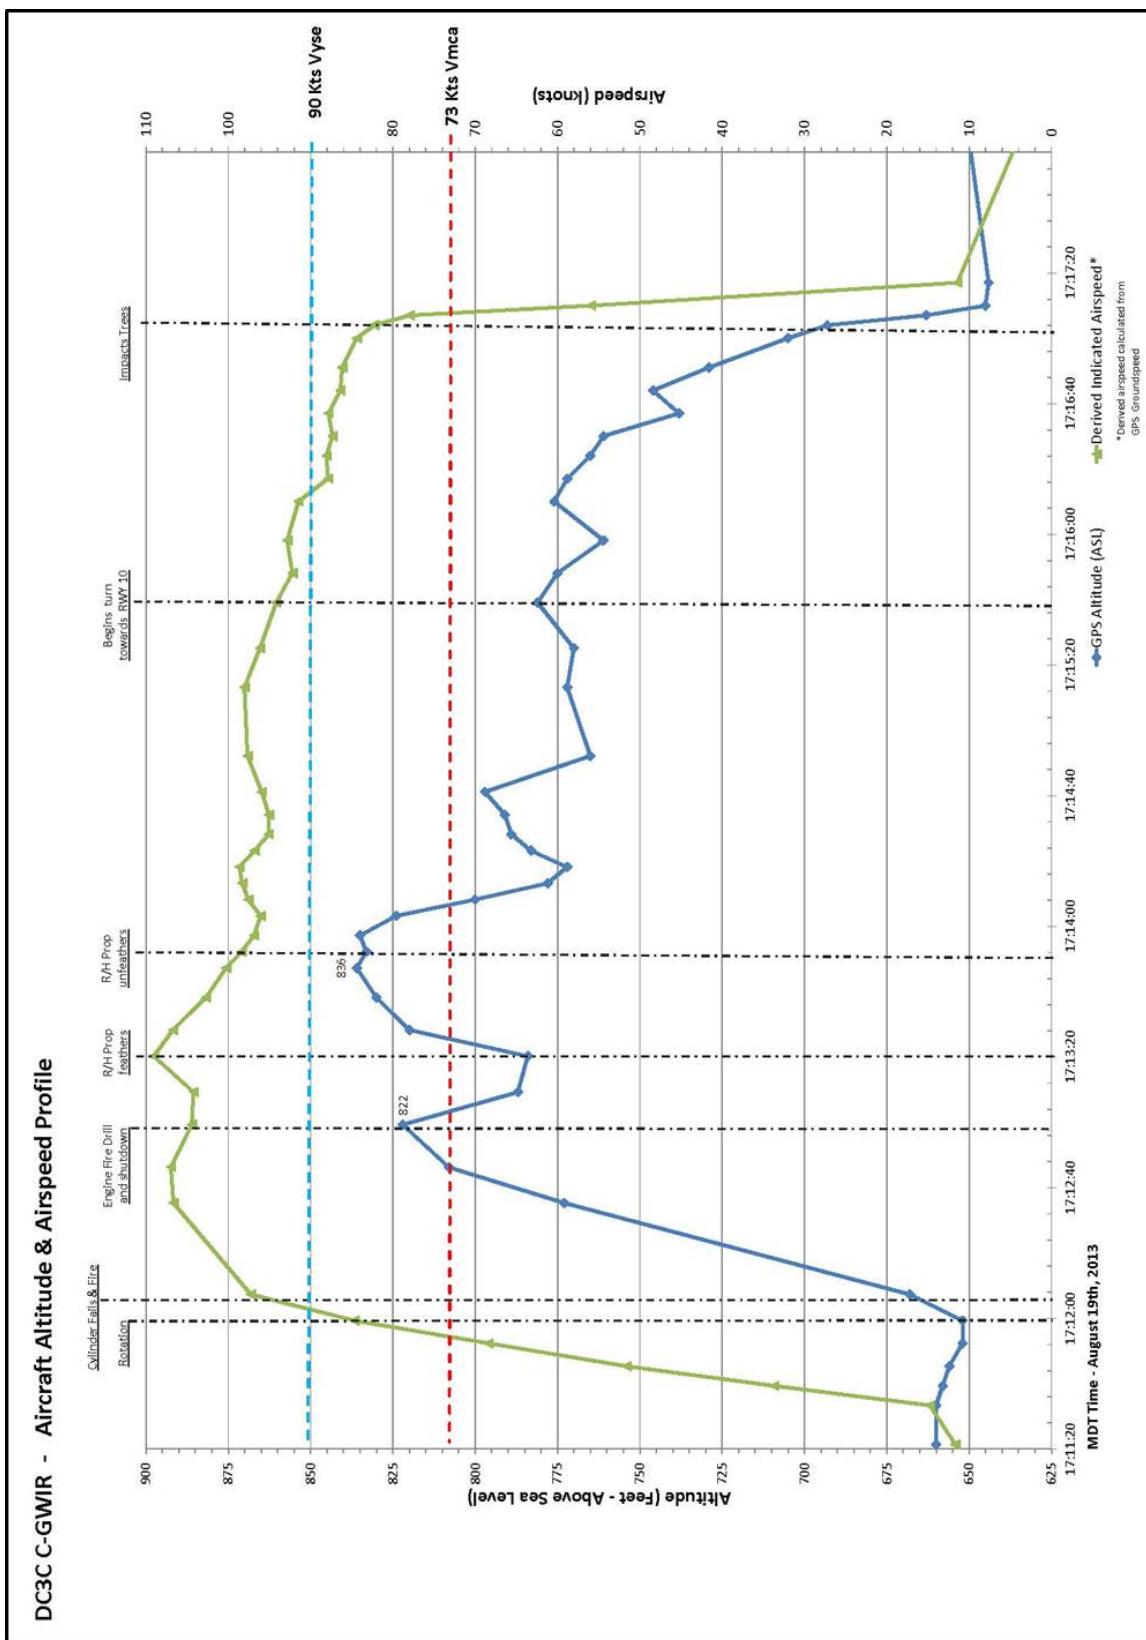
Appendix C - Derived indicated airspeed vs altitude

It should be noted that the performance figures in Table 1 are predicated on the most adverse engine inoperative condition. Failure of the left (i.e., critical) engine will produce the more pronounced yaw/roll condition, which would require greater flight control inputs to counteract these forces. As a result of these control inputs, the aircraft will be exposed to greater drag, which will in turn negatively affect the aircraft's performance. Conversely, failure of the non-critical engine may not result in as great a decrease in performance, but a loss in climb performance will still be experienced. Appendix C illustrates the relationship

between airspeed and altitude on the occurrence flight after the the failure of the right engine and subsequent unfeathering of the right propeller.
