Unstabilised approach, triggering of GPWS and MSAW warnings, dual input, missed approach, at night under instruction

Aircraft	Airbus A320 registered SX-BHV
Date and time	April 11 2012 at around 00 h 24 ⁽¹⁾
Operator	Hermes Airlines
Place	On approach to runway 36L at Lyons Saint-Exupéry airport (69)
Type of flight	Non-scheduled public transport of passengers
Persons on board	Student pilot-in-command (PF), instructor (PNF); 5 cabin crew members; 178 passengers
Consequences and damage	None

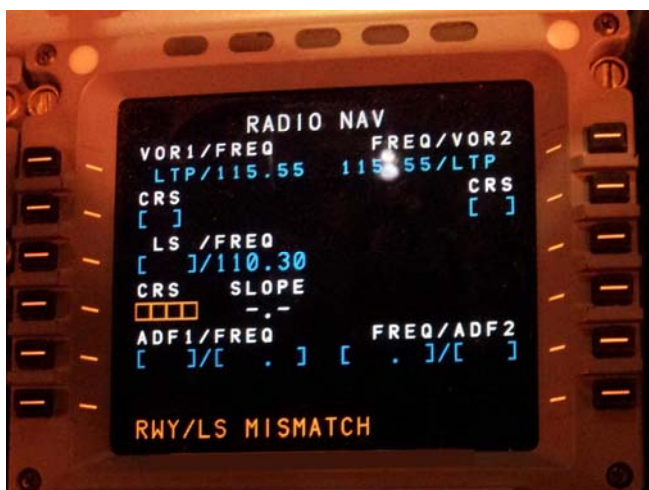
Where there is a difference between the frequency of the ILS approach FMGS entered manually and the RADIO NAV page, the post RWY / LS MISMATCH is displayed at the bottom of the MCDU screen (see example below).

In this example, the font size of the frequency automatically entered by the FMGS (e.g. VOR1 and 2) is by default smaller than that manually entered (e.g. ILS).
