# **Air Accident Investigation Unit Ireland**

**FORMAL REPORT**

**Avions de Transport Regional 72-212,**

**EI-SLM**

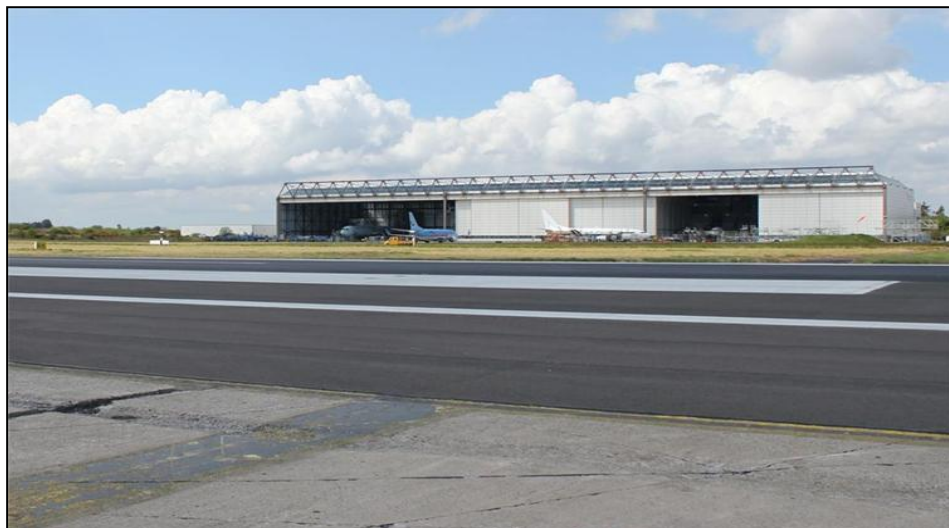
**Photo No. 1: Hangar from opposite the TDZ aiming point**

A secondary runway (RWY 13/31), originally constructed in 1945/46, was withdrawn from service, due to its surface condition not being in conformity with ICAO recommendations regarding longitudinal slope changes and smoothness of surface. The Investigation was informed by the airport operator that a maximum weight restriction of 25 tonnes for landing or take-off movements had been imposed and the runway was last used in 2001 for landing and take-off. RWY 13/31 was declassified as a runway on the 26 July 2012; it is currently used as a taxiway. A single isolated Hangar (**Photo & Graphic No. 1**) is located 450 m to the northwest of the TDZ aiming point on RWY 24. The Hangar is 240 m long, 92 m wide and 24.6 m high.

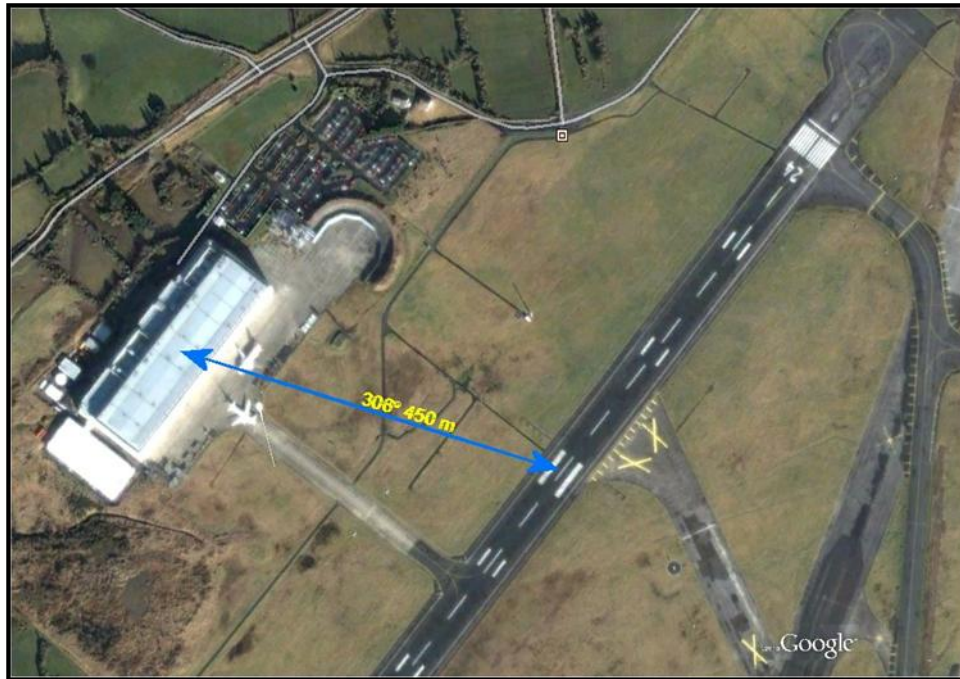
**Graphic No. 1: Hangar relative to the TDZ RWY 24**

The Investigation therefore concludes that, depending on the prevailing atmospheric conditions at the time (wind velocity, turbulence, turbidity and instability), the wake effect can locally augment turbulence at the TDZ of RWY 24. The continued reports of turbulence recorded by pilots over the years lend validity to the assumption that the wake effect of the Hangar has a local effect at the TDZ of RWY 24 in strong winds between west and northwest and therefore the turbulence caution is considered warranted.

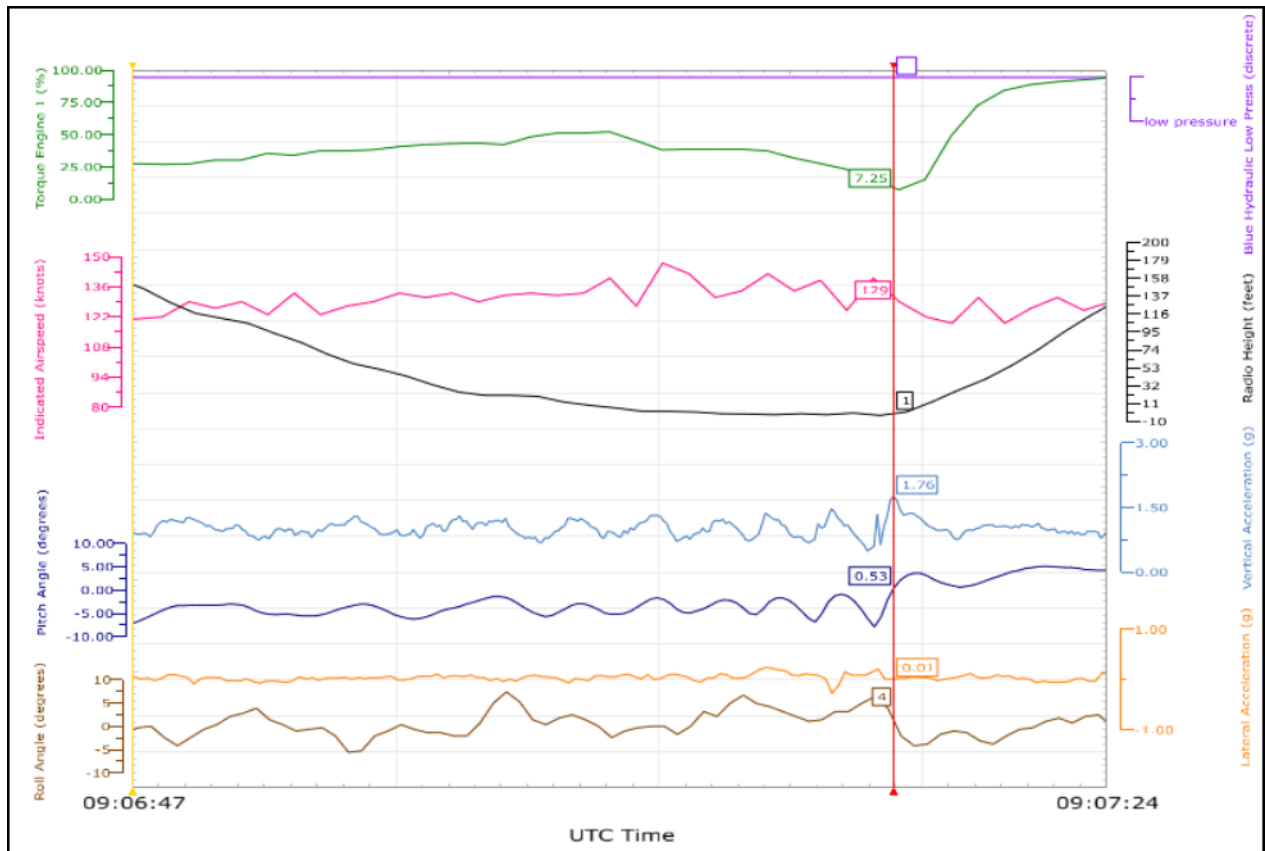
Graphic No. 2: DFDR Recording of First Approach

The DFDR recorded, inter alia, pitch and roll angles and both vertical and longitudinal accelerations. The DFDR data showed that both approaches were flown in turbulent conditions with indicated airspeed (IAS) fluctuations of 10 kts and roll variations of up to 10°. The left drift angle recorded during both approaches was approximately 15° at 1,000 ft Radio Altimeter (RADALT), decreasing to 11-12° at 20 ft.

The DFDR recorded that, at a height of -3 ft following two bounces at 2 second intervals, an elevator input of -5.4° caused a nose-down pitch angle of -7.9° resulting in a 1.34 g-spike in vertical acceleration. The pitch of the aircraft then rose immediately to +0.5° in 0.7 of a second, at which point, a second g-spike of 1.76 g occurred. The DFDR Weight on Wheels (WOW) discrete, which samples once per second did not record main gear ground contact.

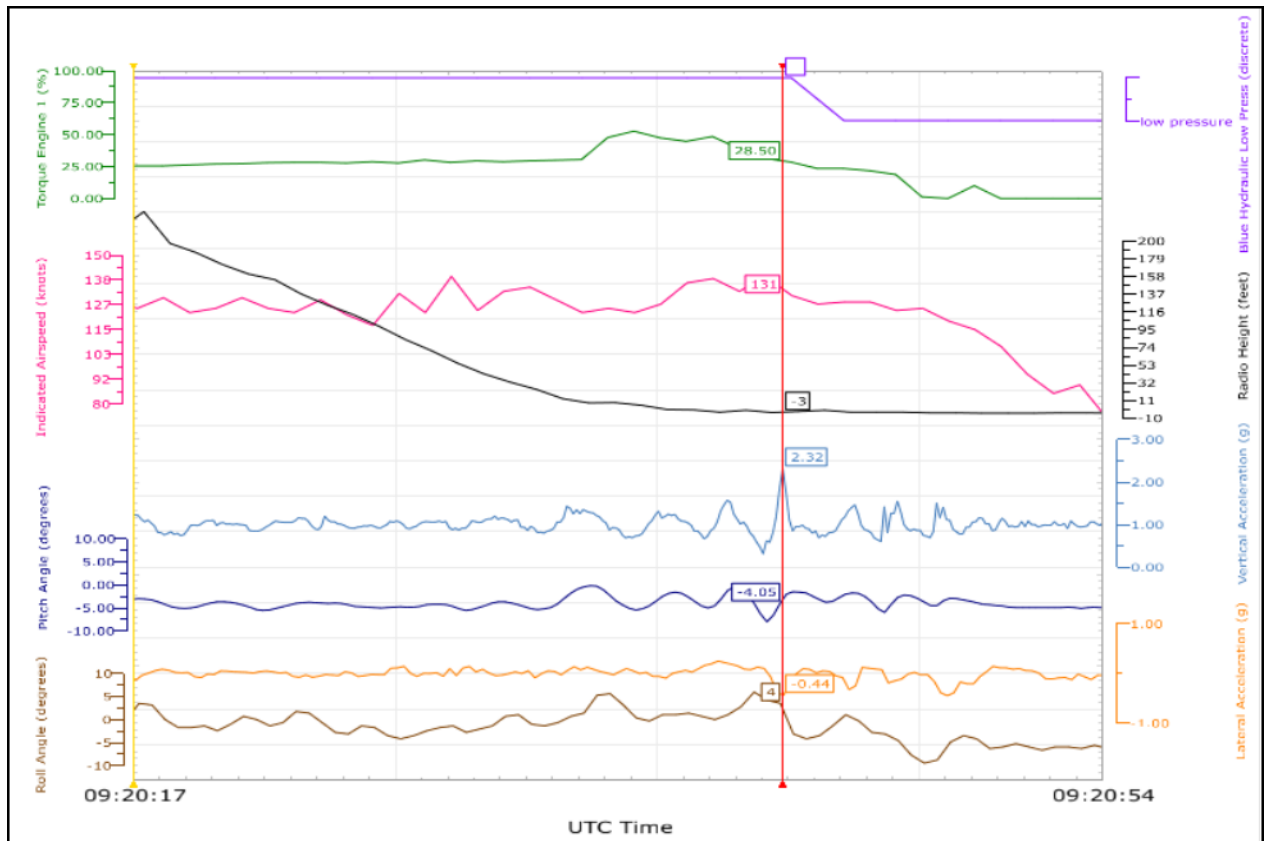
**Graphic No. 3: DFDR Recording of Second Approach**

The DFDR recorded similar turbulent conditions during the second approach. The recording showed that the approach was commenced with the autopilot engaged and that 30° of flap was selected at 1,330 ft at an IAS of 140 kts. The autopilot was disconnected at 660 ft and, from that height to 100 ft, the IAS was generally 126 to 130 kts with engine torque at 27%. At 100 ft the IAS increased from 117 kts to 140 kts (**Graphic No. 3**). Shortly afterwards, at 8 ft, the IAS was recorded as having decreased to 123 kts and torque increased slightly to 30%. Pitch then increased to -1.5° as the aircraft flared and, at -2.8 ft, the pitch oscillated through three cycles by 3° to 4° with engine torque increasing to 48%.

The DFDR then recorded that, at a height of -3 ft, an elevator application of -10.4° caused a nose-down pitch angle of -8.0°, the airspeed at the time being 131 kts. A 2.32 g-spike in vertical acceleration followed immediately. Blue system hydraulic failure was recorded almost immediately. The DFDR subsequently recorded 3 further positive g peaks before the main gear WOW discrete indicated that main wheels of the aircraft were on the ground.

Then, nose down inputs were recorded on the right control column during both approaches. This led to an excessive nose down pitch attitude with a subsequent impact on the nose landing gear. Neither pilot recalled such inputs subsequently.

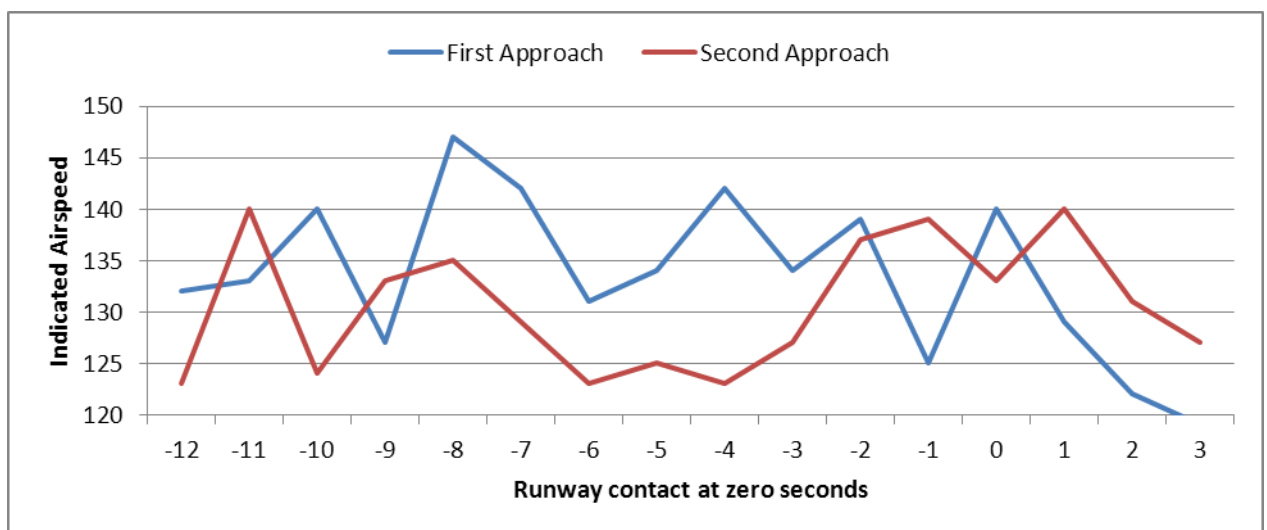
**Graphic No. 4: Indicated airspeeds**

**Graphic No. 4** compares the indicated airspeeds during the final seconds of both approaches.

Nonetheless, the typical IAS flown during both approaches was 20 to 25 kts above that. Although both flares correctly commenced at 20 ft RADALT, the IAS recorded on both occasions were excessive at touchdown, momentarily reaching 139 and 140 kts respectively. This was partly due to the PF increasing torque after flaring and partly due to the prevailing gusty conditions.

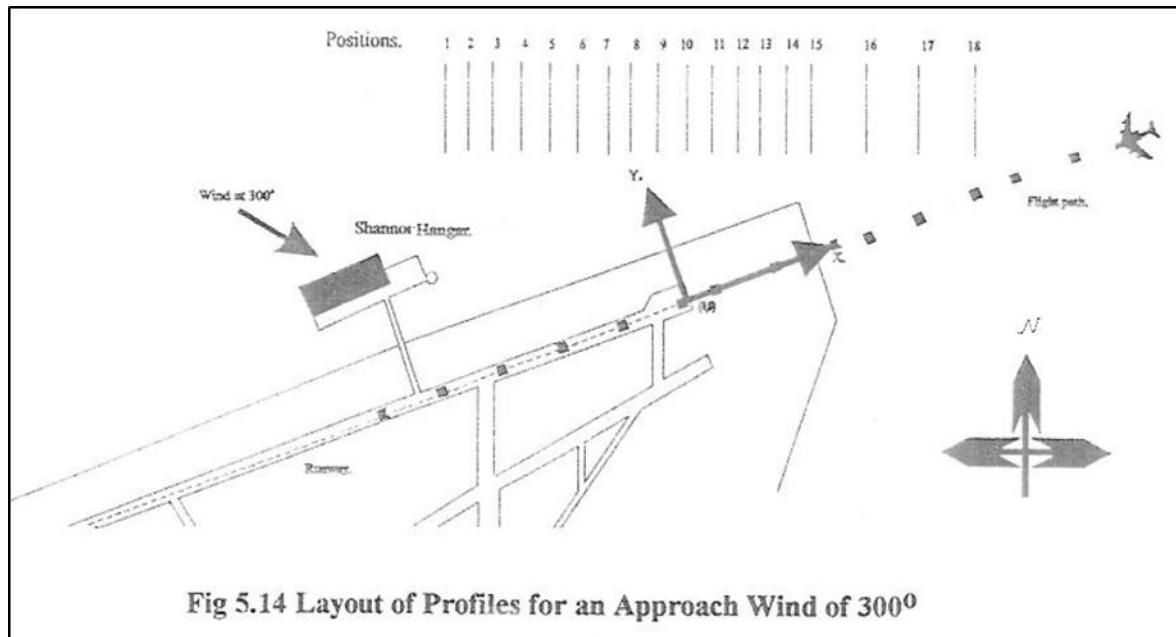
Graphic No. 5: EINN Hanger induced wake turbulence

*In each case it was found that the extent of the wake effect of a single building does not extend beyond 15 to 20 building heights downwind from the building. In this case, this is equivalent to between 370 m to 490 m downwind from the hanger. The service hanger is approximately 340 m from the neighbouring runway. Hence, there are slight wind velocity deficits and turbulence intensity changes along the runway close to the hanger when the approach wind is blowing almost normal to the rear face of the hanger".*
