Status Report

Type of Occurrence:	Serious incident
Date:	3 November 2011
Location:	Munich
Aircraft:	Transport aircraft
Manufacturer / Model:	Boeing / B 777-300 ER
Injuries to Persons:	None
Damage:	No damage to aircraft
Other Damage:	Crop damage
Information Source:	Investigation by BFU
State File Number:	BFU EX010-11

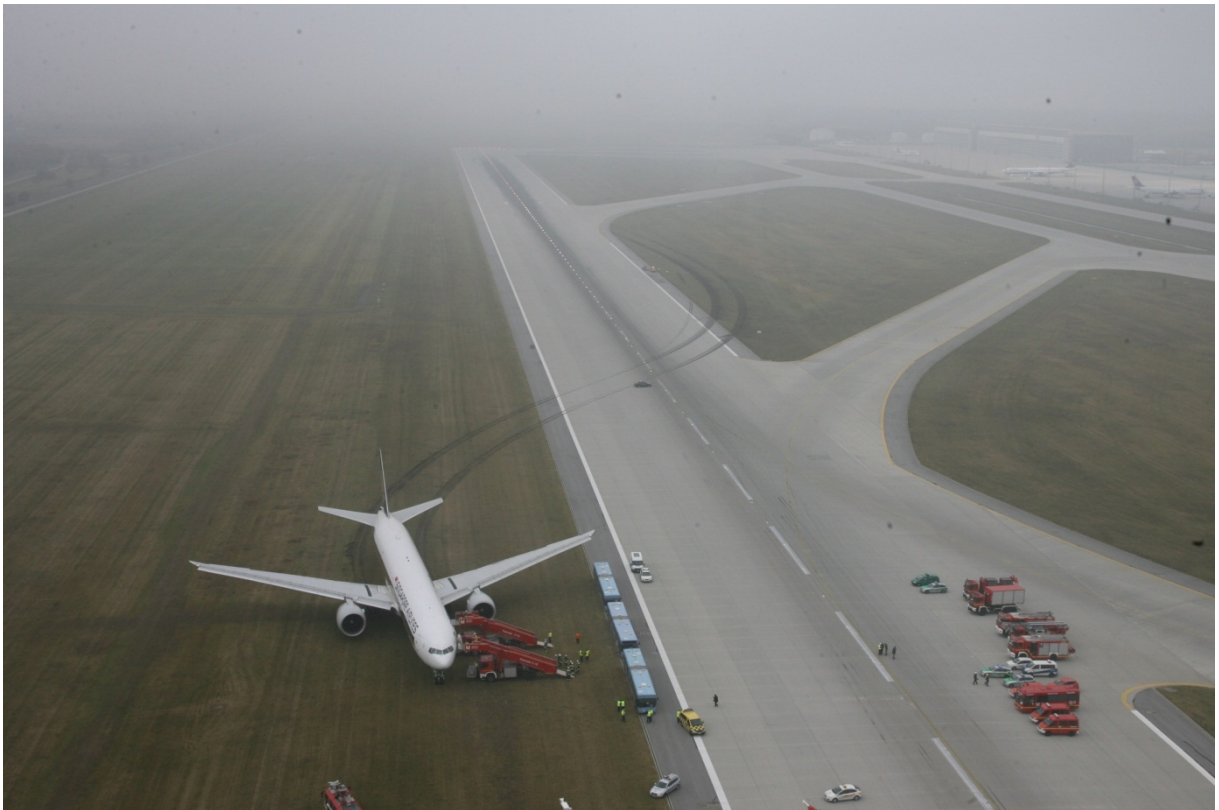
Location of the aircraft after coming to a standstill

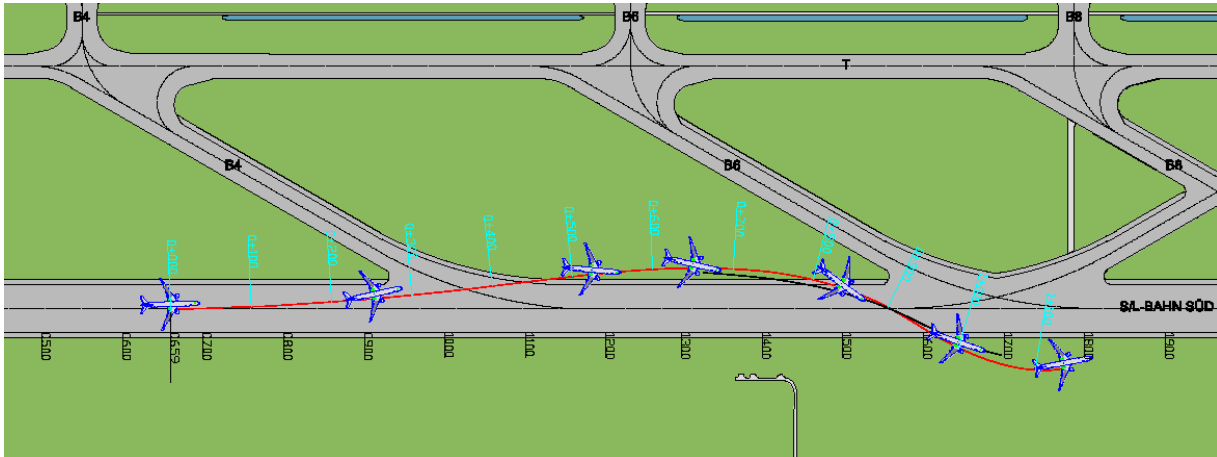
The first visible traces were determined about 659 m after the beginning of the runway. About 1,100 m after the beginning of the runway the airplane left the runway at taxiway B4 and moved over grass. After about 1,300 m the airplane reached with about 40 m the largest lateral deviation to the north of the runway centre line. The airplane turned 46° to the right and crossed the runway between 1,450 m and 1,620 m with a heading of 121°. The maximum lateral deviation towards the south

was reached at 1,740 m with about 60 m from the runway centre line. The airplane came to a stop in the grass after about 1,780 m.

Aircraft path

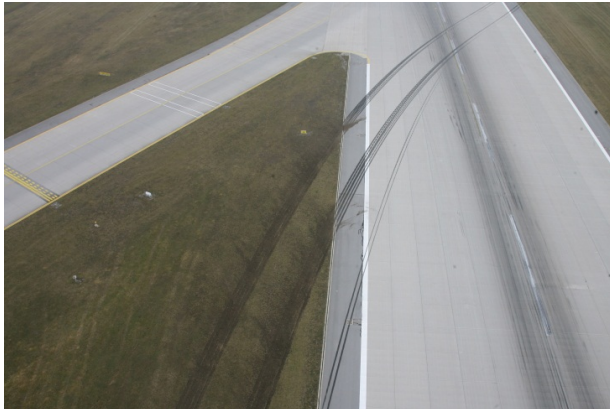
Aircraft path in landing direction

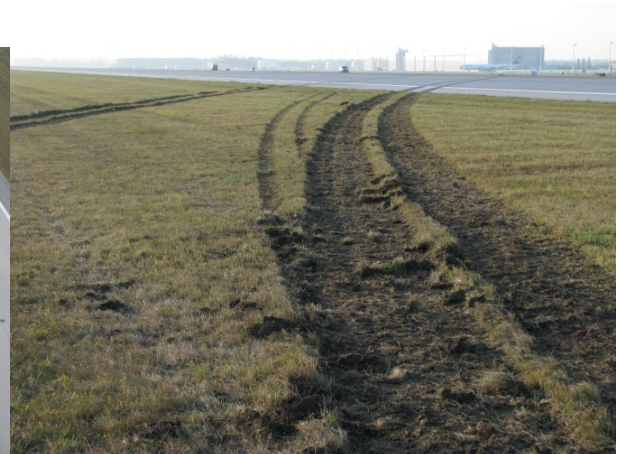
Aircraft path opposite to the landing direction

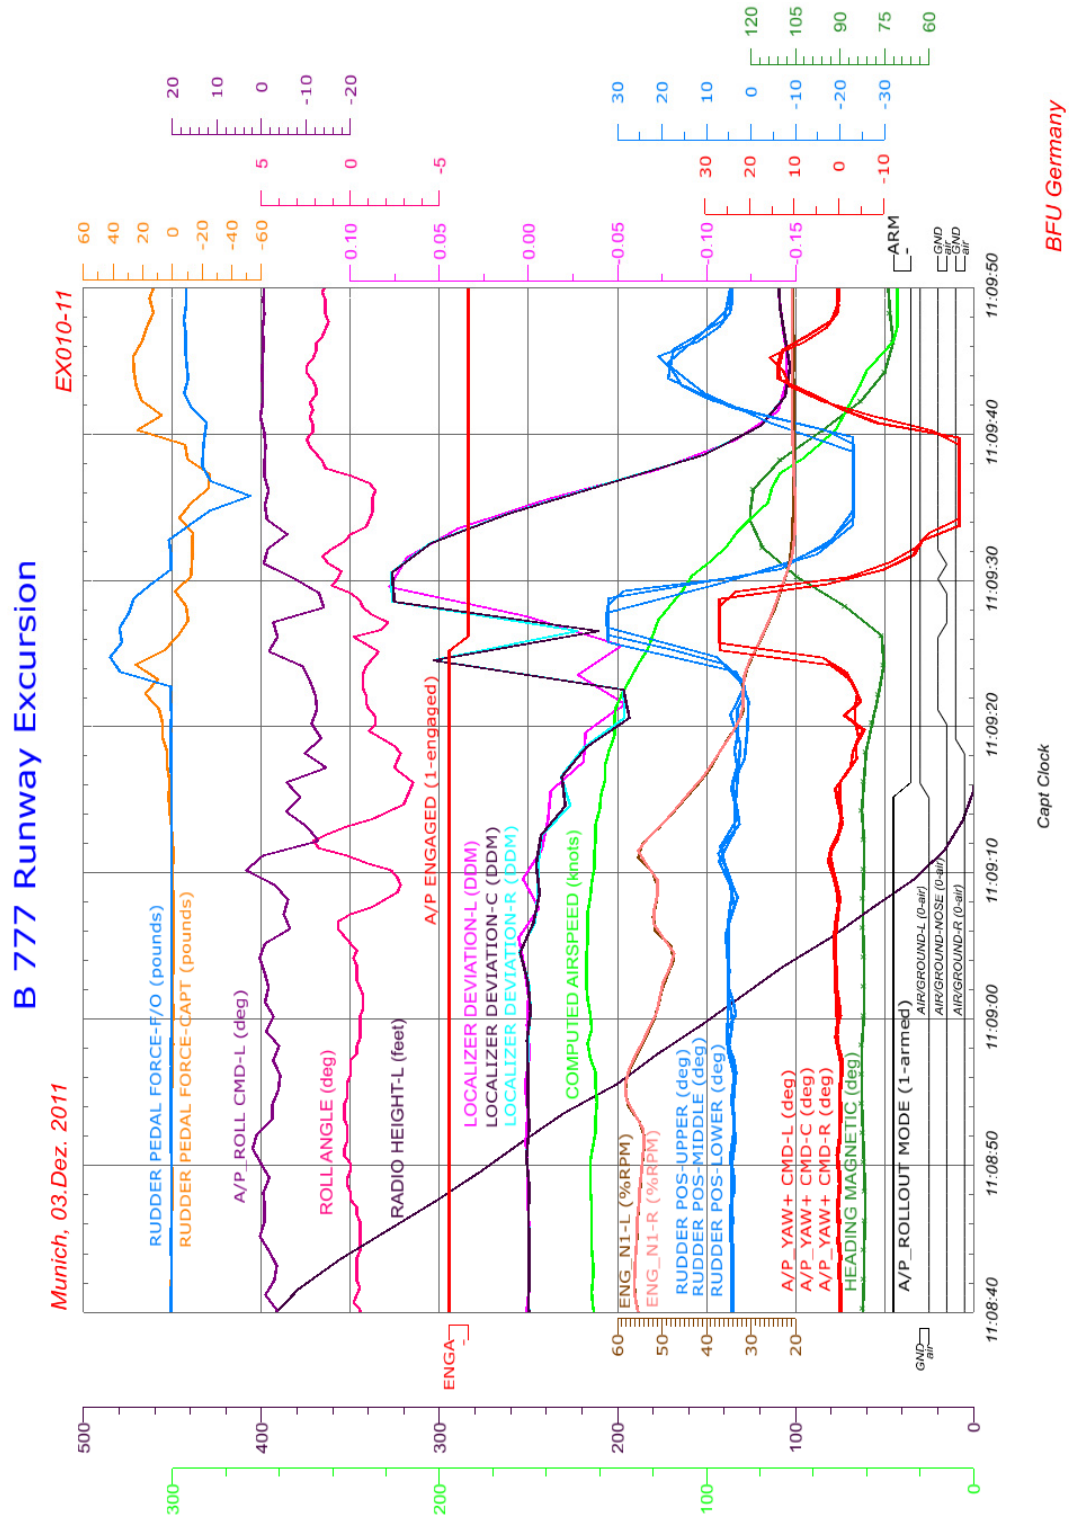
Appendix 1

The read-out of the FDR data showed the following: (Appendix 1).

Until 11:09:00 UTC the approach occurred without incidents. Between 11:09:02 UTC (altitude about 110 ft) and 11:09:10 UTC (altitude about 30 ft) the three parallel working localizer antennas aboard the airplane recorded signals which showed an irregular beam deviation. From 11:09:10 UTC on signals were recorded which showed an

increasing beam deviation from the extended centre line or runway centre line, respectively, towards the right.

The airplane began to roll to the left and at 11:09:16 UTC reached a maximum bank angle of 3.5° when it touched down with its left main landing gear. At the time the autopilot was still engaged; the approach mode changed into rollout mode.
