**04/28/88 Aloha Airlines**

**Official Accident Report Index Page**

<b>Report Number</b>	NTSB/AAR-89/03
<b>Access Number</b>	PB89-91C404
<b>Report Title</b>	Aircraft Accident Report--Aloha Airlines, Flight 243, Boeing 737-200, N73711, near Maui, Hawaii, April 28, 1988
<b>Report Date</b>	June 14, 1989
<b>Organization Name</b>	National Transportation Safety Board Bureau of Accident Investigation Washington, D.C. 20594
<b>WUN</b>	4886A
<b>Sponsor Name</b>	NATIONAL TRANSPORTATION SAFETY BOARD Washington, D.C. 20594
<b>Report Type</b>	Aircraft Accident Report April 28, 1988
<b>Distribution Status</b>	This document is available to the public through the National Technical Information Service, Springfield, Virginia 22161
<b>Report Class</b>	UNCLASSIFIED
<b>Pg Class</b>	UNCLASSIFIED
<b>Pages</b>	262
<b>Keywords</b>	decompression; disbonding; fatigue cracking; corrosion; multiple site damage (MSD); FAA surveillance; maintenance program; nondestructive inspection

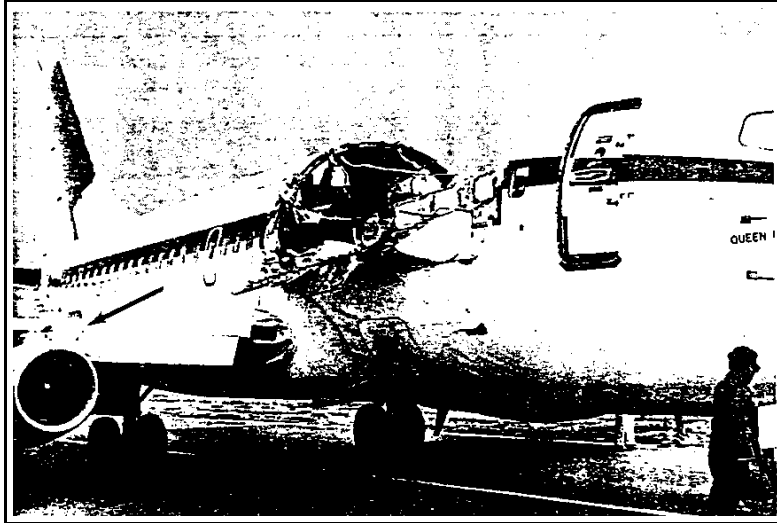
**Figure 2b.--General view, right side of forward fuselage, N73711. Arrow marks fragments of S-4R lodged in the leading edge flap.**

A fuselage section from BS 365 to BS 420 between S-4R and S-8R was trapped between the leading edge flap and inboard side of the right engine strut. This was the only significant piece of structure from the damaged area that was recovered. The recovered piece contained two skin repairs along S-4R. This section and several samples cut

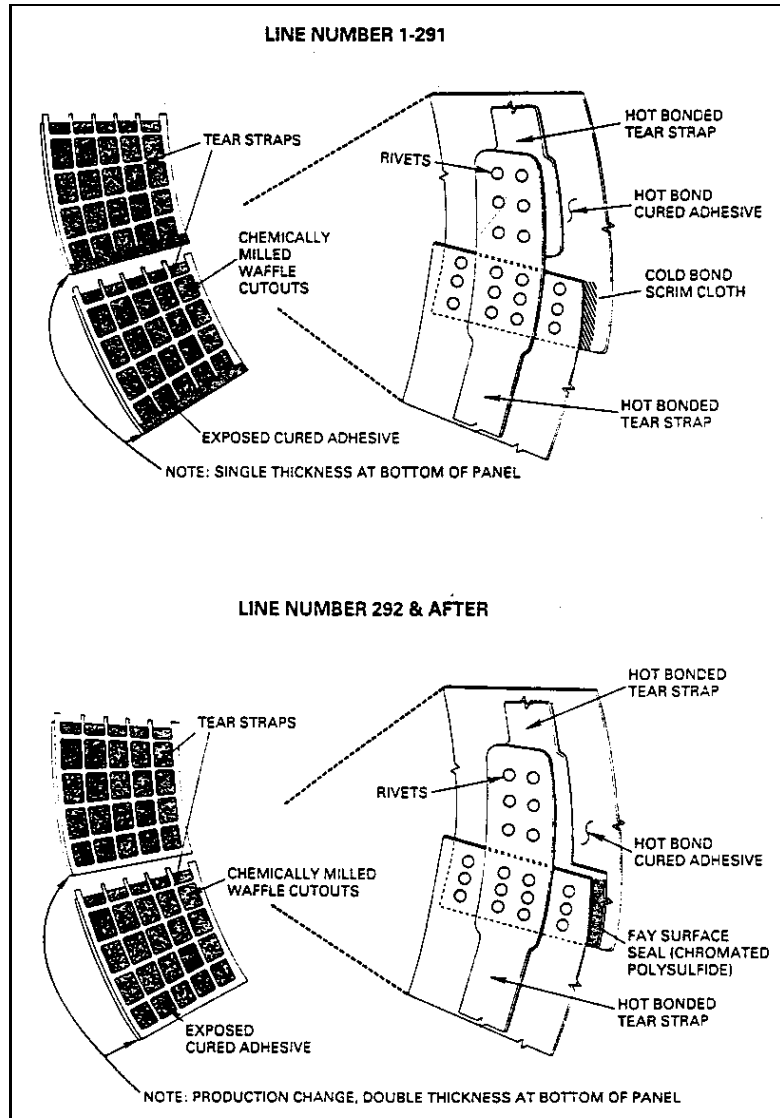
**Figure 3.--B-737 Lap splice configuration**

For B-737 production line numbers 1 through 291, the fuselage skin lap joints were "cold" bonded. A cold-bonded process used an epoxy impregnated woven "scrim" cloth to join the longitudinal edges of the single thickness 0.036-inch skin panels together. In addition, the joint was mechanically assembled with three rows of countersunk rivets. The metal surfaces to be bonded were etched to ensure cleanliness and to prepare a suitable bonding surface. Since the epoxy "cold" bond material was reactive at room temperature, it was stored in rolls at dry ice temperature until shortly before its use. It was then allowed to warm to room temperature before installation. This bond cured at room temperature after assembly.

The early service history of production B-737 airplanes with cold-bonded lap joints (plus B-727 and B-747 airplanes with the same construction technique) revealed that difficulties were encountered with this bonding process. It was found that the cleaning and etching process used on the skin panels had not provided a consistent quality thin surface oxide to be used as a bonding surface.

The service history compiled by Boeing has shown that bond quality can also be degraded if condensation is not removed from the scrim cloth before installation or if the scrim cloth sits at room temperature too long causing it to cure prematurely. According to Boeing engineers, these production process difficulties resulted in the random appearance of bonds with low environmental durability, with susceptibility to corrosion, and with some areas of the lap joints that did not bond at all. Once in service, moisture could enter the joint in the areas of disbond, and corrosion could occur. The moisture and corrosion in some cases contributed to further disbonding of the joint because of the accumulation of oxides, water wicking in the joints, and the freeze-thaw cycles. The cold-bond lap joint production process on the B-737 was discontinued by the manufacturer in 1972. (See figure 5.) A redesigned smooth, close-fitting, "fay" surface sealed lap joint with increased joint thickness was introduced with B-737 production line number 292. This is a riveted joint with chromated polysulfide sealing compound, but it contains no bonding. Production of B-727 line number 850 and subsequent numbers and B-747 line number 201 and subsequent numbers also included fay surface sealed lap joints.

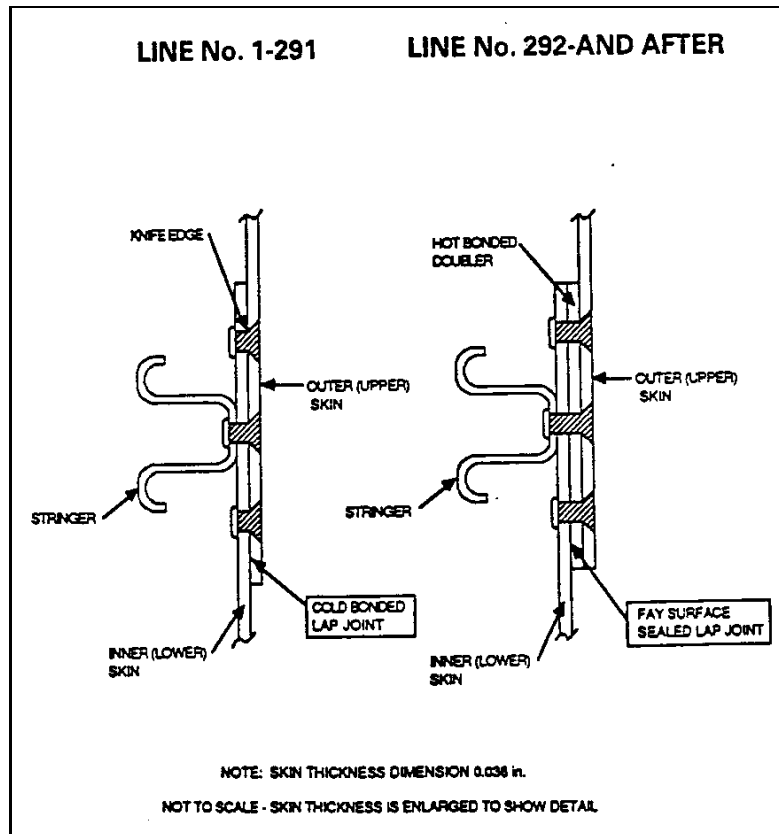
Figure 4a.--Lap joint section between tearstraps

load transfer through the joint is borne by the three rows of countersunk rivets that mechanically fasten the skin panels together. Because of the single thickness skin surface that was facilitated by the bonded construction, the countersink for the flush rivet heads extended through the entire thickness of the outer 0.036-inch sheet. A knife edge was created at the bottom of the hole which concentrated stresses. These stresses were cyclic with pressurization loads, and fatigue cracking ultimately occurred at the site.

In a cylindrical fuselage like the B-737, the circumferential pressurization stresses are twice as large as the longitudinal stresses. As fatigue effects take place, cracks propagate longitudinally, perpendicular to the dominant pressurization (hoop) loads. In the B-737, fatigue cracking initially is expected to occur in the outer layer of skin along the lap joint because the outer layer contains a knife edge at each of the countersunk rivet holes. Furthermore, the fatigue cracking primarily is found in the upper row of the outer skin panel lap joint rivet holes because this area carries the greatest stress. For the underlying skin of the lap joint, the area of greatest stress is through the lower row of lap joint rivet holes. However, since the rivet holes in this skin panel are not countersunk, fatigue cracking is not as likely to initiate at this location.

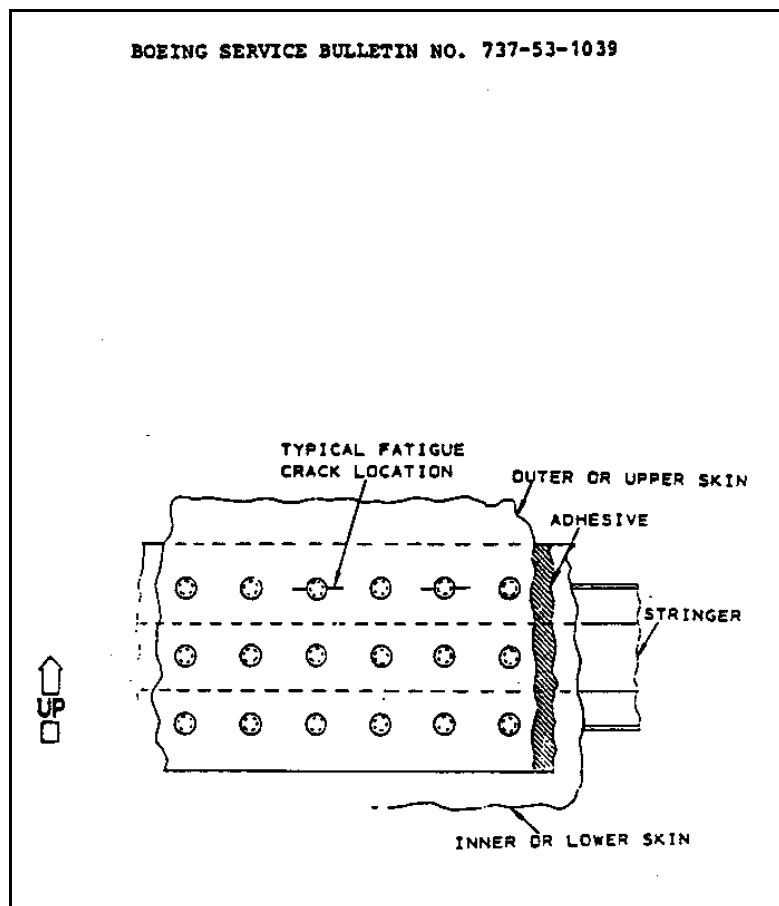
**FIGURE 5. FATIGUE CRACK LOCATION**

- A. With the aid of a bright light, visually inspect the body skin forward and aft of the head of the lap joint upper row fasteners for fatigue cracks. **See Figure 5.**

- B. If fatigue cracks are found, eddy-current inspect the skin adjacent to all joint upper row fastener heads the the full length of the panel in which cracks were found. See Nondestructive Test Document D6-7170, Part 6, Subject 53-30-00 for inspection equipment and technique.
- C. Repair fatigue cracks using a repair similar to that shown in Structural Repair Manual, Subject 53-30-3, Figure 16, and replace all remaining upper row flush joint fasteners in that panel joint with oversize protruding head fasteners per Part IV - Repair Data.
- D. Areas where no fatigue cracks are found should be reinspected annually. Reinspection for fatigue cracks may be terminated by replacing the existing upper row of joint fasteners with standard protruding head solid fasteners per Part IV. However, a corrosion inspection program should be maintained.
