Unstabilised approach, hard landing

Aircraft	Embraer ERJ 145 MP registration F-GUBF
Time and date	1.07 p.m. ⁽¹⁾ on Monday 24 May 2010
Operator	Regional CAE
Location	Ljubljana aerodrome (Slovenia), runway 31
Nature of the flight	Scheduled public transport of passengers
(Flight) crew	Pilot-in-command, co-pilot
Consequences	Damage to landing gear and structural components

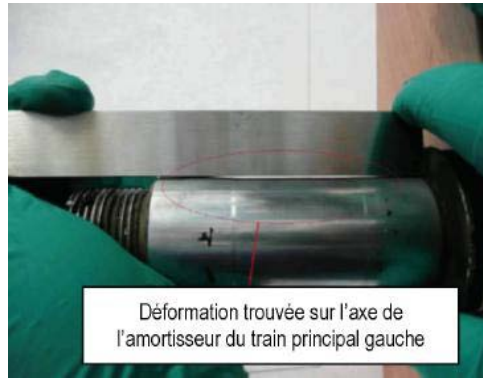
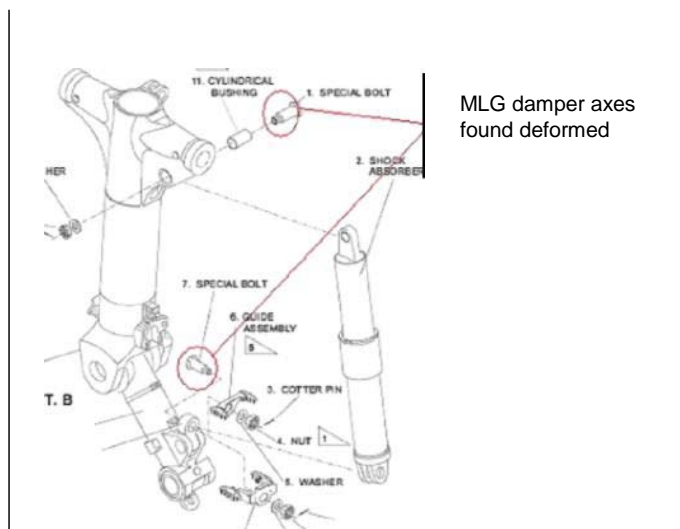
Contact with the ground was made with a load factor⁽²⁾ in excess of 4 G and with a vertical speed calculated at -1,300 ft/min. The aircraft bounced and the load factor on the second contact with the runway was 2.26 G. The pilot-in-command controlled the aircraft's track on the runway and proceeded to the apron.

The shock-absorbers of the left and right main landing gear were found to be distorted. The landing gear had to be changed.

Deformation to the damper axes of the main landing gear

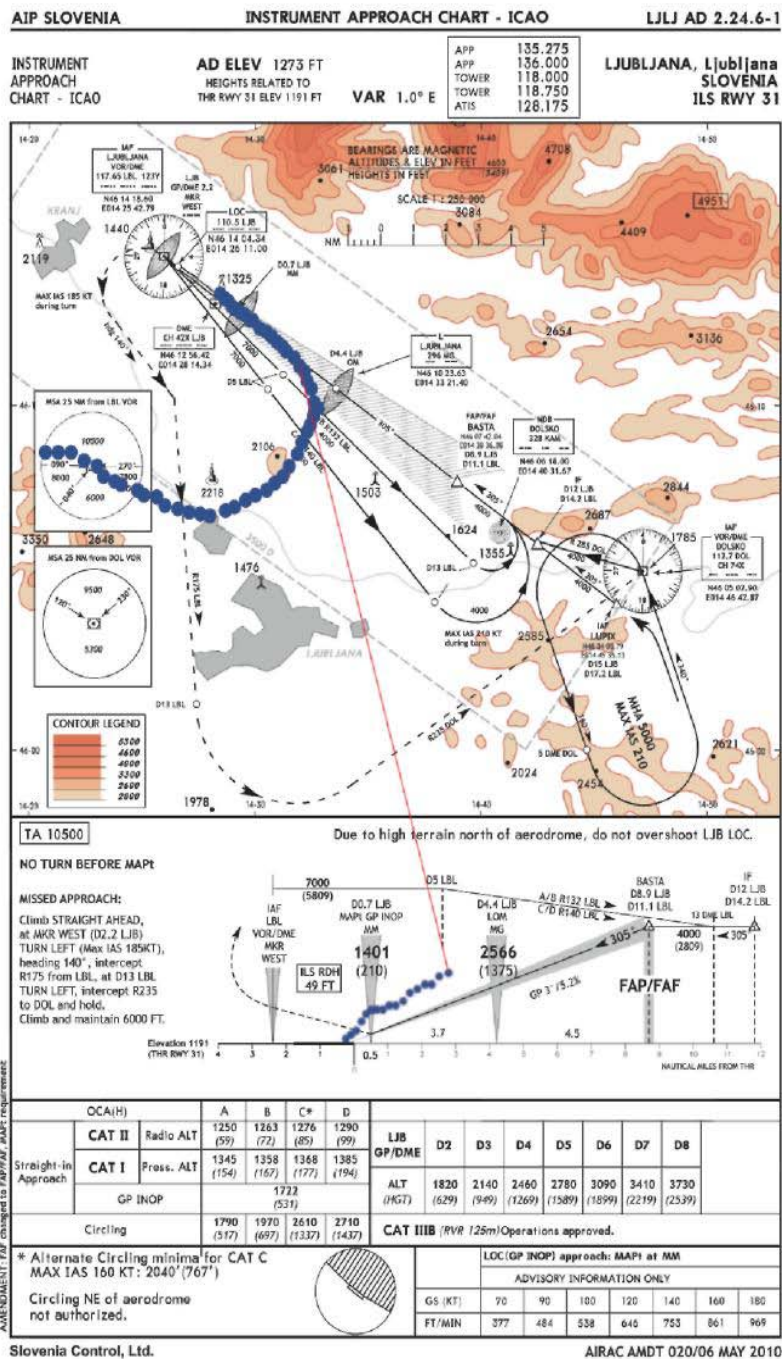
The approach carried out by the crew was not stabilised at any point. At a height of 1,337 ft, the angle of descent being followed was 4°, the configuration was flaps 22° with the landing gear down with the speed 170 kt compared to a Vapp calculated for this configuration of 134 kt. At a height of 800 ft, the pilot-in-command levelled off the aircraft to set the flaps at 45°.

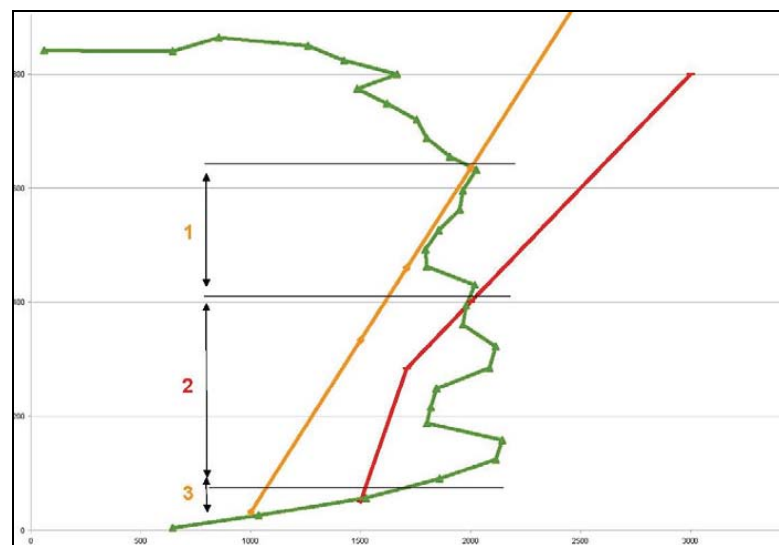
The following graph shows the activation envelope for the "excessive rate of descent" mode (Mode 1). The area between the yellow curve and the red curve corresponds to the SINK RATE Alert. The area under the red curve is that in which the PULL-UP Warning is triggered. The green curve is derived from the parameters of the aircraft⁽⁴⁾

Vertical axis shows height in ft /Horizontal axis shows vertical speed in ft/min

During the final approach, several EGPWS activation occurred. Despite a PULL-UP Warning alarm lasting 11 seconds, the crew did not commence a go-around. When the pilot-in-command took over the controls for the final approach, his experience as a glider pilot and aerobatic pilot reassured him in his decision to continue to land, and thus not to respond to the EGPWS calls.
