DATA SUMMARY

Date and time	Tuesday, 07 August 2012; at 15:40 local time ¹
Site	25 NM NE of the Tenerife South Airport (Spain)

Registration	G-LSAH
Type and model	BOEING 757 – 21B
Operator	JET2.COM

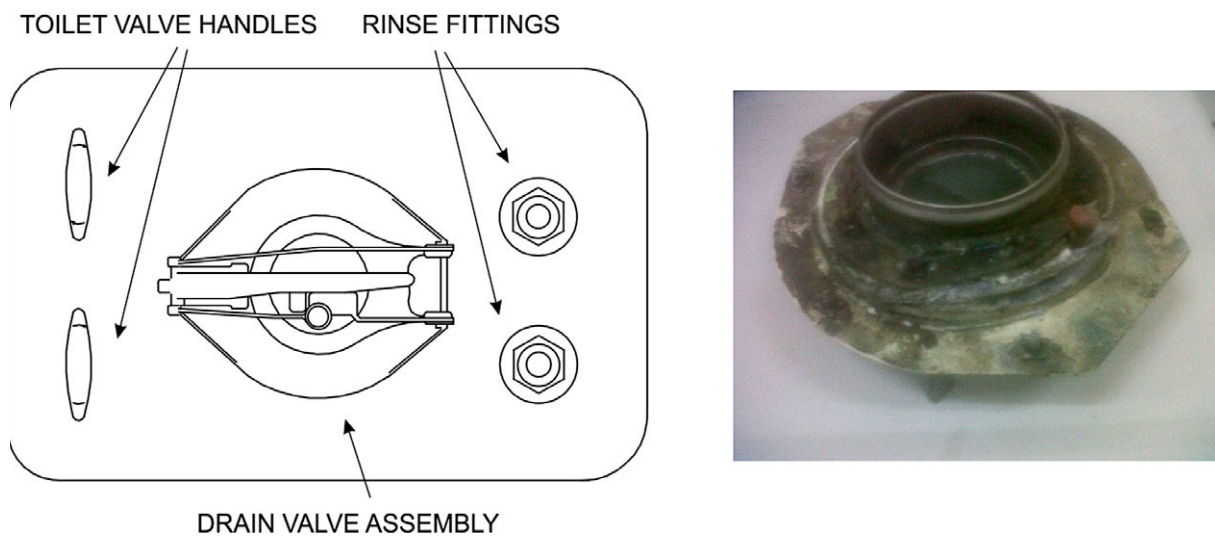
At about 14:15 h maintenance personnel were contacted when a problem was detected with a service connection for the aft bathrooms. The drain valve had detached from its housing on the service panel and was hanging by the elastic sealant material, which was making it impossible to drain the water.

Figure 1. Diagram of the service panel and the affected valve

The valve involved in this incident was used to empty the wastewater tank for the aft bathroom, and was located on the underside at the aft part of the fuselage.

The technician investigated the malfunction and concluded that the valve, which was stuck to the fuselage, had detached due to use and time in service. The clamp that holds the rubber to the drain valve was also loose.

A final inspection of the area around the bathroom drain valve exhibited evidence of an air leak.

The results of the post-incident inspection indicate that the depressurization took place in the area of the detached valve and that the valve had deteriorated as a result of corrosion.

As a result, it may be concluded that the aircraft experienced an in-flight depressurization due to an air leak through the area where the deteriorated drain valve for the aft bathrooms was located. This was caused due to an improper action of maintenance, without taking into account the relevant documentation on aircraft maintenance or the process for deferring items. The acceptance by the flight crew of the maintenance measures taken on the ground was a determining factor in the incident.

The drain valve for the aft bathroom had failed due to a corrosion problem. The valve was repaired, and in addition the spent oxygen generators and bottles were replaced and the oxygen masks were re-stowed.

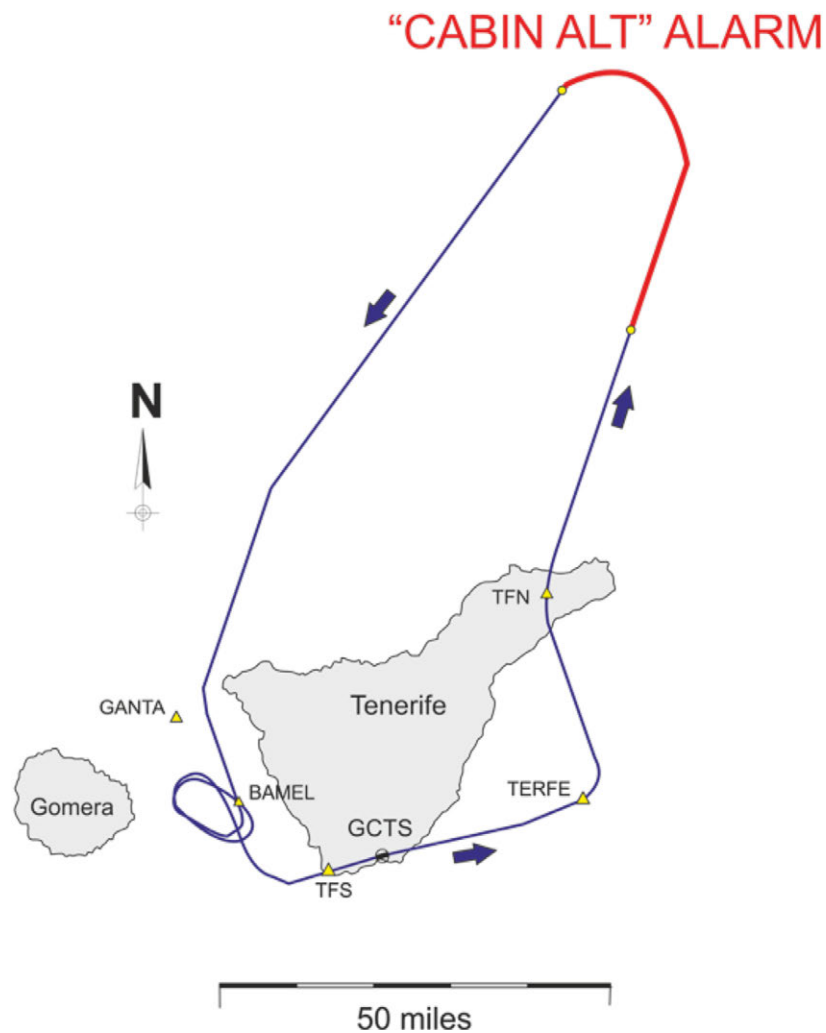
Figure 2. Aircraft flight path
