**REPUBLIC OF NAMIBIA  
MINISTRY OF WORKS AND TRANSPORT**

**Accident Reference: ACCID/112913/1-12**

# **Aircraft Accident Investigation Interim Report**

11/29/2013  
Embrear 190  
C9-EMC  
Bwabwata National park.  
NAMIBIA

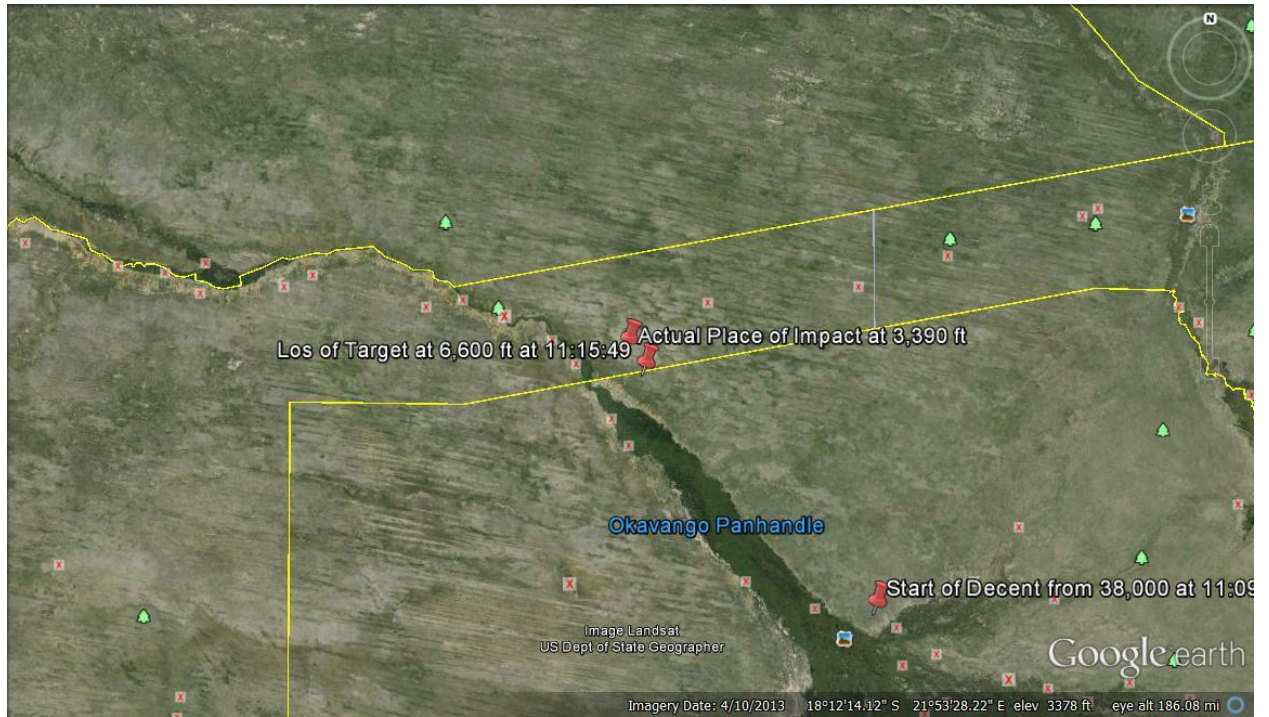
Map1 : Estimates from descent point to Radar loss Gaborone Airspace by the Namibian radar

Horizontal distance from top of descent to loss of radar 87.4 Km

Vertical distance from top of descent to radar loss 9 571m

Time taken from the descent till loss of Radar 6 min 43 sec

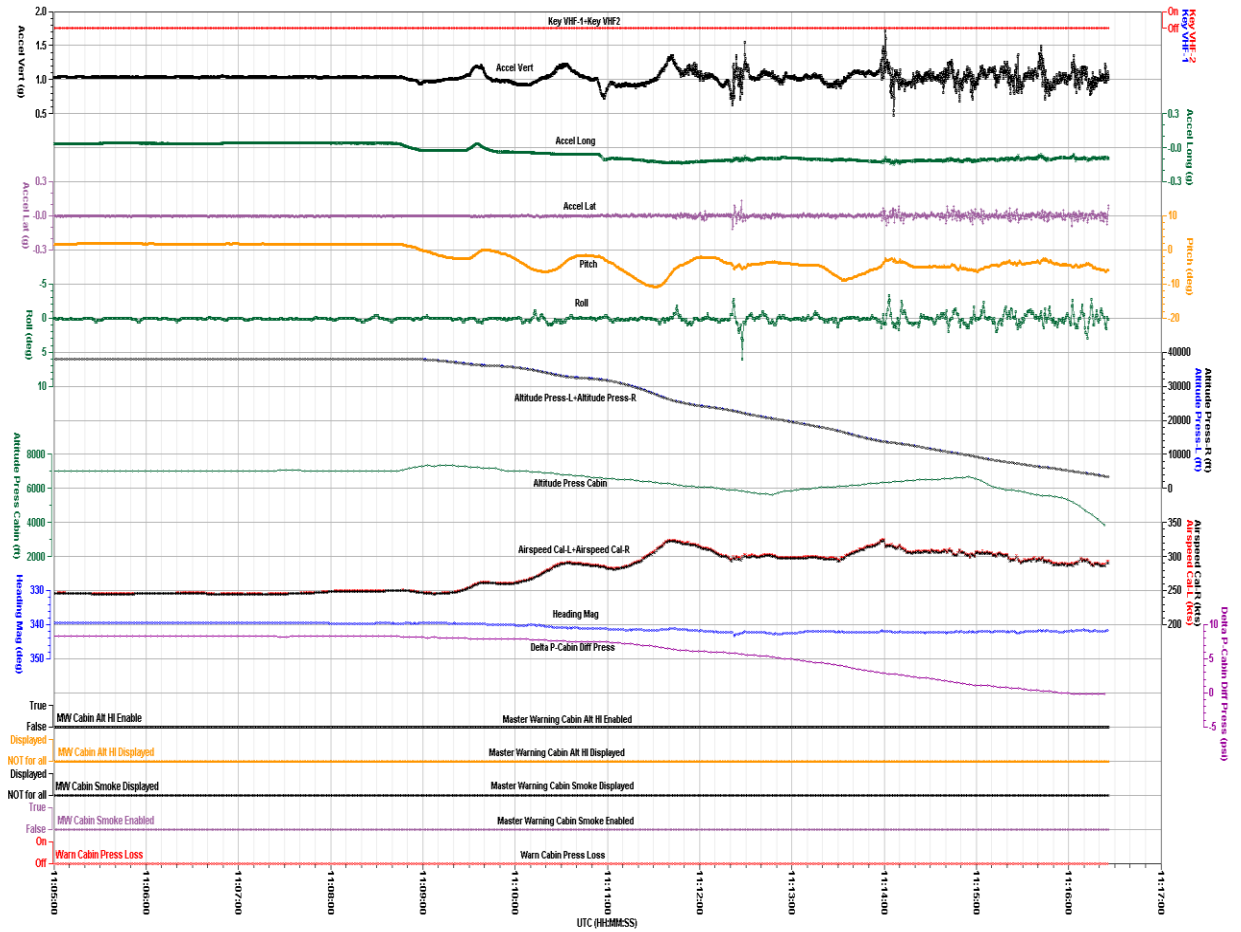
GRAPH 1 Basic parameter of the last 12 minutes of descent.

Two minutes later at around 11:06:36 -the altitude preselect adjustment (from FL380 to 4,288 ft,) which is also consistent with clicks picked up by the CVR of the altitude preselect rolling. At **11:06:52** the altitude preselect is adjusted from 4,288 to 1,888 ft, and finally from 1,888 ft to 592 ft.

**11:08:42** – The autothrottle was manually reengaged and the throttle levers were automatically retarded. This is the expected behavior as the FLCH mode was engaged and the desired altitude (altitude preselector) was below the current aircraft altitude.

**11:10:54** - The SPEED BRAKE HANDLE parameter indicates that it was commanded to open the spoiler panels and remained in this position until the end of recording. This was manually commanded as the parameter monitors the handle position.

After the speed brakes were commanded open, the vertical speed rises reaching a maximum value of 10560 fpm at **11:11:34**. Also, the indicated airspeed rises, leading to the automatic transition of the flight director vertical mode from FLCH to OVSP (over-speed) at **11:11:34; 11:13:57; 11:15:01; 11:15:08 and 11:15:15**.

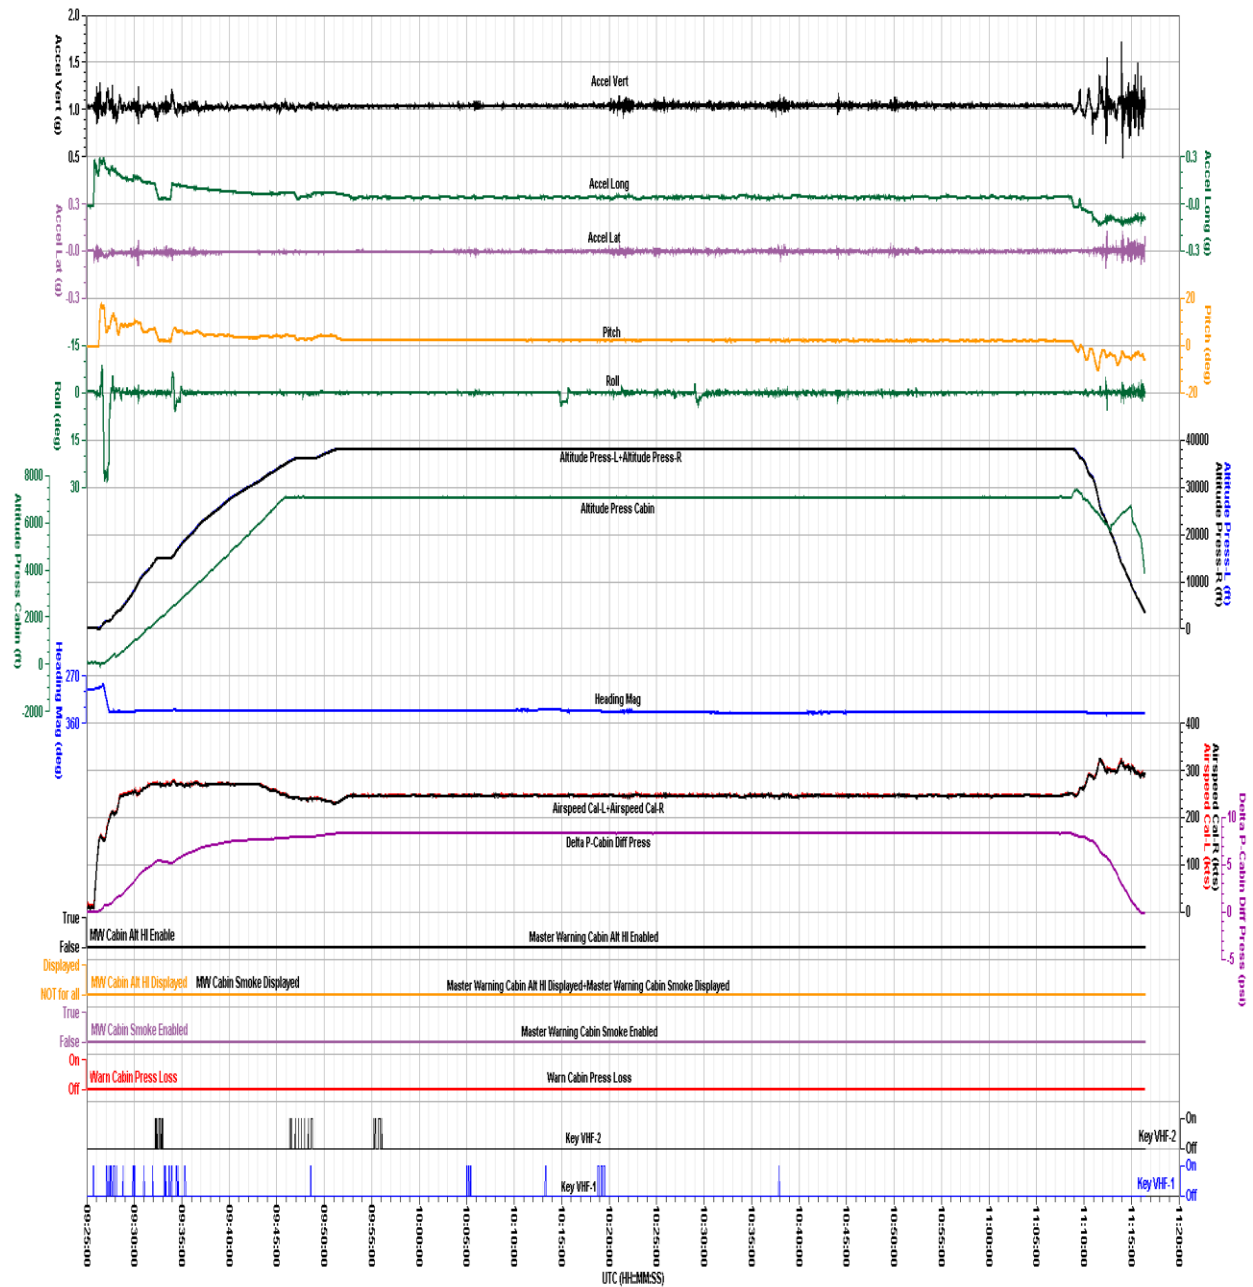
Graph 2 Basic parameters of the entire flight

DFDR Data show the aircraft performing a normal take-off, climb and cruise. Only after approximately 1h 39m was there any anomaly as per flight plan. At this time 11:04 UTC The aircraft was flying at FL380, with ALTITUDE PRESELECTOR set to 38000 ft. Autopilot was engaged (and remained engaged until the end of recording) with flight director vertical mode VALT (FMS altitude hold).
