SL RAP.: 8/2006

**REPORT ON THE AIRCRAFT ACCIDENT AT BERGEN
AIRPORT FLESLAND, NORWAY, ON 31 JANUARY 2005
INVOLVING ATR 42-320, OY-JRJ, OPERATED BY DANISH
AIR TRANSPORT**

SUBMITTED
April 2006

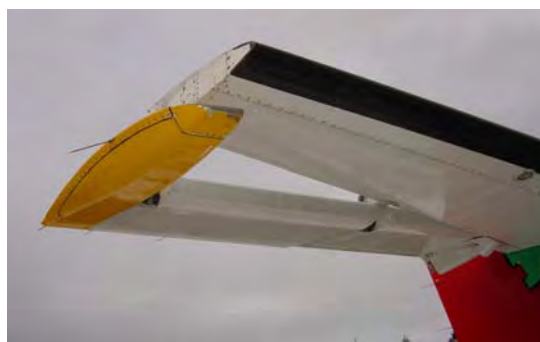
- 1.1.9 When the crew left the aircraft and inspected the aircraft the cause of the control problems became immediately apparent. The right elevator had detached completely from the hinges that normally connect the elevator surface to the horizontal tail surface (the stabiliser). Only the inboard hinge next to the tail fin was still intact. The tip of the elevator was hanging 30 cm below the stabiliser.

Fig. 1 OY-JRJ's elevator seen after landing

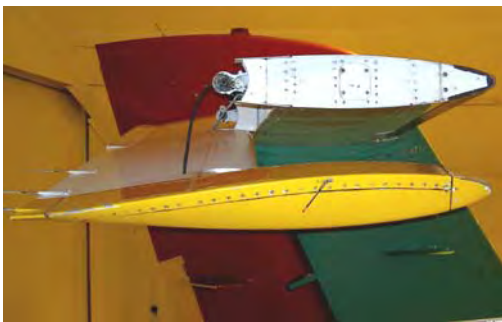
Visual inspection was made and photographs taken before the elevator was dismantled. There was a bolt missing from both the centre and outer hinges. The condition of the inboard was normal; the nut was tightened, washers and bushings were in place and the bolt was not bent. There was no sign of deformation of the stabiliser.

Fig. 4a The right tail surface from the side

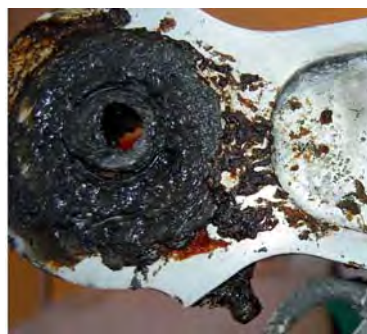
Fig. 4b Outboard hinge point

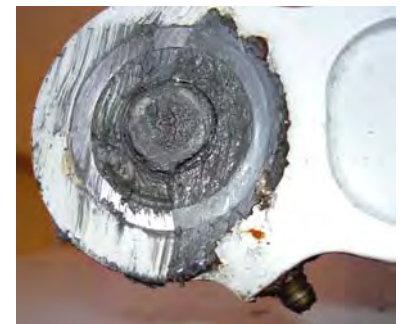
Fig. 4c Centre hinge point

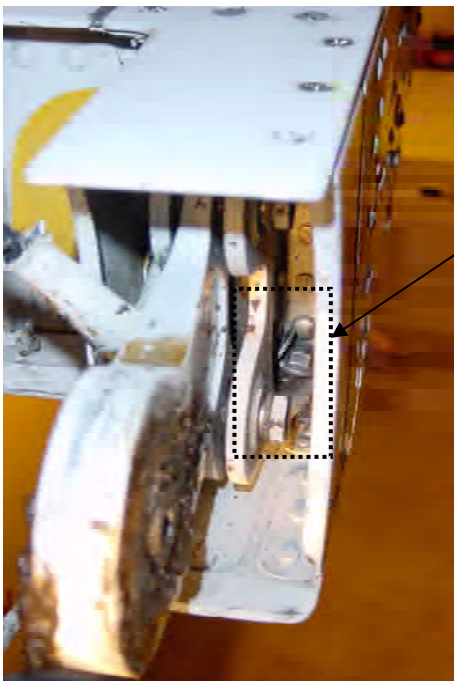
Fig. 6a Outboard hinge point right stabiliser

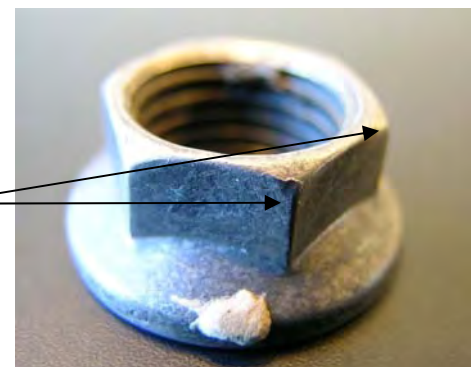
Fig. 6c Nut with tool marks and torque seal

In connection with investigation of this accident, the self-locking nut from the outboard hinge screwed onto the bolt from the outboard hinge using finger force, and tightened with a tool until two threads of the bolt were visible on the "outside" of the nut. The torque that was necessary to turn the nut further was measured at 33 lb in. This is the torque that is necessary to break the self-lock on the nut in the condition that it was in when it was found (uncleaned and not lubricated). In comparison, the self-locking nut from the inboard hinge was installed on the same bolt (outboard hinge bolt). The equivalent measure torque was 50 lb in.

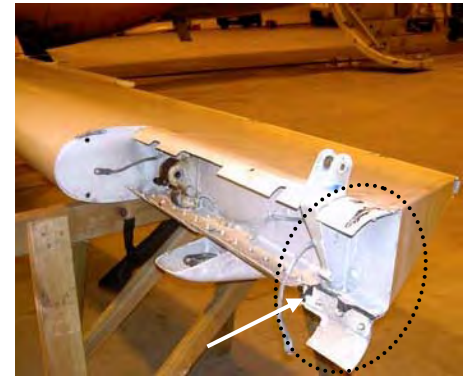
Fig. 7c Damage to the elevator's leading edge fairings close to the tail fin

- 2.3.1 In the opinion of AIBN, the damage to the leading edge fairings and the flange on the main beam resulted from abnormal movement when the hinges became loose. The lightning strike marks that were discovered subsequent to the event are assumed to be of an earlier date, and had no effect on this occurrence.
