# Investigation Report of the Aircraft Accident Investigation Bureau

to the Saab 340B aircraft, registration HB-AKK

of Crossair flight CRX 498

on 10 January 2000

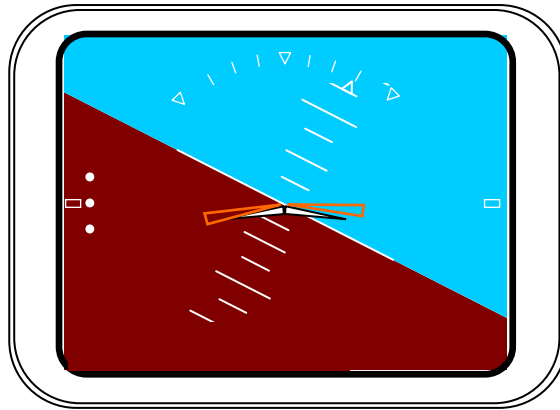
In addition to the inverse representation of roll, mention should also be made of the decoupled representation of roll and pitch in the Russian instrument compared with the combined representation in the western type.

In Russia, the risk of confusion when interpreting the artificial horizon display and when reading off the roll angle is well known since the introduction of the western type horizon on a number of aircraft types (TU-154, all western types). Several accidents have been caused by this.

Illustration: comparison of western and Russian horizon, left bank angle 27°, pitch 1° ANU

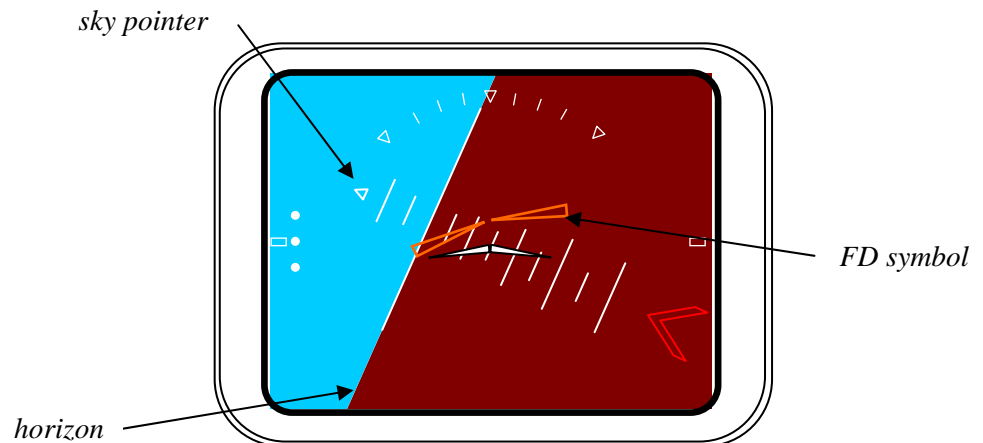
The EADI display was now already difficult to interpret. The combined representation of two parameters (bank attitude and pitch) made it essential to perform mental extrication. This applies especially in comparison with the Russian-type horizon with a decoupled representation where attitude and pitch can always be read independently of each other. The bank angle was shown in the angle of the horizon line (blue-brown dividing line) of the EADI compared with the instrument case. With the dominant display of the brown element and the slipping of the horizon line to the top left corner, this became increasingly difficult. The sky pointer had exceeded the scaling limit at  $60^\circ$  bank angle. The pitch display was now no longer represented as the position of the horizon line in vertical reference to the neutral line of the instrument. With vertical bank, for instance, a change in pitch caused a lateral movement of the horizon line.

Illustration: representation of the EADI with FD symbol for a right bank angle of  $65^{\circ}$  and a pitch of  $15^{\circ}$  AND

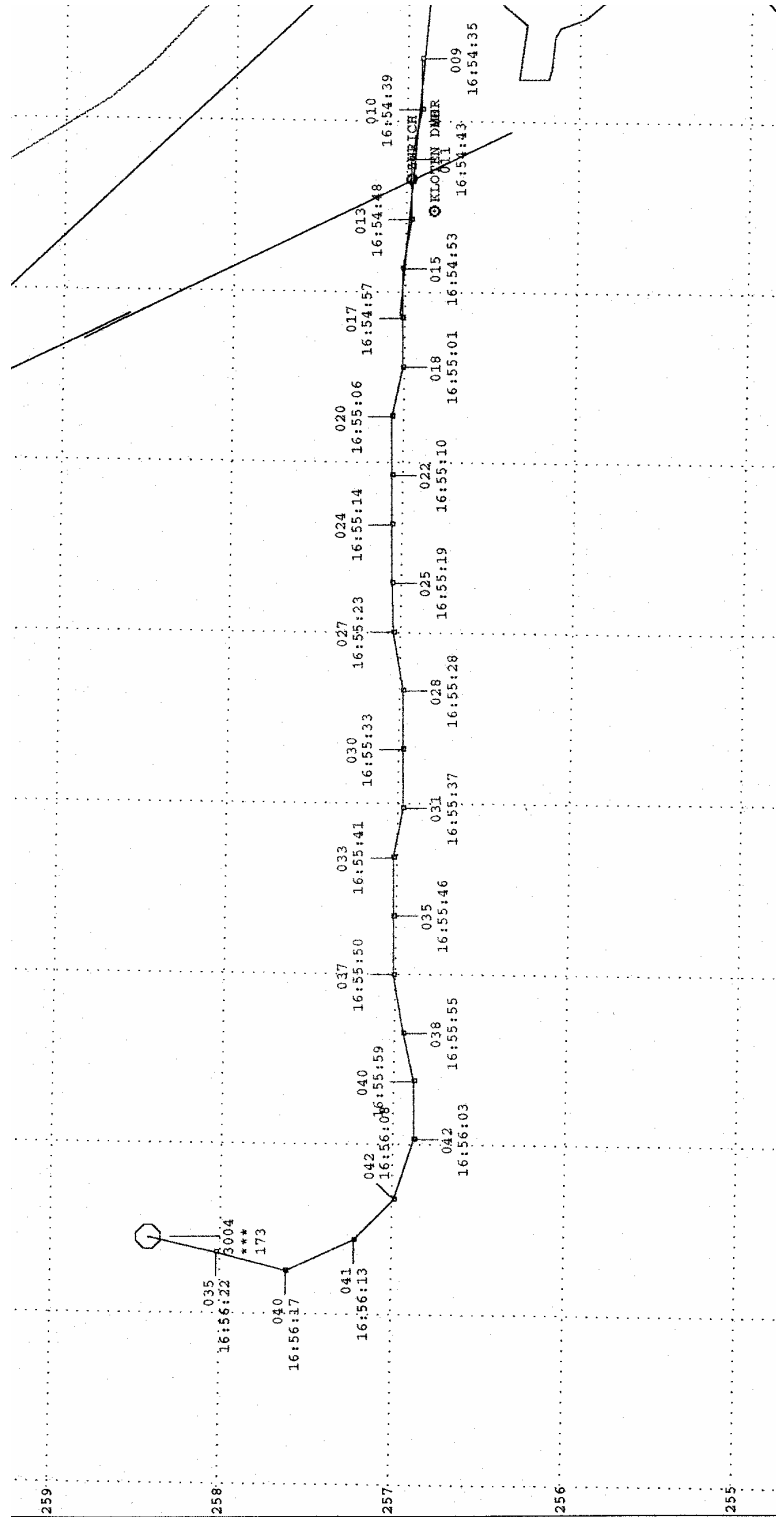
## Annex 2

Radarplot of flight CRX 498

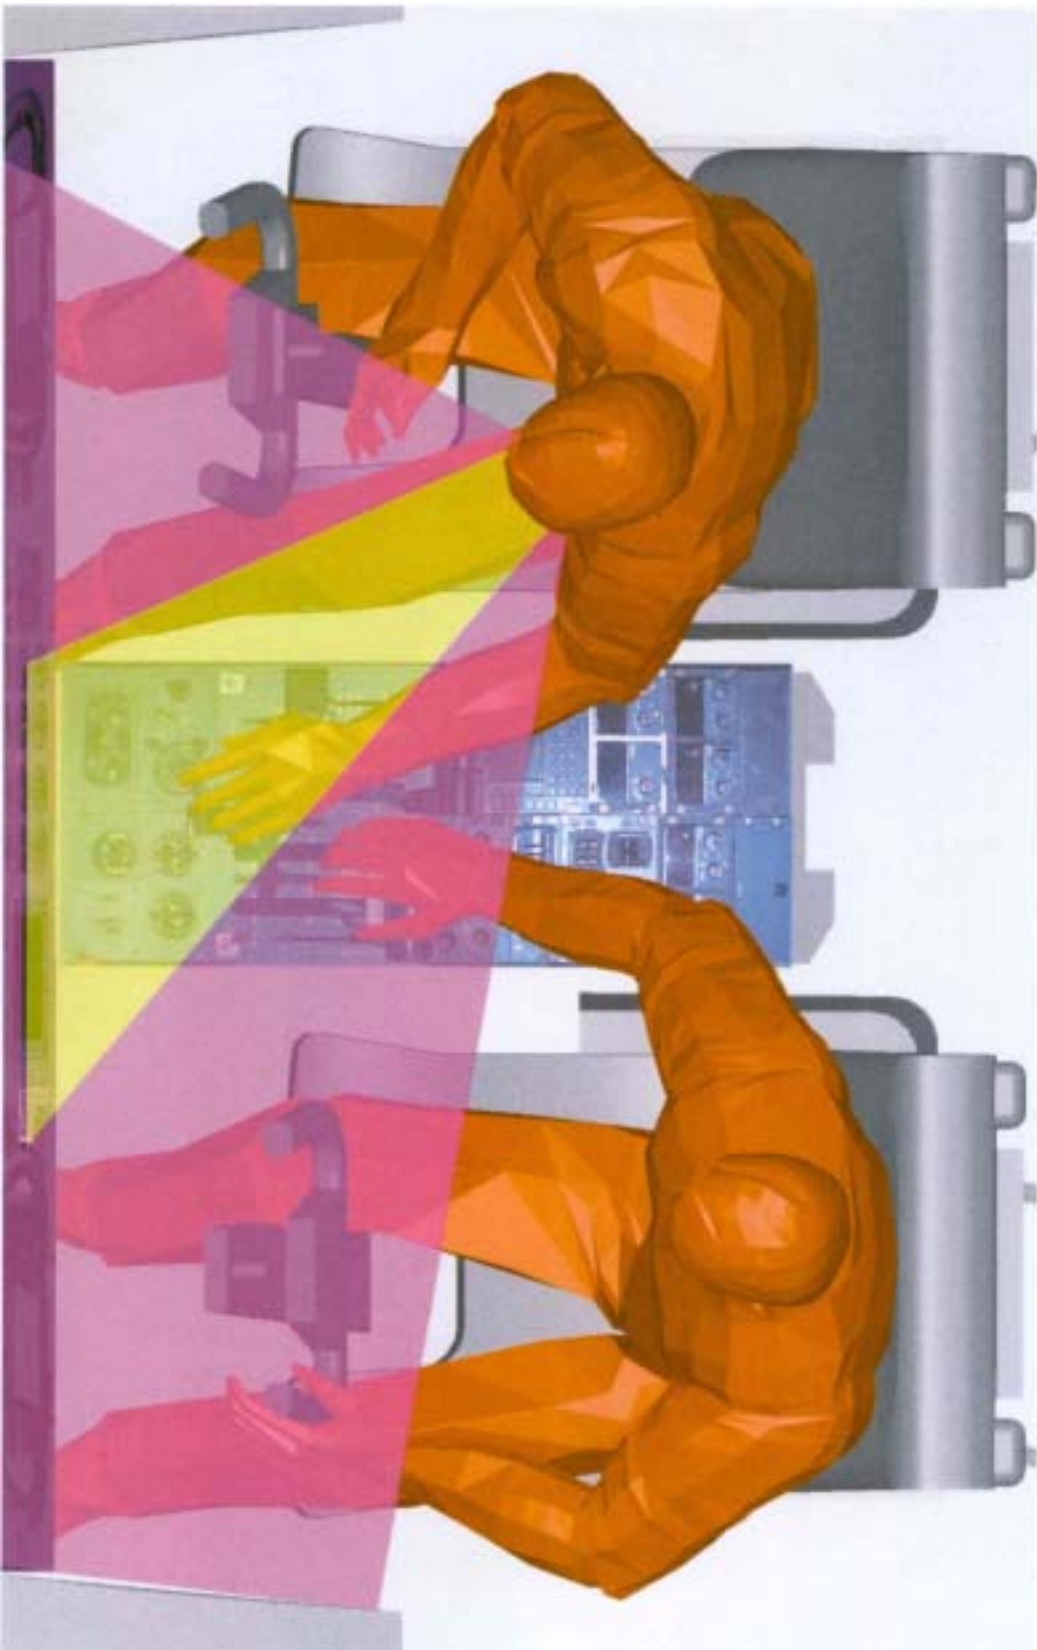
**Annex 5**

First officer's field of view – plan form

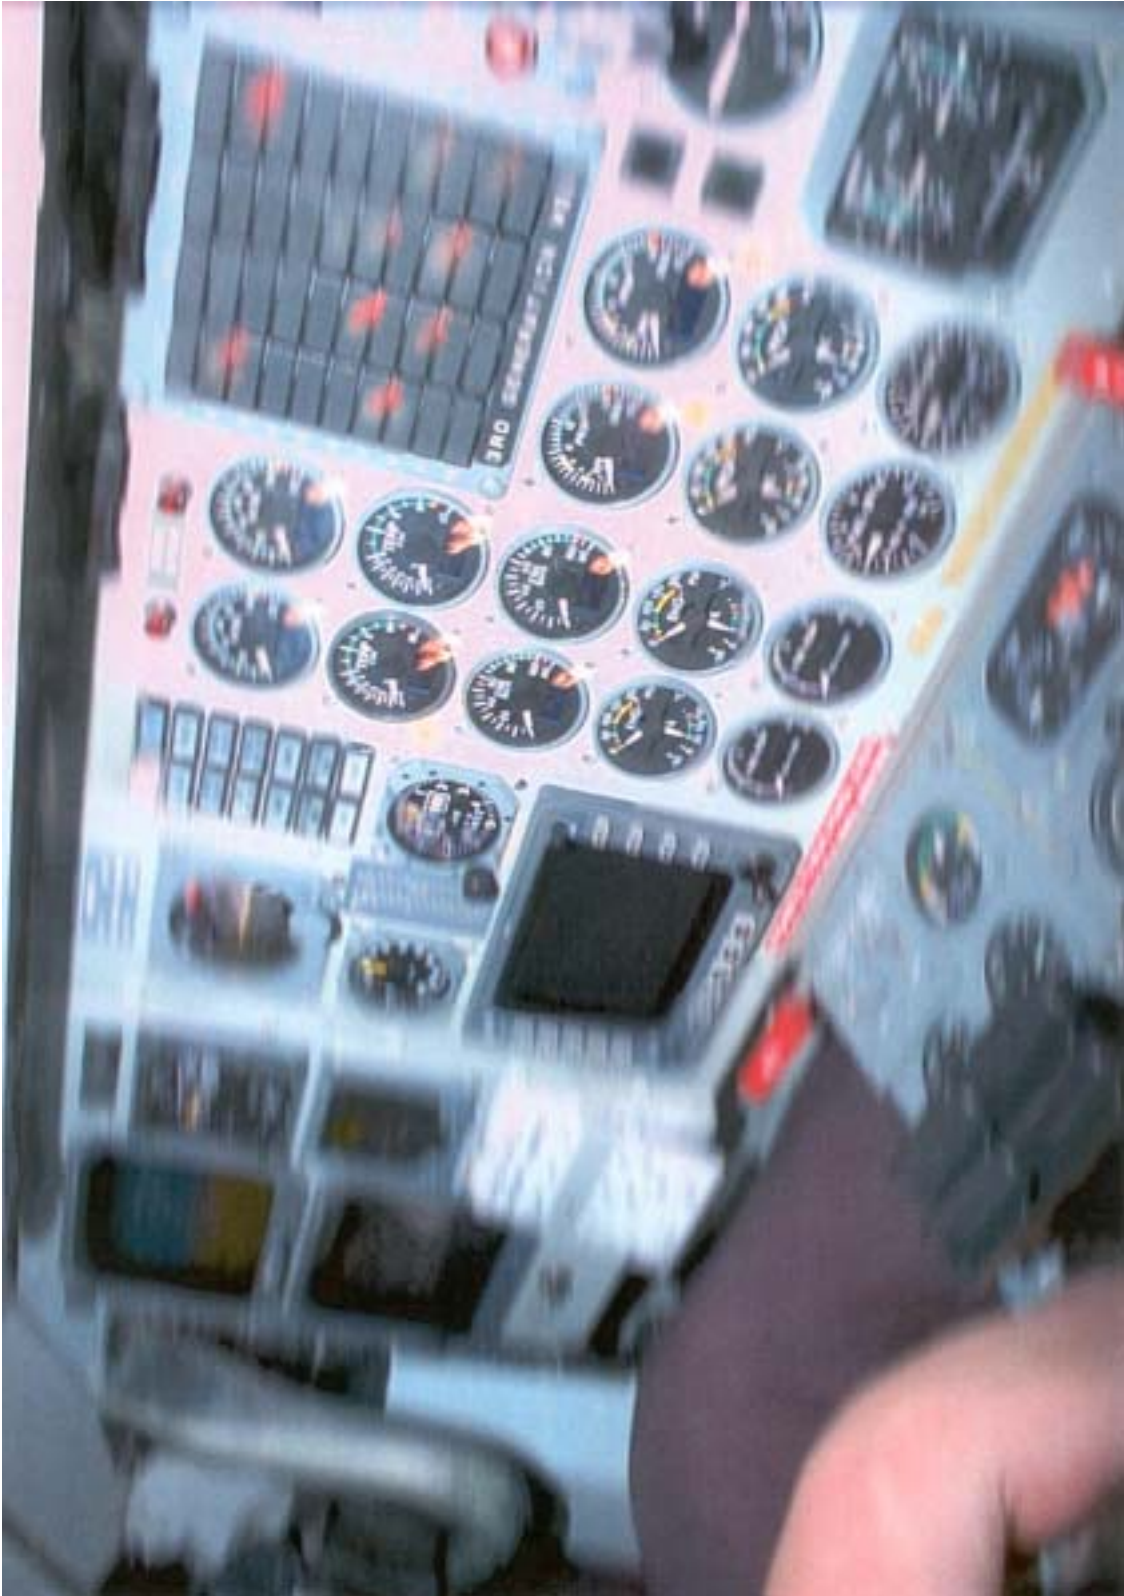
First officer's field of view – simulation

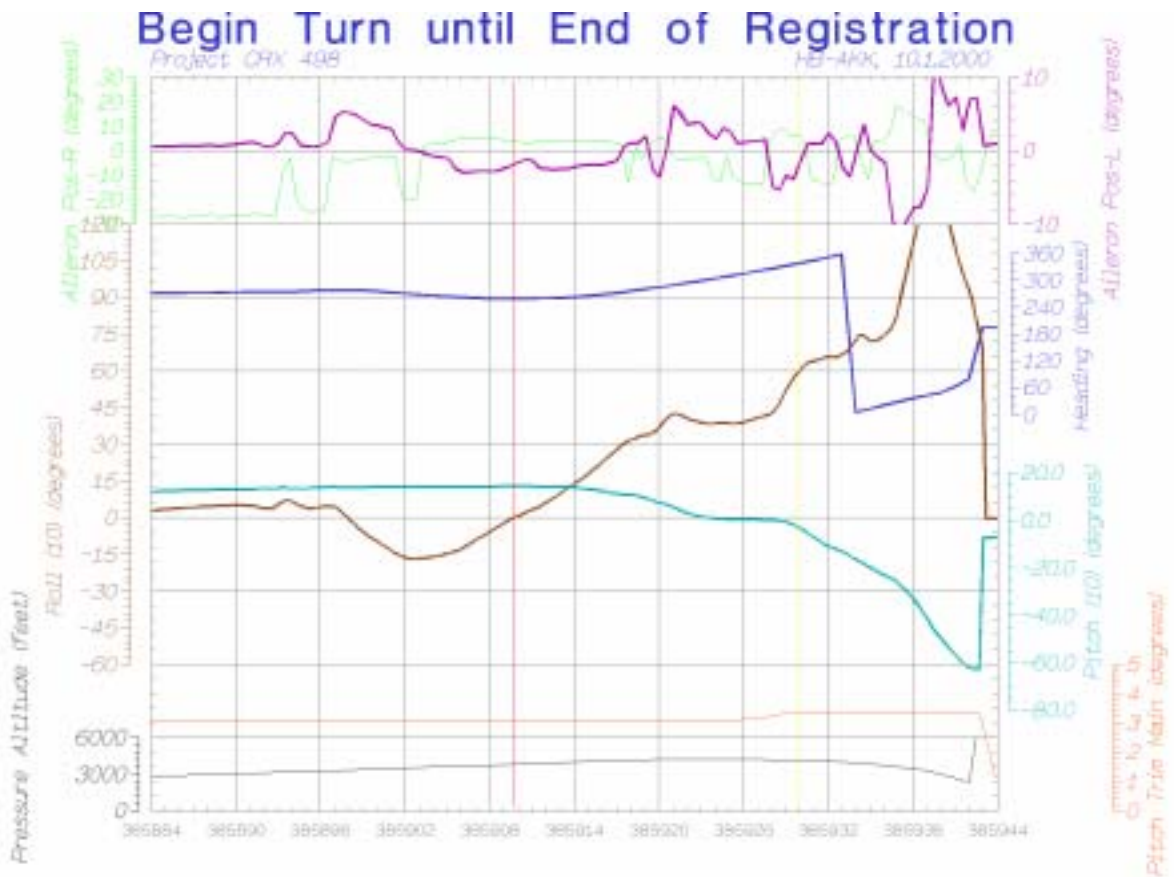
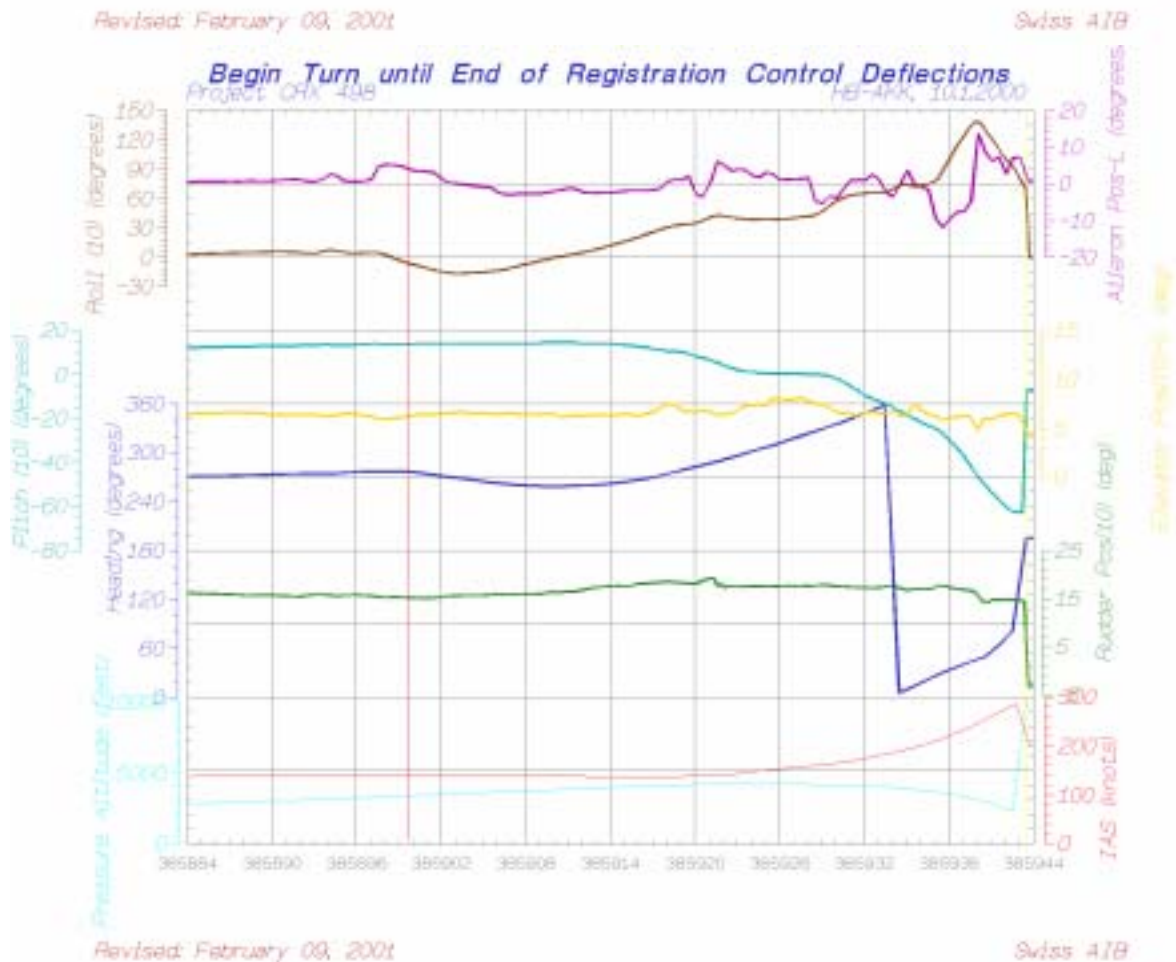
### Annex 9

Excerpts from the recordings of the *digital flight data recorder (DFDR)*.
