## **FINAL REPORT**

### **AIRCRAFT ACCIDENT INVESTIGATION INTO M/s BHOJA AIR FLIGHT BHO-213, BOEING 737-236A, REG # AP-BKC CRASHED ON 20<sup>th</sup> APRIL, 2012 NEAR BBIAP, ISLAMABAD**

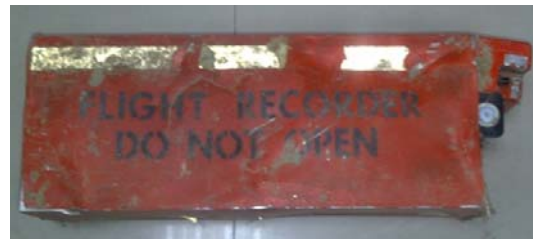
1.19.4.1 As per the NTSB report, the FDR and CVR recorders had suffered moderate impact damages. However, the memory modules were removed from the units at NTSB facilities and the respective data was successfully downloaded.

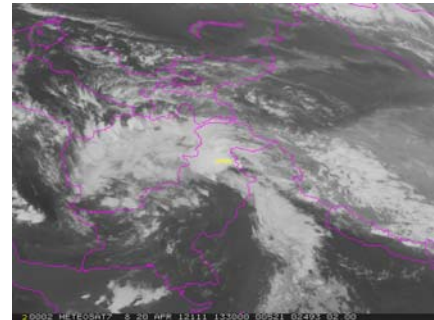
**13:30 UTC 20 April 2012 Meteosat7 infrared satellite image**

2.1.301 According to the above mentioned weather picture, BBIAP Islamabad (OPRN) was covered by a large canopy of bright white (cold topped) clouds. This cloud system appeared to be a convective system given the round shape and tight cloud gradient seen on the southern edge.

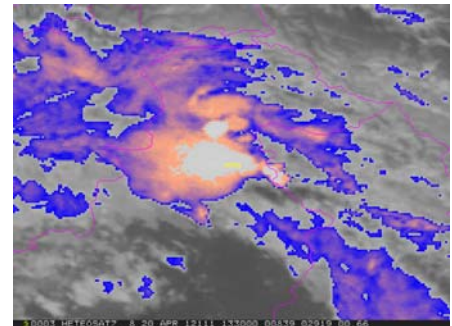
#### 2.1.302 Colour Enhanced IR Satellite.

The enhanced colour satellite imagery of Meteosat7 infrared satellite for 18:30 PST on 20 April 2012 image also highlighted areas of deep convective clouds. The colour scheme used to identify the most intense (cold deep cloud tops) as bright white. BBIAP, Islamabad sat under deep convective clouds at the time of the accident.

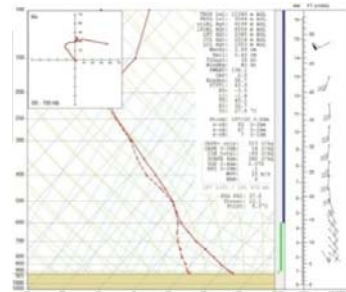
2.1.304 **GDAS model atmospheric sounding OPRN 1700 PST.** The GDAS model atmospheric sounding was carried out for 1700 PST BBIAP Islamabad. The model appears to be resolving a convective cloud environment that is characterized by a dry sub-cloud layer (ie high based convection). The surface inflow to the convective system had a temperature / dew point spread of 35° Fahrenheit (90F/55F), which results in an inverted-V type sounding and the potential for **Model Atmospheric Sounding**

strong convective downdrafts. Also, the downdraft convective available potential energy (a parameter called DCAPE) can be used to assess downdraft strength potential. There was 348 J/kg of DCAPE on this sounding. DCAPE values can be converted to theoretical downdraft magnitude potential which results in 40-50 knots of potential downdraft in this case.

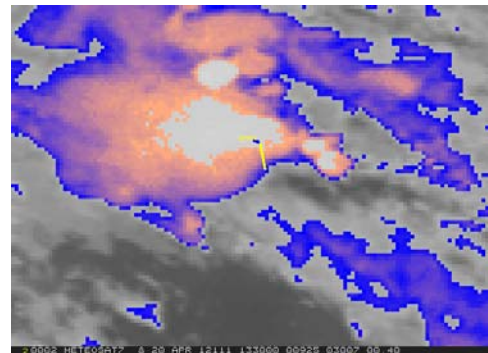
**Plot of Flight Segment**

**2.1.306** The final segment of the flight (yellow / blue) over the colour enhanced IR satellite image from 18:30 PST. The colour have been arranged so that blue / beige are associated with cirrus anvil clouds below the tropopause and white is where the deepest convective clouds have penetrated into the tropopause and / or stratosphere. Enhanced white areas are associated with the deepest convective clouds and greatest potential for heavy precipitation generation. The flight path has been colour coded such that the yellow segment represents warm recorded outside temperatures and the blue segment represents cold recorded temperatures. The transition from warm air to cool air occurred under the deep convective cloud and likely represents an evaporatively cooled downdraft.

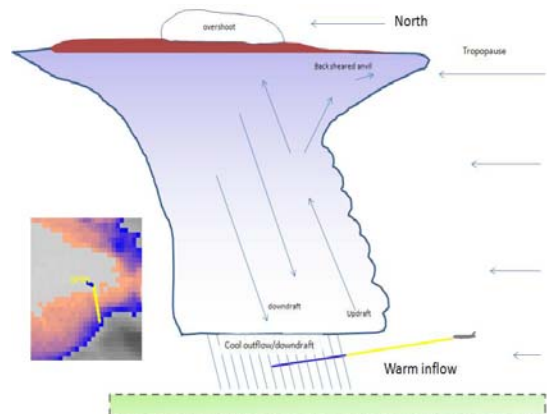
**2.1.307 Conceptual Model of Convective Cloud.** The conceptual model cross section of the convective cloud is shown below. Due to increasing southerly winds with height, the convective cloud would have been vertically sheared towards the north with height. As the aircraft entered the convective system from the south, they would have likely flown under the back sheared anvil cloud (blue and beige areas) while in warm inflow. Then as they continued to enter the convective system, they would have entered the downdraft region. Given the high cloud bases on this day, there was potential for considerable sub-cloud evaporative cooling resulting in significant cold downdraft production. Therefore deteriorated weather condition was one of the factor in the causation of this accident.

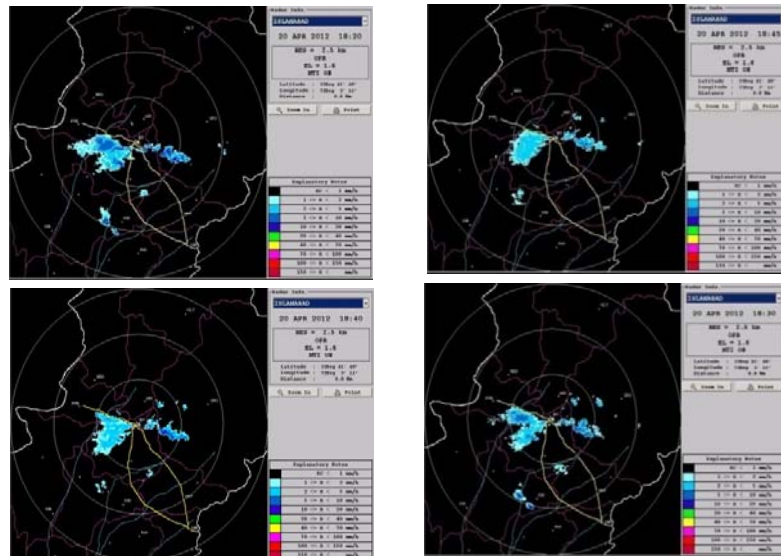
- 2.4.19 Radar echoes of weather system depict frontal weather activity that generated severe turbulence and caused high wind shears that were responsible for the microburst.
- 2.4.20 Radar echoes from 1820 PST to 1845 PST of 20th April 2012 inserted above depicted that weather activity over BBIAP and east of Islamabad & Kashmir was more severe and embedded Cb clouds producing updrafts and downdrafts were mapped by radar system during the period.
