**AIRCRAFT ACCIDENT INVESTIGATION COMMITTEE
MINISTRY OF TRANSPORT AND COMMUNICATIONS
THAILAND**

**LAUDA AIR LUFTFAHRT AKTIENGESELLSCHAFT
BOEING 767-300ER
REGISTRATION OE-LAV
DAN CHANG DISTRICT
SUPHAN BURI PROVINCE
THAILAND**

26 MAY B.E. 2534 (A.D. 1991)

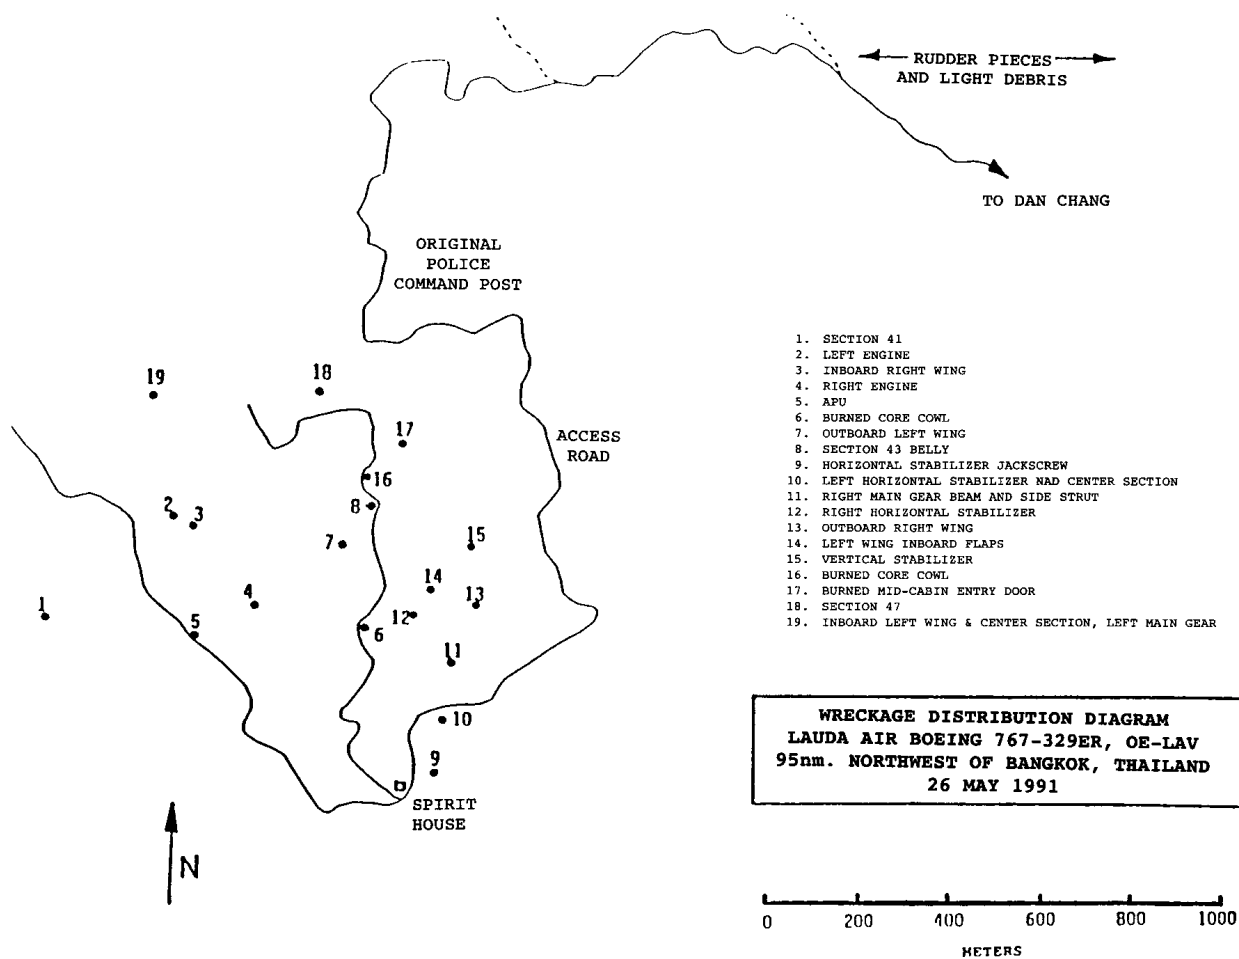
FIGURE 1

Most of the wreckage was found in a one square kilometer area, but some lighter weight components were found up to 2,000 metres from the initial impact point. The horizontal stabilizer was the first major component found in the debris pattern, which was along a generally northwest/southeast track. Thrust reverser actuators from the left engine (both sleeves) were found in the fully deployed position. A diagram of the wreckage spread is included in this report as [Appendix B](#).
