**ACCIDENT**

| <b>Aircraft Type and Registration:</b> | ATR 42-320, G-DRFC | |
| <b>Date &amp; Time (UTC):</b> | 16 June 2012 at 0723 hrs | |
| <b>Location:</b> | Jersey Airport, Jersey, Channel Islands | |

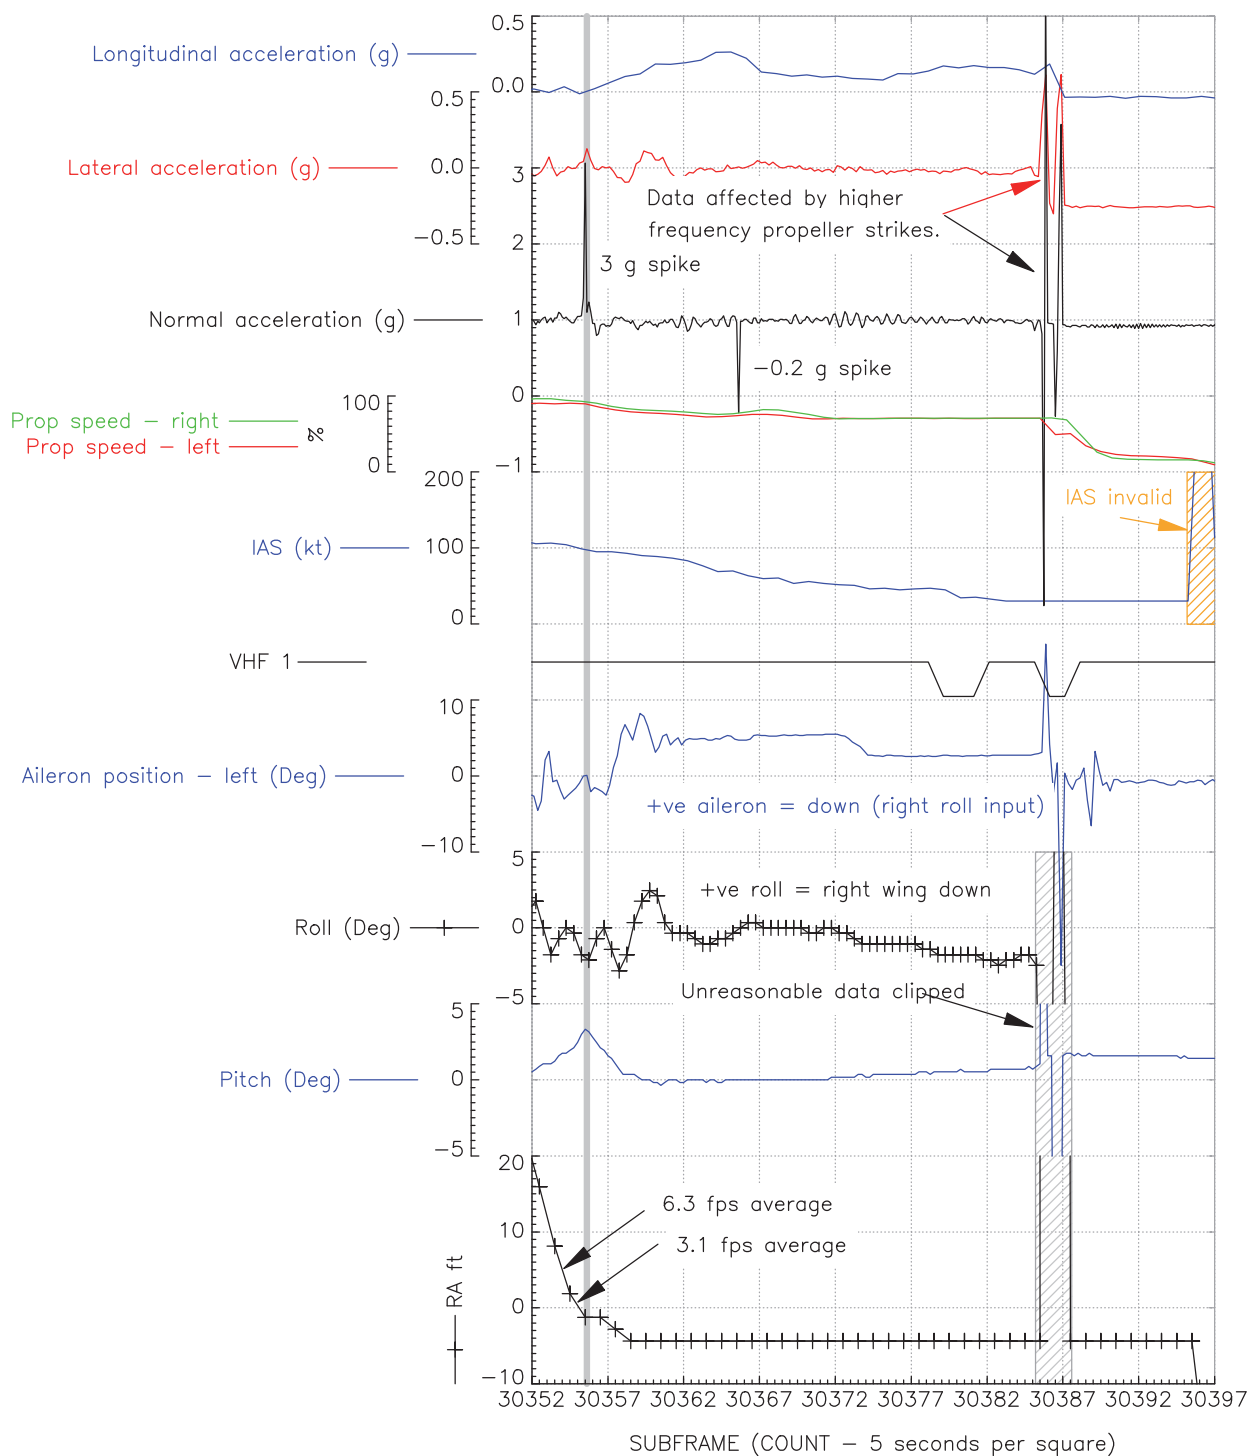
**Figure 2**

Pertinent FDR parameters

The FDR recorded a 3g normal acceleration spike on touchdown, significantly higher than would be expected during a landing. However, the recorded radio altitude profile indicated a descent rate averaging approximately 3.1 fps over the second just prior to touchdown which was only slightly higher than normal when compared to ten other flights recorded by the FDR. These calculated descent rate figures have limitations due to the low sample rate of once per second; the final height loss may have occurred within a shorter period than the one second between samples.

An isolated -0.2g spike in normal acceleration was recorded approximately 10 seconds after touchdown. No other parameter activity was associated with this spike. Many isolated spikes, that are also similar in value, are present throughout the FDR recording, in flight and on the ground. These are not considered real events. A similar comparison for the 3g spike recorded on landing showed that the other high value spikes were all associated with spikes in other parameters that were not evident during the landing and were likely to be associated with power interrupts. This indicates that the 3g normal acceleration spike is genuine.

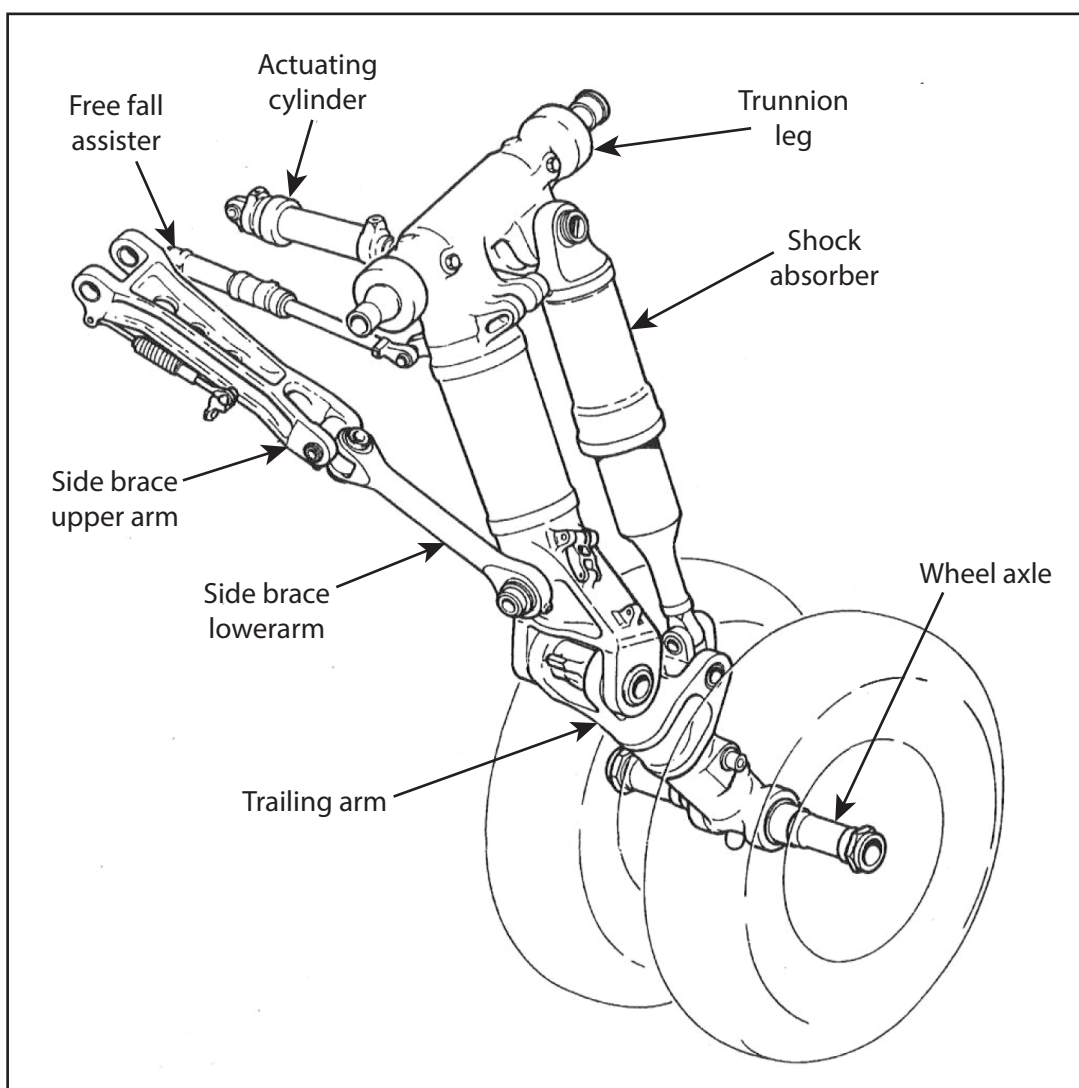
**Figure 4**

Main landing gear general arrangement

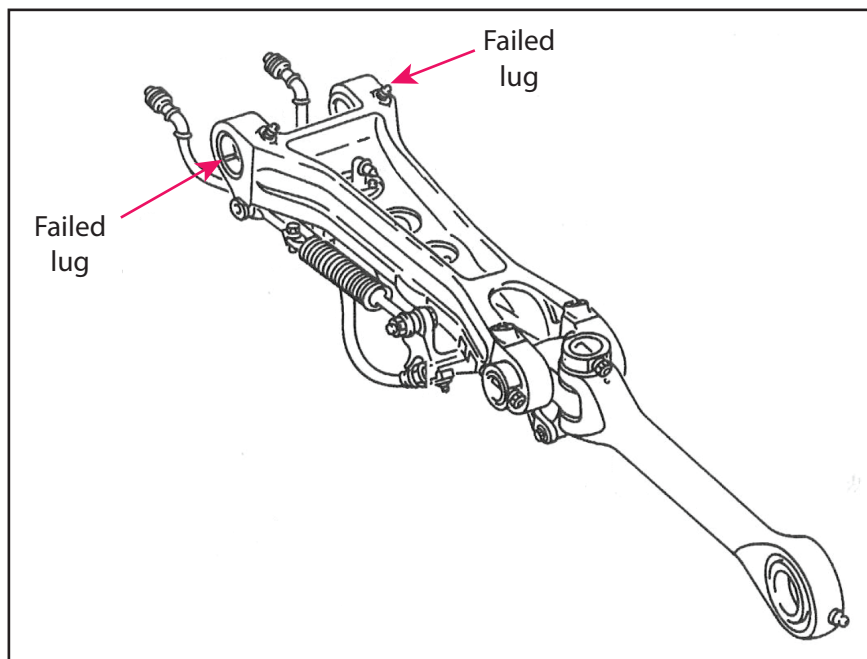
**Figure 5**

It was found that the side brace upper arm of the left main landing gear had suffered a structural failure. This had taken the form of a fracture of both lugs at their attachment to the through bolt in the fuselage-mounted pivot bracket (Figure 5). The failure

had rendered the side brace ineffective allowing the main leg to pivot outboard beyond its normal fully deployed position. This had resulted in non-design loading being transferred to the actuating cylinder and overload failure occurring in its attachment bracket to the fuselage structure. The unrestrained main trunnion had thus continued to translate outboard. Part of the lower fuselage had ultimately come into contact with the runway surface. The fractured lug recovered from the runway was found to be the forward of the two lugs of the side brace upper arm.

Side brace fracture locations
