FINAL REPORT

AAIU Synoptic Report No: 2005-018

Aircraft Type and Registration:	B737-800, EI-CSA
No. and Type of Engines:	2 x CFM 56-7B
Aircraft Serial Number:	29916
Year of Manufacture:	1999
Date and Time (UTC):	21 July 2004 @ 13.40 hrs
Location:	Approach to Skavsta Airport, Sweden
Type of Flight:	Public Transport
Persons on Board:	Crew - 6 Passengers - 184
Injuries:	Crew - Nil Passengers - Nil
Nature of Damage:	None
Commander's Licence:	Airline Transport Pilot's Licence
Commander's Details:	Male, aged 38 years
Commander's Flying Experience:	5,000 hours approximately (of which 1,500 were on type)
First Officer's flying Experience:	700 hours (of which 400 were on type)
Information Source:	Reports received from the Operator and Pilots. AAIU Field Investigation.

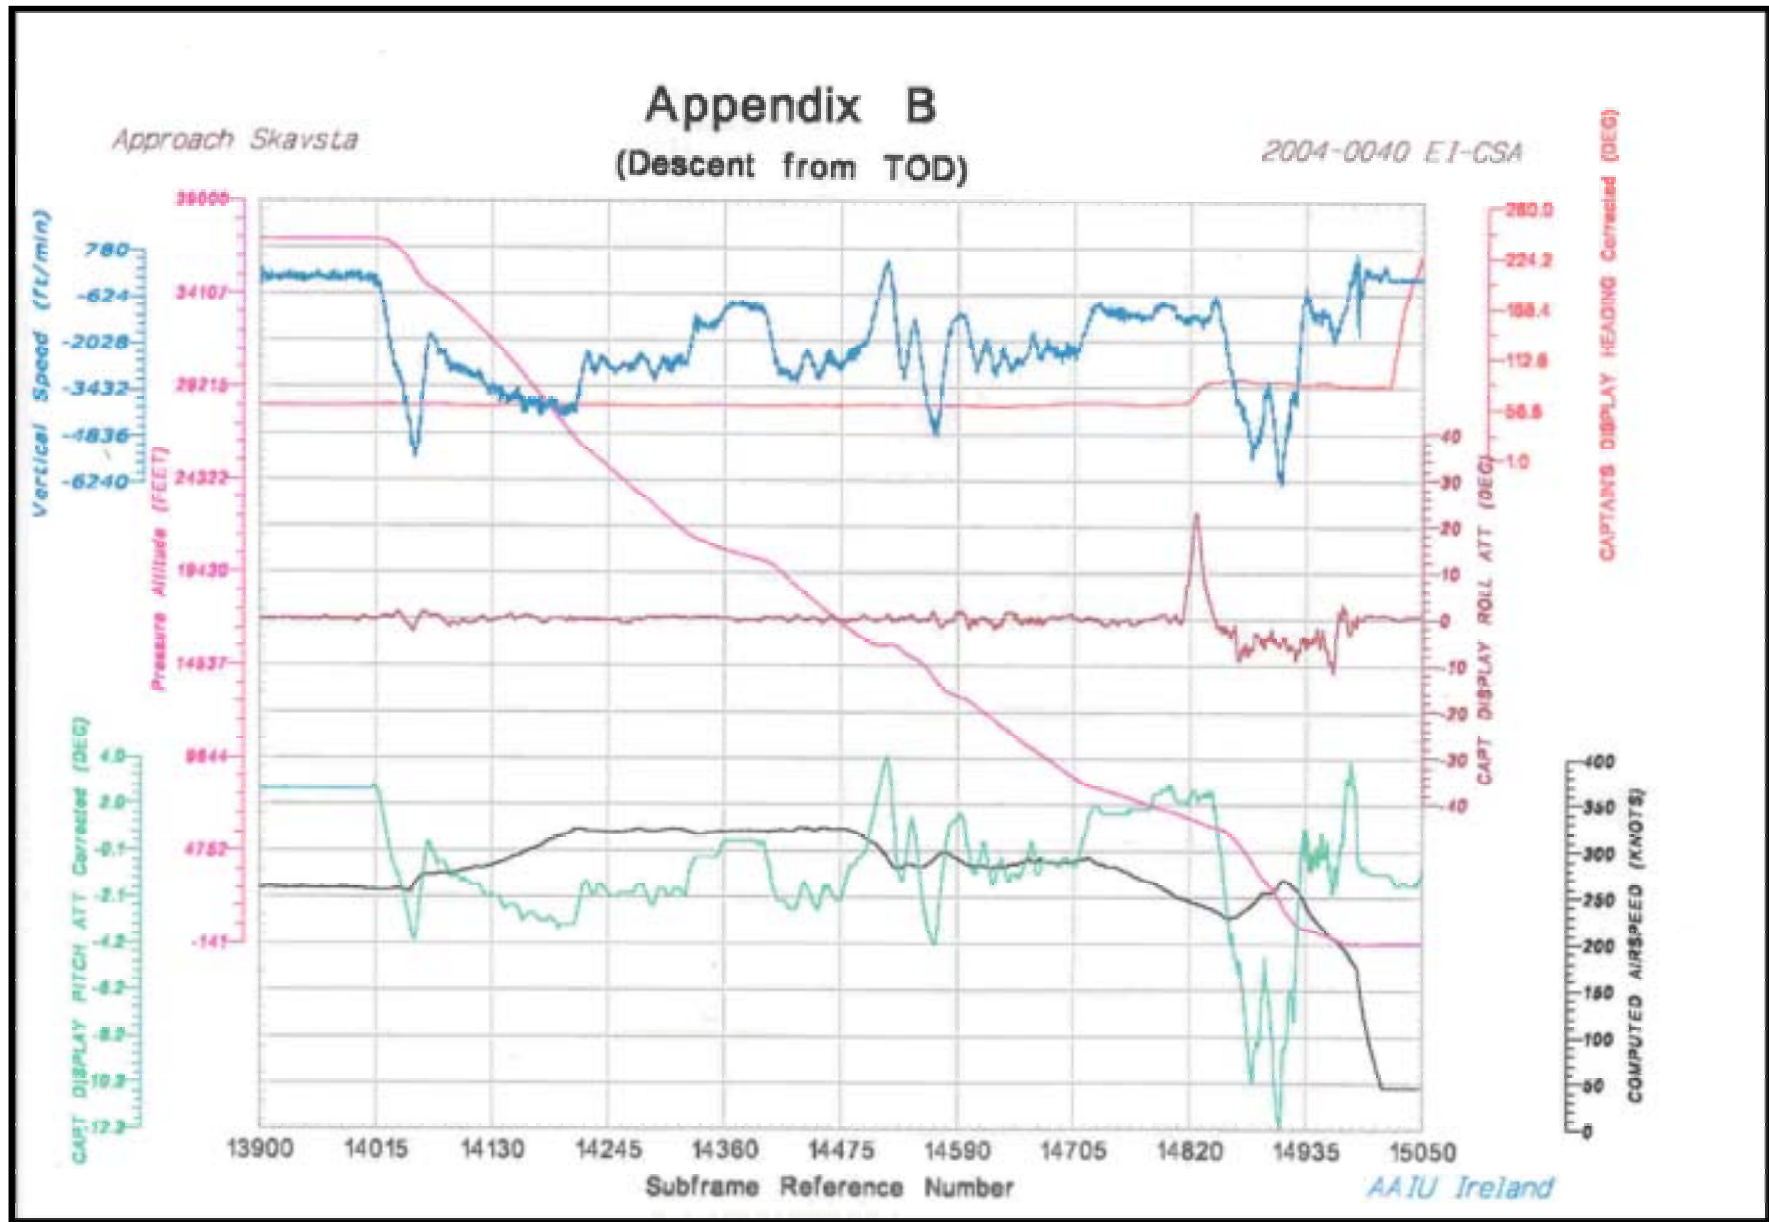
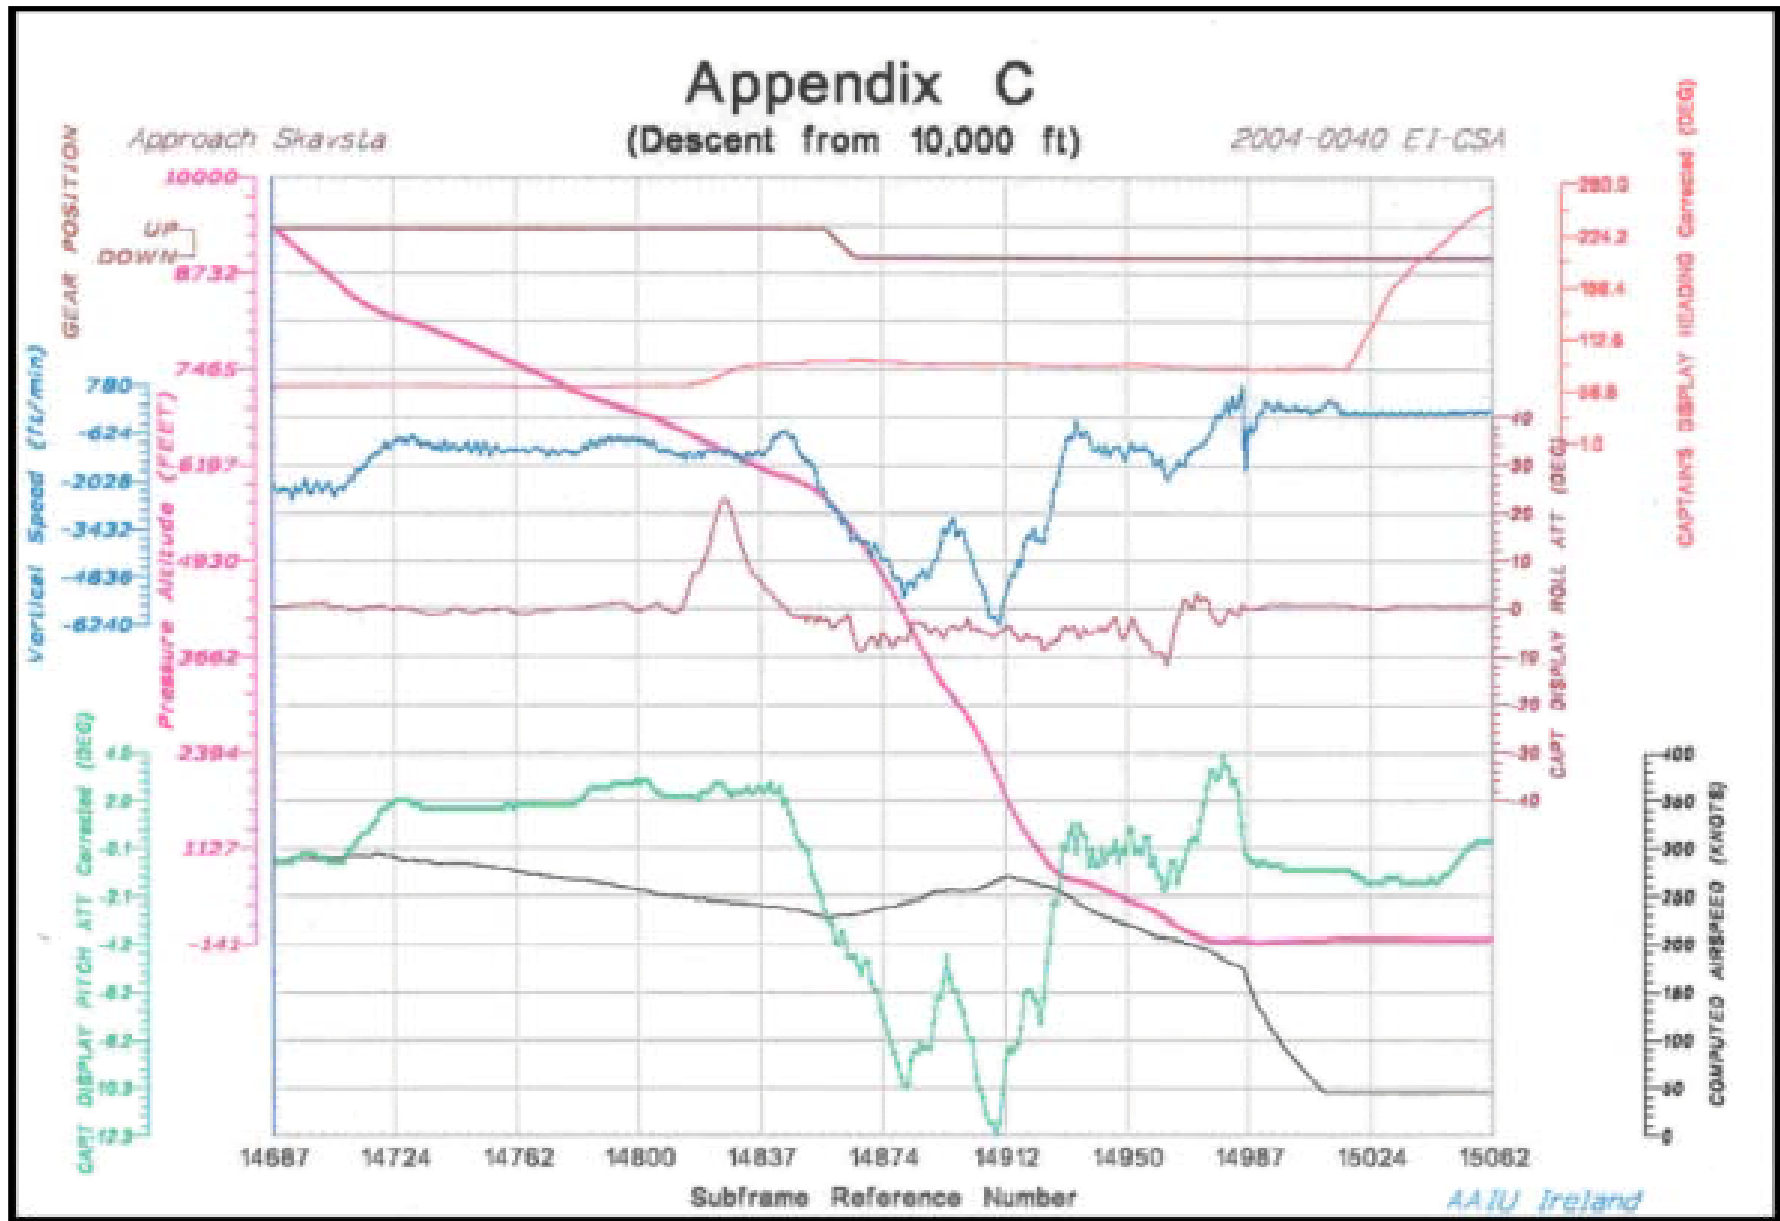
Nose down pitch reached 12.3° which, in turn, with the use of side slip contributed to excessive Rates of Descent (ROD), up to 6,200 fpm were recorded, and excessive speeds for flap deployment (**Appendix B and Appendix C**). These, in turn, led to GPWS alarms sounding which were ignored by the PF, as were the speed and height warning inputs from the PNF. All of the foregoing led to an unnecessarily high speed landing. In his written statement the PF attempted to address his behaviour over that fifteen minute period. He stated, inter alia *"I cannot understand what possessed me to continue the approach, I have replayed these events in my mind hundreds of times and, at no instance, do I arrive at the decision I took. I became fixated and lost sight of the big picture. It was only at such a late stage that the events taking place around me actually penetrated my mind; but by then I found myself in the landing roll"* and *"I cannot understand myself how it was possible for me to show such poor judgement. I can only imagine that certain personal stresses and tiredness affected my ability to think rationally. I do not offer this as an excuse but merely an insight into my deficiency for logical thought"*.
