REPORT

**ON ACCIDENT TO
M/S KINGFISHER AIRLINES ATR-72 AIRCRAFT
VT-KAC AT MUMBAI ON 10.11.2009.**

**AIR SAFETY DIRECTORATE
O/o DIRECTOR GENERAL OF CIVIL AVIATION
OPP. SAFDARJUNG AIRPORT, NEW DELHI**

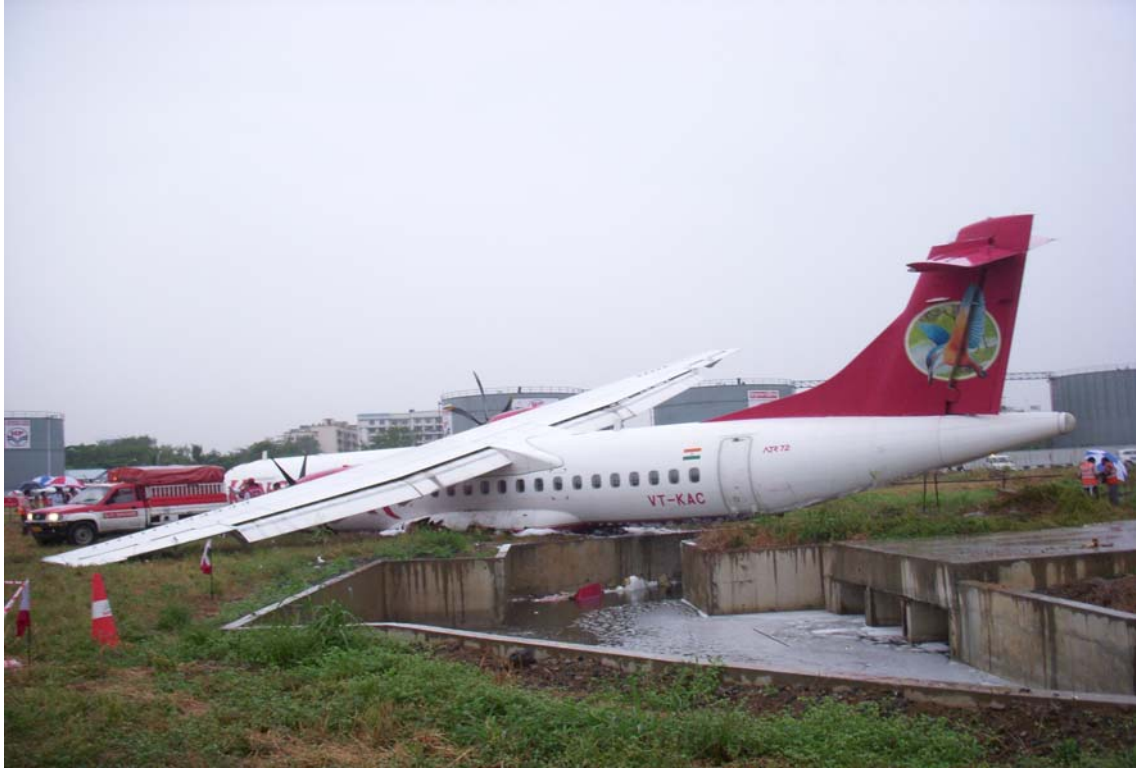
Aircraft in the final resting position

Both the wings were attached to the fuselage and there was no apparent damage to wing fuselage attachment. Damage was observed on the LH wingtip due to rubbing. Also aircraft wreckage was resting on LH wing tip on ground in final position of wreckage. The aircraft in final position resting on the LH wing tip

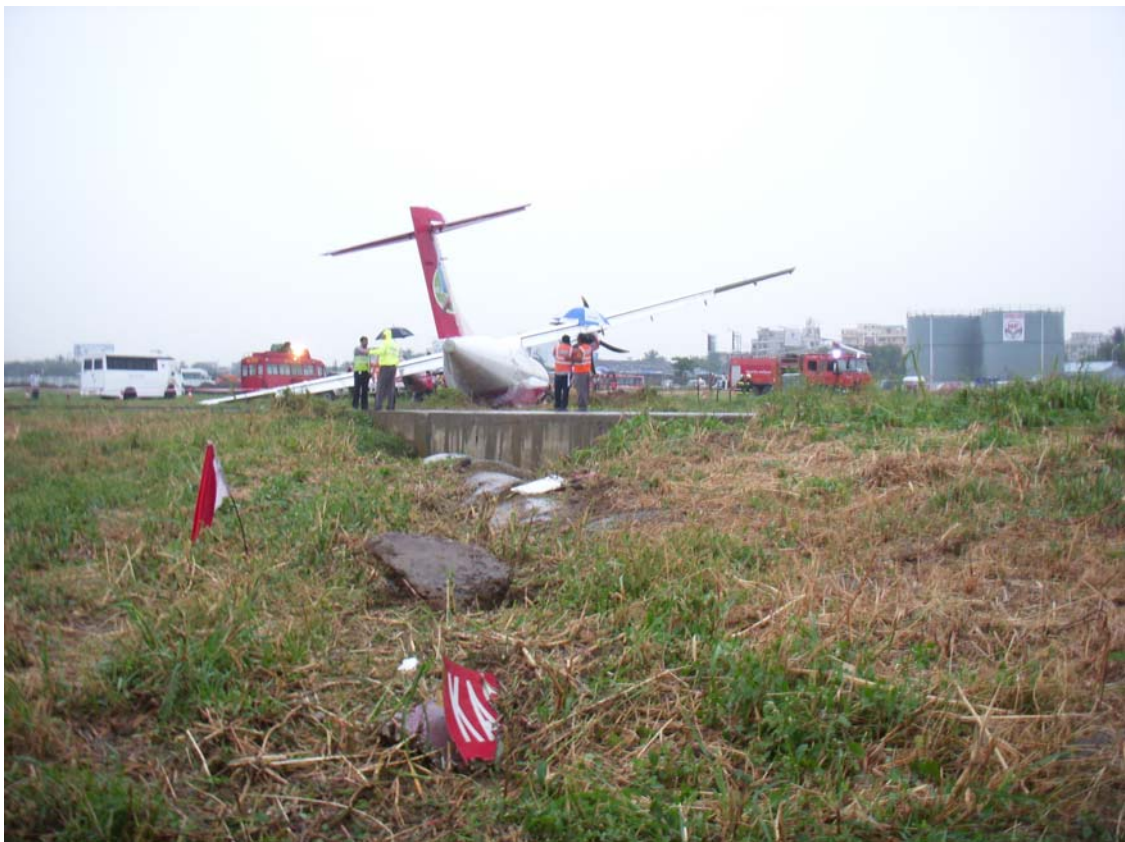
Rear view

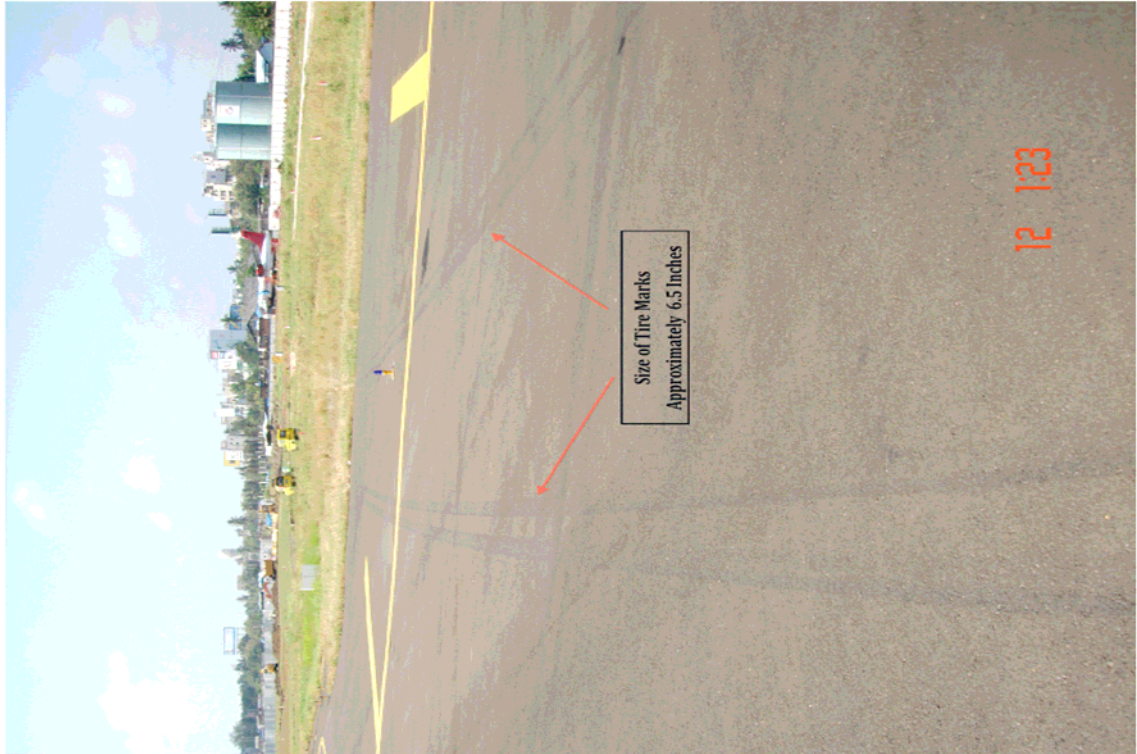
Point from where aircraft turned into unpaved wet area

Seeing the runway end, the pilot initiated 45 ° right turn after crossing N10 and exited the runway. It rolled into unpaved wet area. Just prior to leaving the runway the pilot asked for the Condition Levers to feather/fuel shutoff. After the aircraft stopped the right engine was still running though the Condition Lever was shut off. The crew then pulled the right emergency handle followed by the left emergency handle but the engine failed to shutoff. Crew came out from the emergency hatch and then went to the left side forward cabin emergency exit and assisted the cabin crew with the evacuation of passengers. All the passengers including crew evacuated safely without any major injuries. There was no fire.

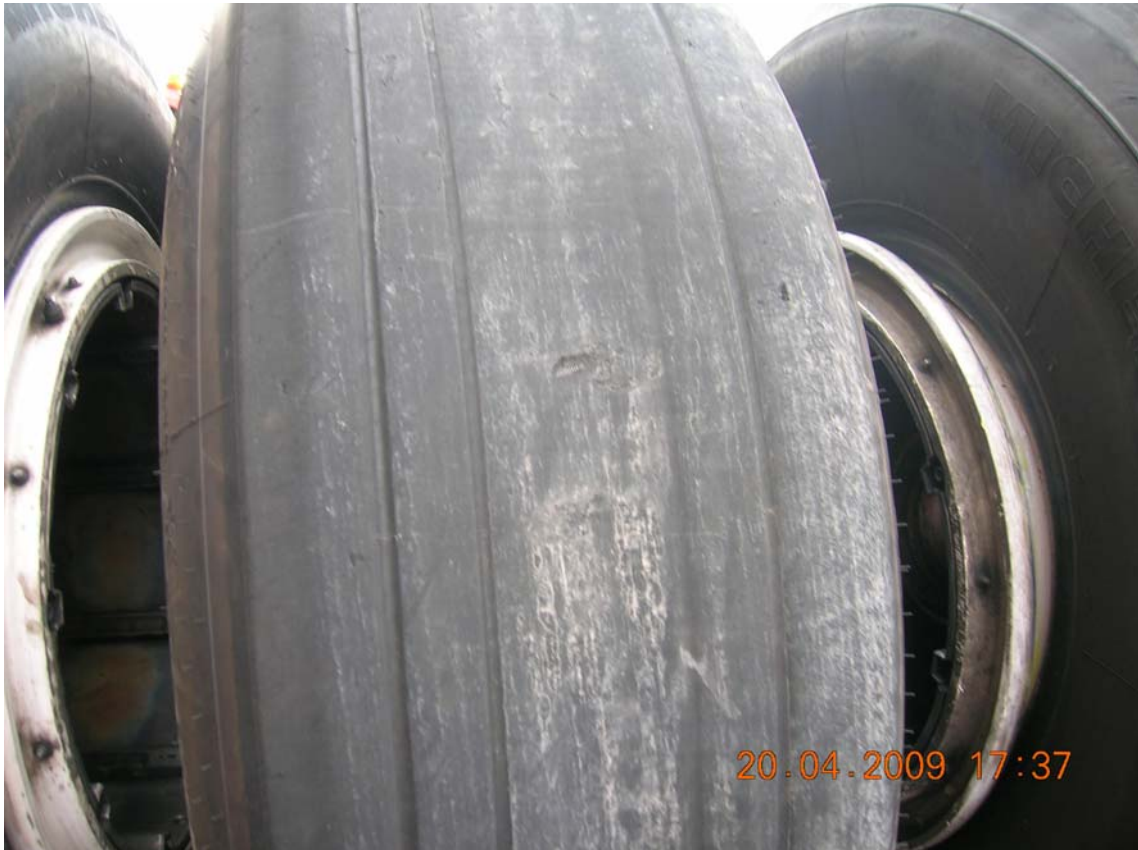
Tire inspection showed signs of partial aquaplaning. All the four brake assembly were inspected at Kingfisher wheel and brakes shop & no discrepancy was observed.

Tyre indicating signs of partial aquaplaning

The increase in landing distance on water-affected runways is primarily due to reduced coefficient of friction between the tyres and the runway. The reduced coefficient of friction can effect deceleration and directional control. The extent of reduction depends on the depth of water, the aircraft ground speed and type of aquaplaning. Reverted-rubber aquaplaning occurs when a wheel 'Locks up' (or stop rotating) is dragged across a wet surface, generating steam. The steam pressure lifts the tyre off the runway surface. Heat from the steam causes the rubber to revert to its unvulcanised state, leaving a black, gummy deposit of reverted rubber on the tyre. Reverted-rubber aquaplaning will also typically leave distinctive marks on the runway, with black marks on the edges of the contact patch and clean section in the middle where the runway surface have been effectively steam cleaned. Inspection of the tyres and the runway indicates that due to full brake application by the crew Reverted-rubber aquaplaning took place.
