DATA SUMMARY

Date and time	31 October 2008; 07:15 UTC
Site	Lanzarote Airport

Registration	EC-HJQ
Type and model	BOEING 737-800 S/N: 28387
Operator	Air Europa

Operation	Commercial air transport – Passenger – Non-scheduled
Phase of flight	Landing

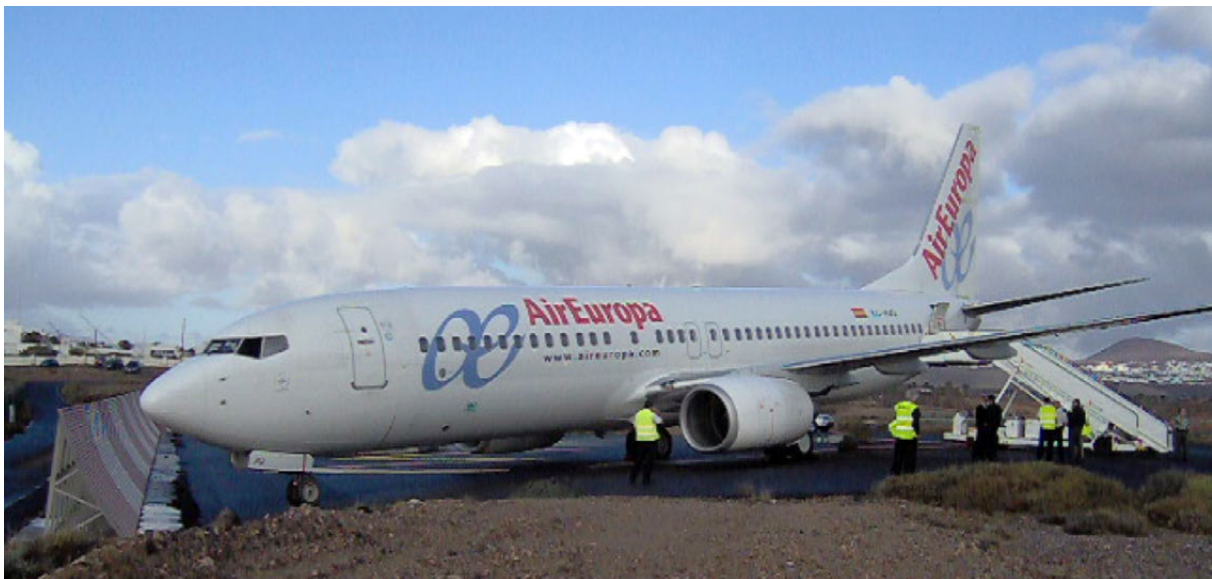
The airplane ran off the end of the runway at a ground speed (GS) of 51 kt and traveled over the 60 m of the stopway, before stopping approximately one meter away from the 03 threshold jet blast barrier, alongside the airport's perimeter fence.

Figure 1. Final aircraft position

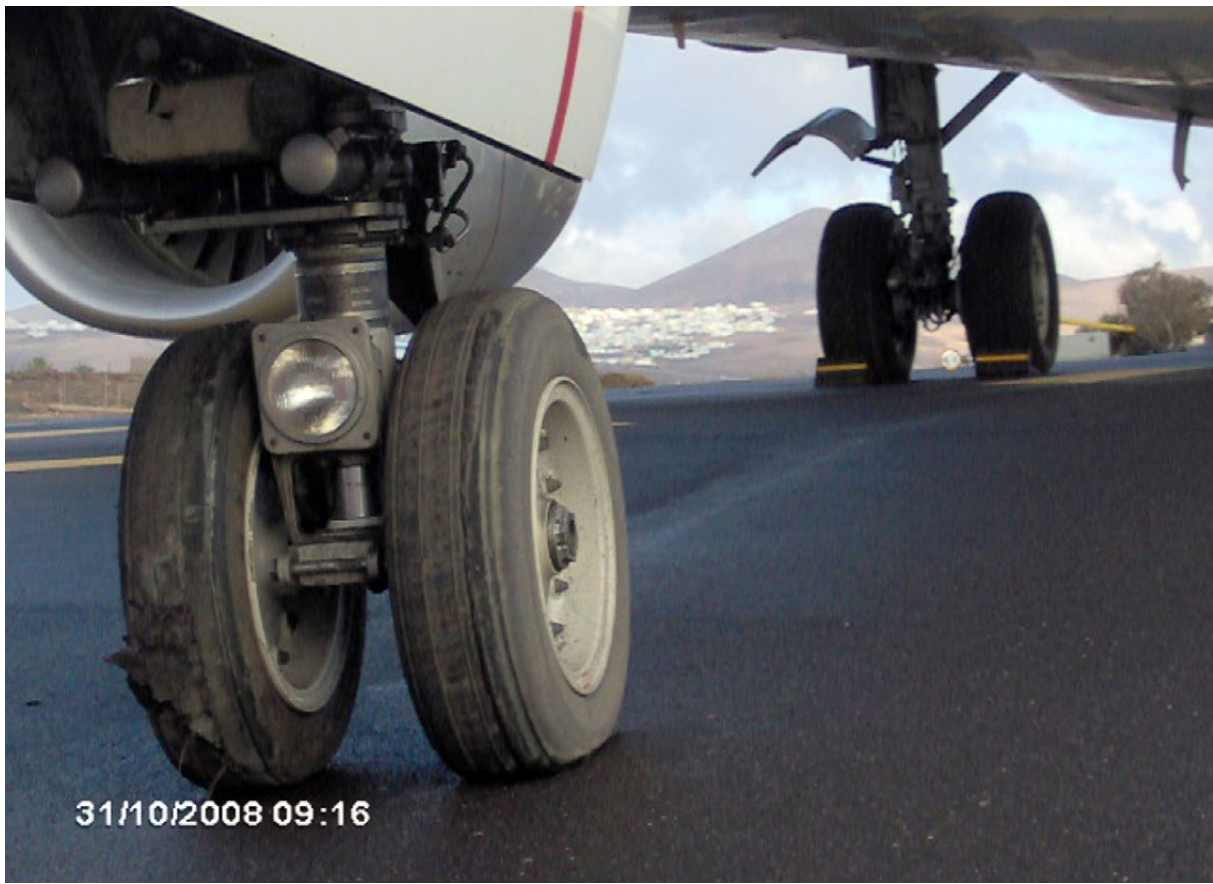
Figure 2. Damage to the nosewheel landing gear

The material damage was limited to the airplane's tires, which had to be replaced following an inspection by the airline's own maintenance personnel, and to two landing approach lights on the opposite threshold.

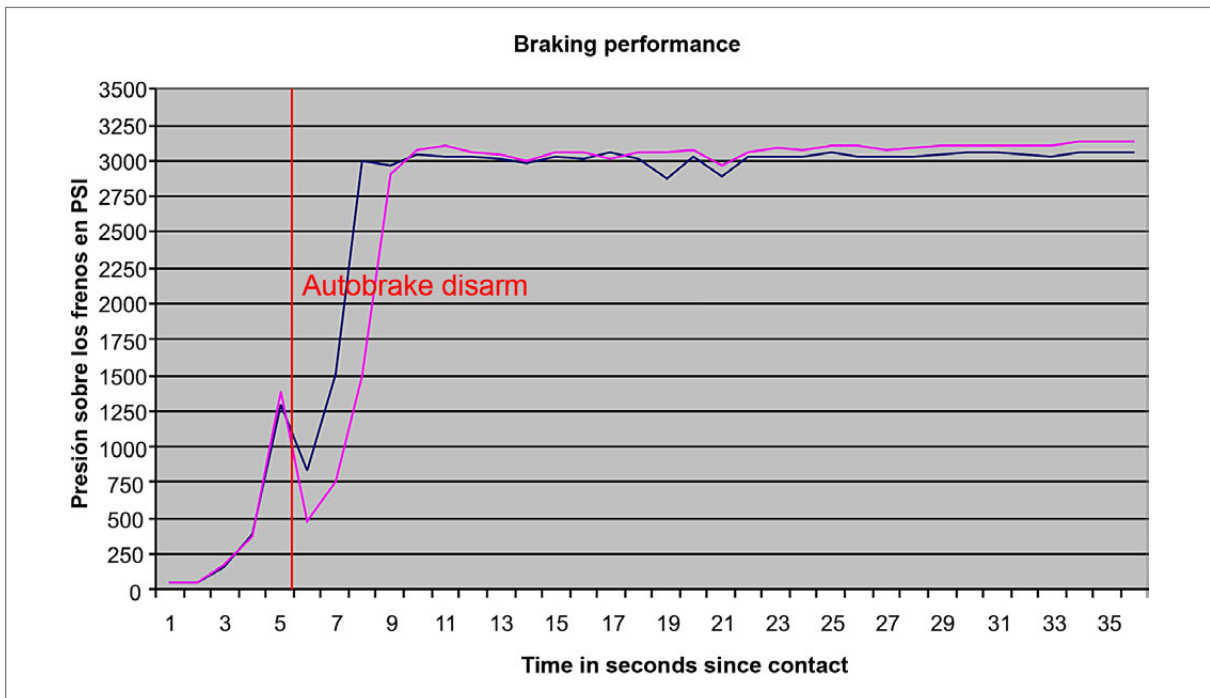
The autobrake was disengaged five seconds after touchdown. Maximum manual braking was applied from that point on.

Figure 3 shows the pressure (in psi) reached in the brake system as commanded by both the autobrake and by the pilots via the brake pedals. The magenta line (bottom) represents the right brake and the blue line (top) the left.

Figure 3. Braking performance during landing run

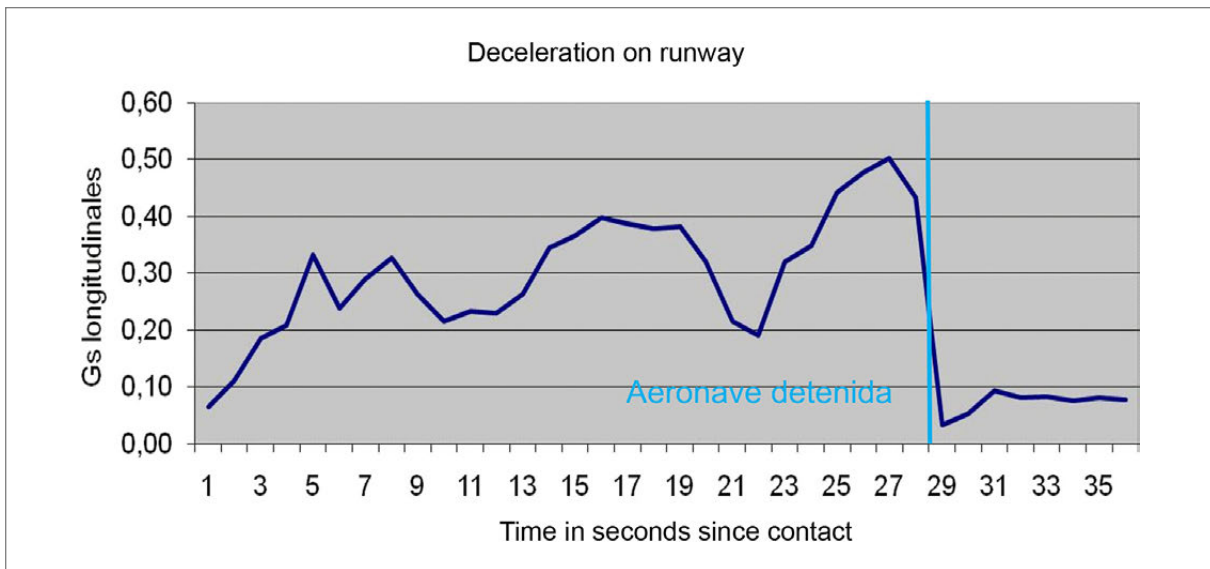
Figure 4 uses positive values to represent the negative longitudinal acceleration (deceleration) attained as a result of the braking action, as recorded by the FDR at ¼ second intervals.

Figure 4. Deceleration during landing

Experience and an analysis of flight recorder data shows that smooth braking yields values of up to 0.2 g. Between 0.2 g and 0.4 g is normal braking, with anything above 0.4 g being hard braking that is uncomfortable to the passengers. During the first 13 seconds of the landing run, while the airplane's speed was still high, the braking efficiency varied between the low values typical of normal braking and values corresponding to smooth braking. It then increased, though it dropped during a 2 to 3 second period, reaching the highest values at the end of the run.

Between 9 and 12 seconds after touchdown, the deceleration decreased almost by half, to -0.22 g, while maximum pressure (3,000 psi) was applied to the brakes. The most likely explanation is that the airplane was crossing the area of runway close to the 1,000 ft marks for runway 03 where the rubber buildup is extensive and the coefficient of friction lower, especially if the surface is wet or damp, as the crew had noted and as was verified during the investigation.

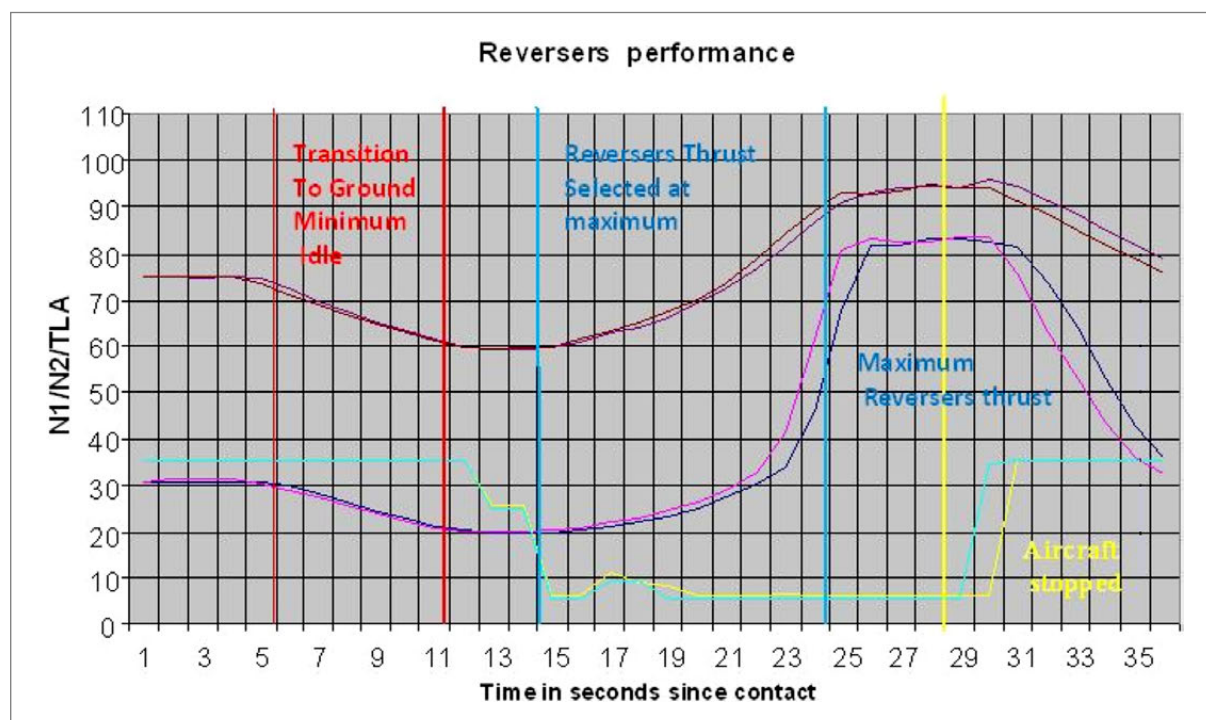
Figure 5 shows the values of N1 (bottom curves in magenta for the no. 1 engine and indigo for the no. 2), N2 (top curves in purple for the no. 1 engine and brown for the no. 2) and TLA (throttle lever position) (bottom curves in straight segments, yellow for the no. 1 engine and blue for the no. 2) from the moment of touchdown until the end of the landing run.

As shown in the graph, five seconds after contact was made with the runway surface, the N1 and N2 engine parameters start to decrease without any change to the position of the throttle levers (TLA). As noted in 1.3.2, this is because the engines transitioned from approach idle to ground minimum idle. This transition is complete six seconds later. When the crew selects maximum reverse thrust, it takes the engines on the order of ten seconds to achieve this commanded maximum reverse thrust.

Figure 5. Engines performance during landing – reversers thrust

The “approach idle” mode in the engines is selected automatically when the flaps are in a landing configuration, since the higher % RPM for N1 and N2 lowers the engine spin-up time in the event that a go around is required. The engine’s ability to respond is degraded, therefore, when they transition to “ground minimum idle”.

- REC 52/11.** It is recommended that the aircraft manufacturer include in the appropriate aircraft documentation (FCTM, AFM, etc.) a warning on how delaying an input to the throttles after landing, either to activate the reversers or to execute a go around, can result in a corresponding delay in engine response.

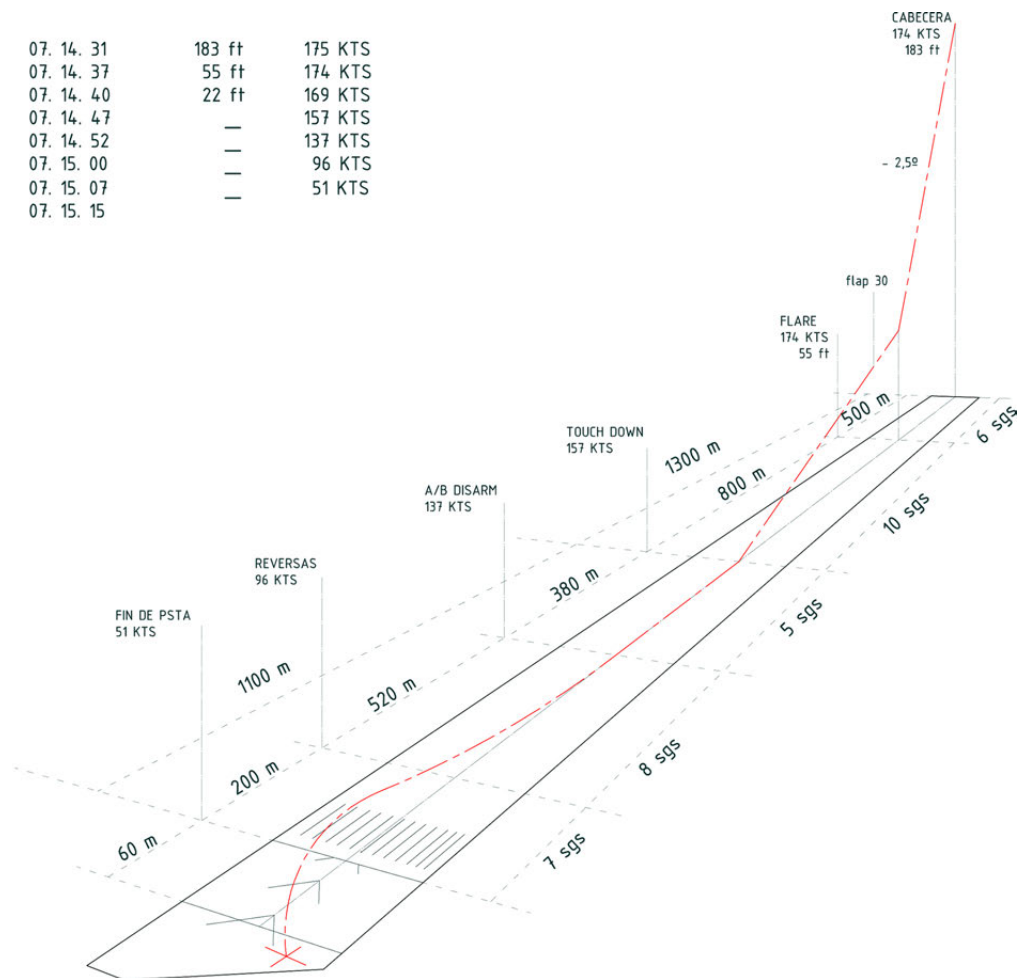
APPENDIX B

cabecera 21	07. 14. 31	183 ft	175 KTS
flare	07. 14. 37	55 ft	174 KTS
flap30	07. 14. 40	22 ft	169 KTS
touch down	07. 14. 47	—	157 KTS
A/B disarm	07. 14. 52	—	137 KTS
reversas	07. 15. 00	—	96 KTS
colisión fin pista	07. 15. 07	—	51 KTS
stop	07. 15. 15	—
