KNKT.07.11.27.04

**NATIONAL
TRANSPORTATION
SAFETY
COMMITTEE**

**Aircraft Accident Investigation Report
BOEING AIRCRAFT COMPANY B737-200
PK-RIL
ABDURRACHMAN SALEH AIRPORT,
MALANG
EAST JAVA
REPUBLIC OF INDONESIA**

1 NOVEMBER 2007

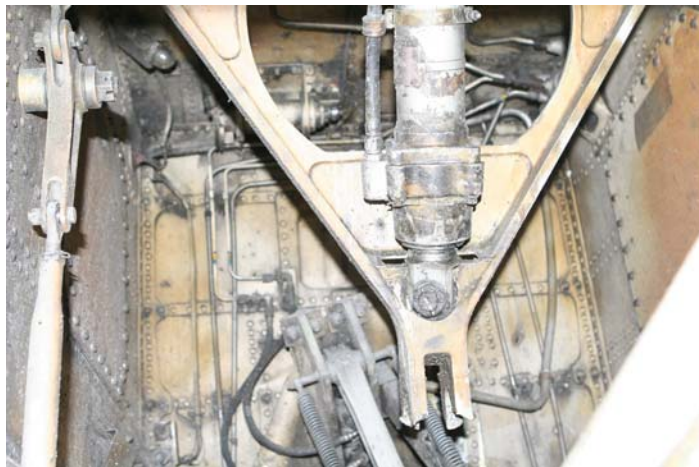
The underside of the forward fuselage area, extending aft to the electrical and electronics compartment bay, was severely damaged. The damage occurred following contact with the runway after the lower drag strut of the nose landing gear fractured. This resulted in the rearwards collapse of the nose landing gear, and the separations of the lower nose landing gear shock strut and wheel assembly. Both nose landing gear axles and wheel rims were fractured by the impact forces.

Figure 1: Fractured lower strut of the nose landing gear

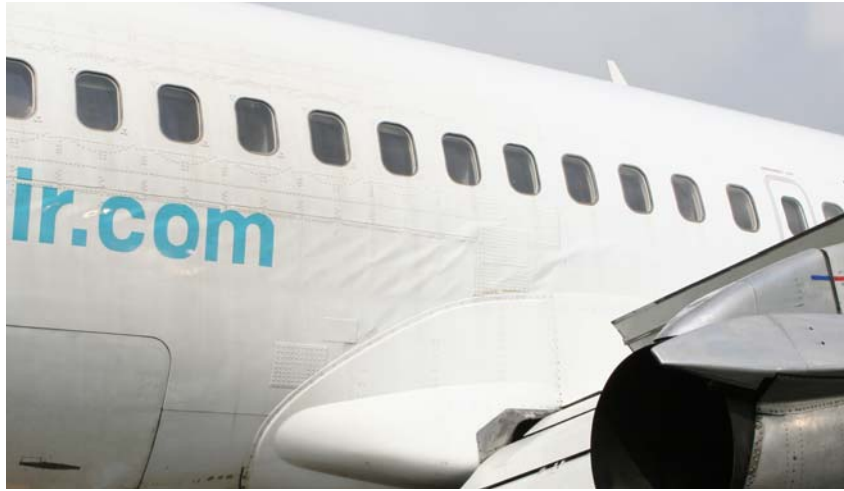
The right centre fuselage section aft of the right wing was wrinkled, and the right inboard wing section was deformed.

The skin of that section of the wing was also wrinkled, and it was 'oil canned'⁴. The left engine cowling was damaged due to impact with the runway, and there was oil leakage from the left engine accessory gearbox.

Figure 2: Wrinkling on the right centre fuselage section

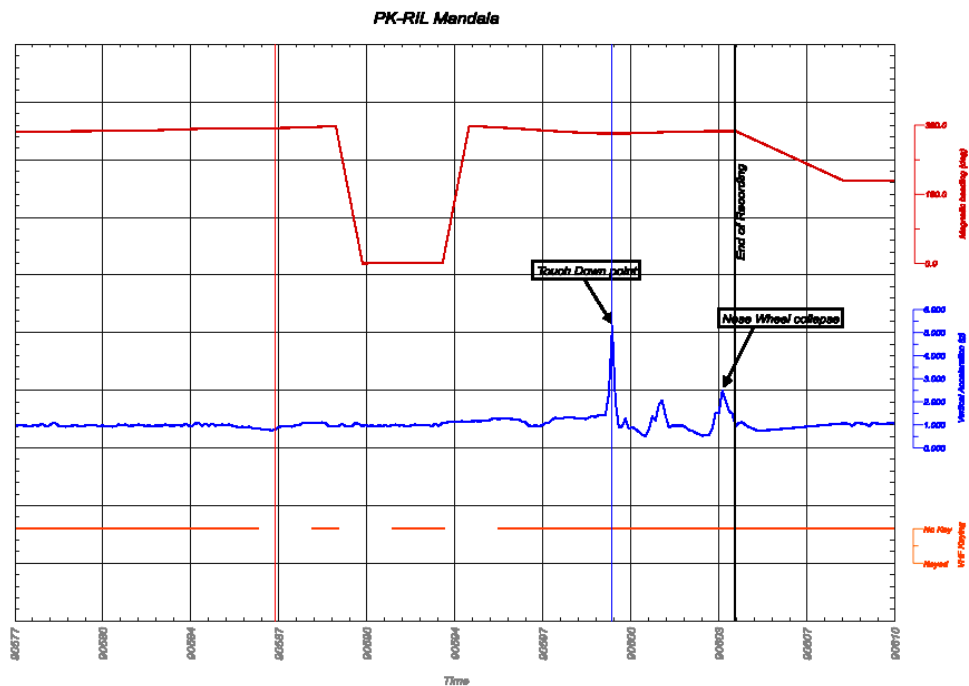
The assessment and verification of the FDR data tables also revealed that during the 22 seconds before the severe hard landing initial touchdown, the aircraft's average derived ROD had been about 1,750 feet / minute. That therefore represented an unstabilized approach.¹⁴

Derivation of the FDR data also revealed that the aircraft bounced to a height of about 20 feet after the initial severe hard landing.

Figure 3: Recorded flight data plots
